# Related Companies Office Lighting Retrofit

**A complicated, after-hours lighting retrofit that greatly improved the office environment, reduced lighting energy use by 56% and shaved peak demand from 70kw to 30kw.**

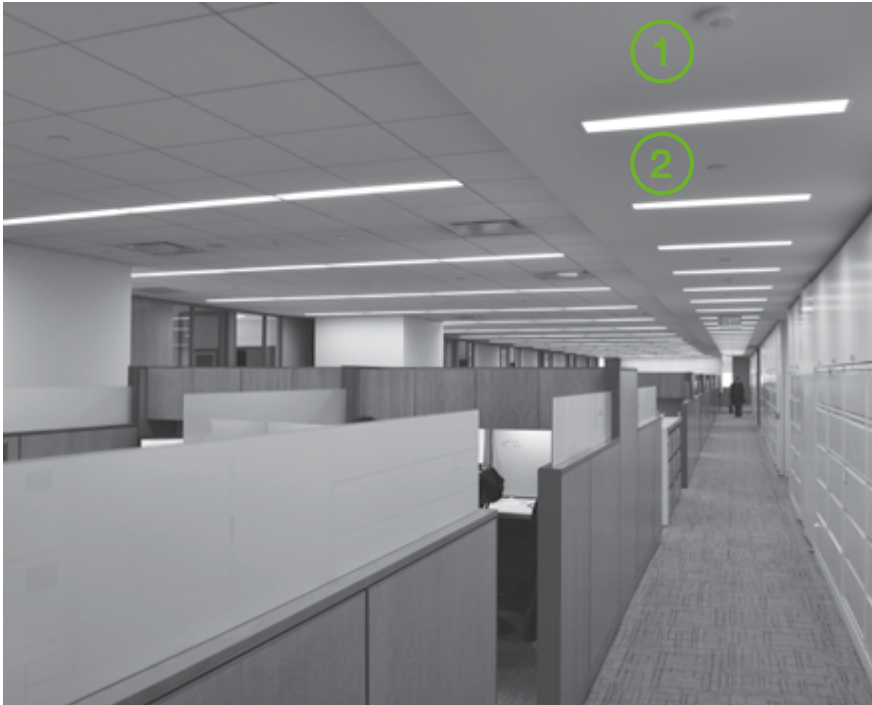
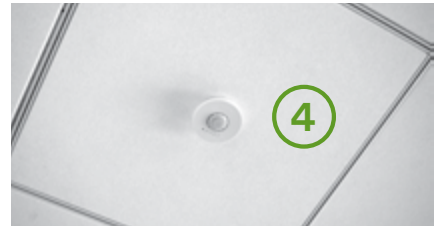
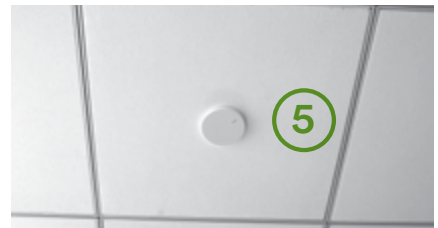
The retrofit retained the existing fluorescent light fixtures, but increased functionality through the addition of dimmable ballasts, carefully positioned wireless sensors and a control system that features a web-based user interface.

**1 Existing Fluorescent Fixtures**  
The project utilized the existing fixtures, modifying them only as need to receive dimmable ballasts

**2 New Dimmable Ballasts (not visible)**  
Lutron Electronics  
[www.lutron.com](http://www.lutron.com)  
Each existing fixture was outfitted with dimmable ballasts to enable the functionality required

**3 Wireless Daylight Sensor**  
Lutron Electronics  
[www.lutron.com](http://www.lutron.com)  
The daylight sensors are small and as the system is commissioned can be moved (or more added) to optimize the functioning of the system

**4 Wireless Occupancy Sensor**  
Lutron Electronics  
[www.lutron.com](http://www.lutron.com)  
This equipment can also be moved or added to as needed to ensure optimal function of the system

**5 Wireless Sensor Module**  
Lutron Electronics  
[www.lutron.com](http://www.lutron.com)  
This small unit acts as a relay for wireless information, ensuring that the control panel can communicate with all sensors and ballasts in the various rooms and spaces

Lutron's fully dimmable system was cost effective, in part, because the sensors and controls communicate wirelessly, avoiding the costly installation of additional wiring. Furthermore, the wireless nature of the system enabled the occupancy and daylight sensors to be located and relocated as necessary to optimize performance. This was very attractive to Related because the primary reason that many of their existing occupancy sensors did not function properly was due not to a technology error but due to poor location. The wireless system not only allowed occupancy sensors to be moved but for additional sensors to be added easily when necessary. Ultimately, this flexibility and the low installation costs gave Related the confidence to install occupancy sensors not only in the conference rooms but also in private offices and throughout the open office areas, eliminating the need for a time clock.

The programmability of the occupancy sensor controls enabled further savings. For example, during "working hours", when a row of cubicles is unoccupied, the occupancy sensor is programmed to dim the lights of that particular row enough to save energy but not enough to be perceptible to the neighboring rows. After "working hours", the lights in unoccupied rows turn off, unless a neighboring row is still occupied, in which case they simply dim.
