ENGINE 16

223 EAST 25TH STREET MANHATTAN, NY

MICHAEL INGUI, RA
Certified Passive House Designer
AMY FAILLA, RA
Certified Passive House Designer

BAXT INGUI - COMPLETED PASSIVE PROJECTS

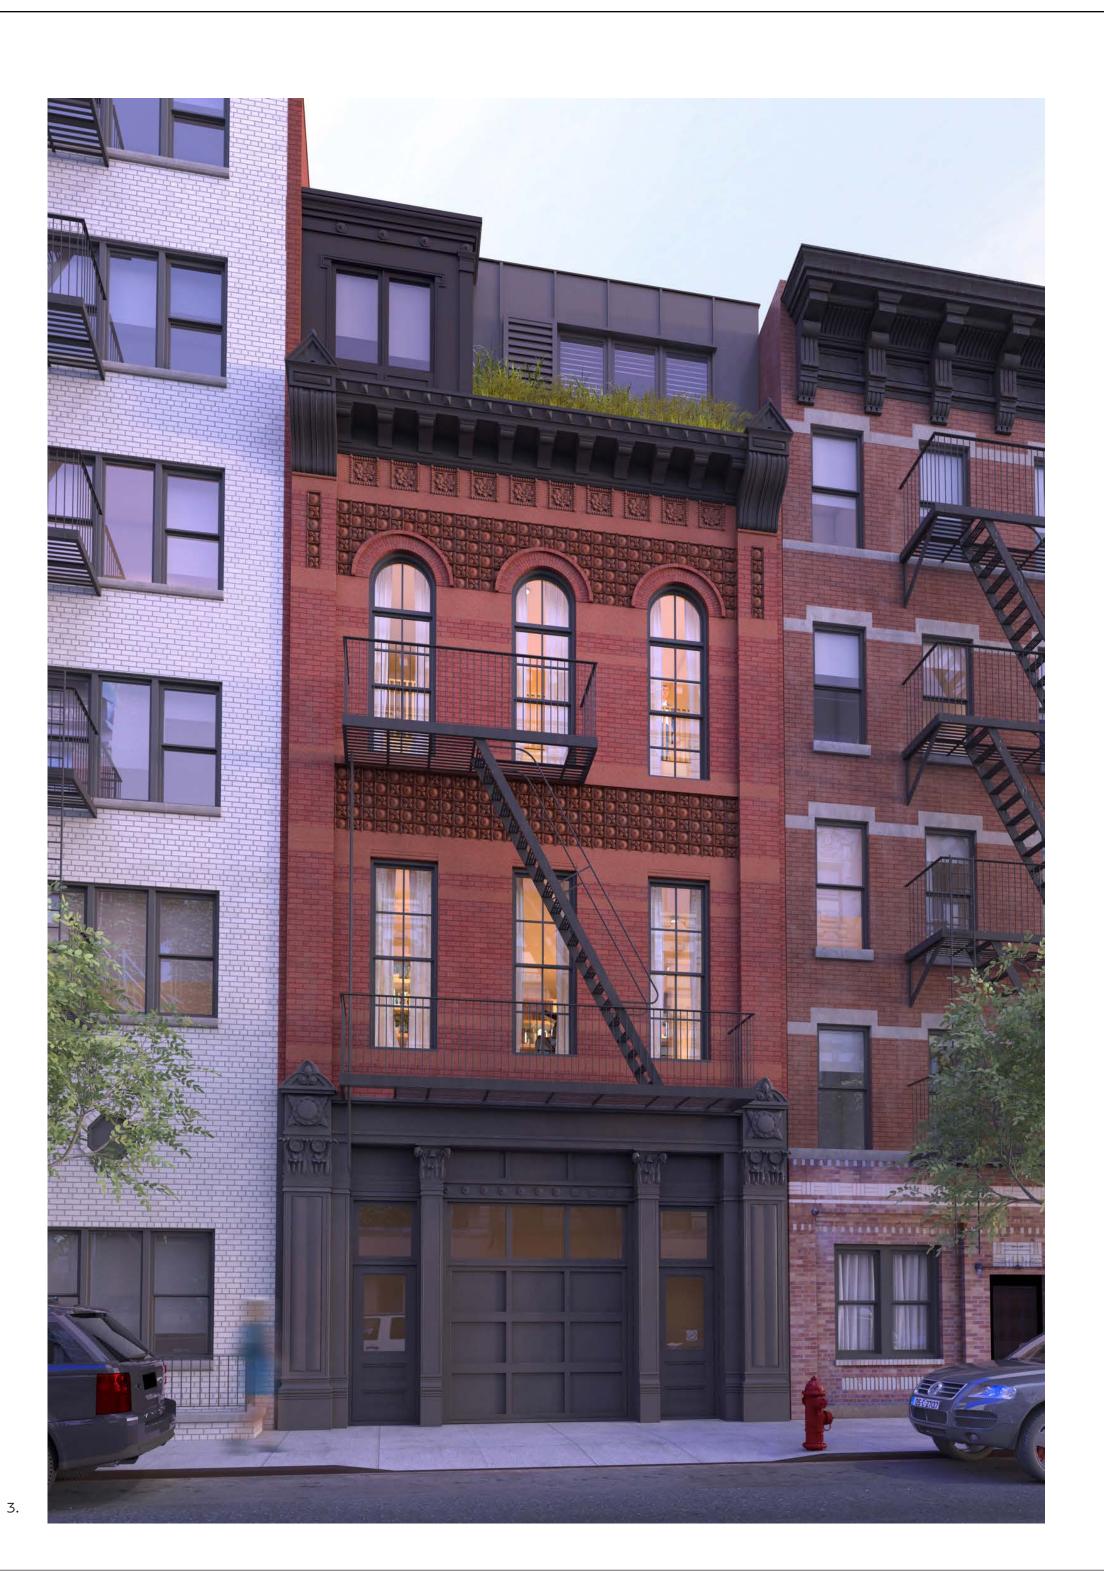
1. PHOTO: CIRCA
1950.
2. PHOTO: CIRCA
1925.
3. RENDERING OF
PROPOSED FRONT
FACADE.
CREDIT:
PERSPECTIVE ARTS

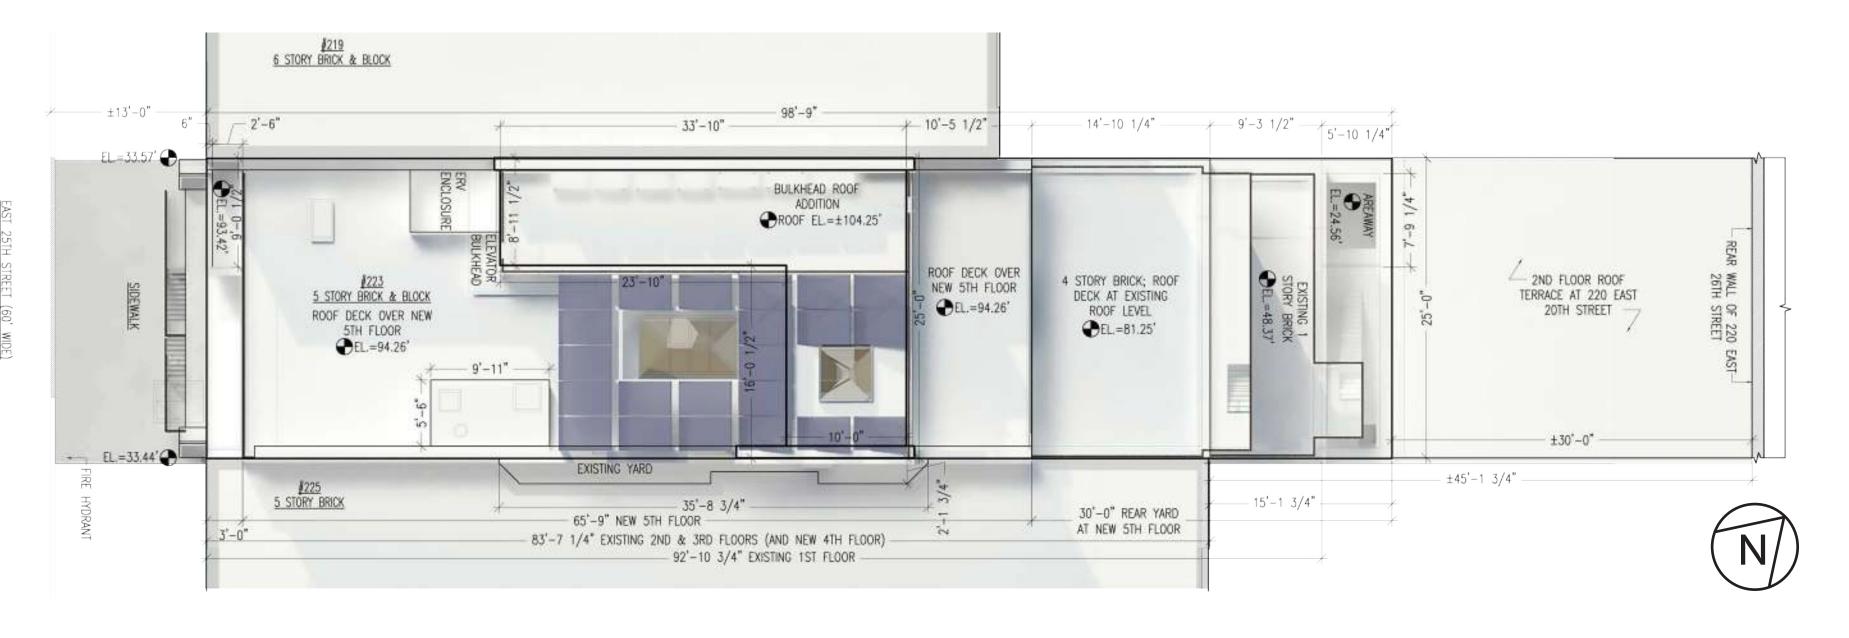
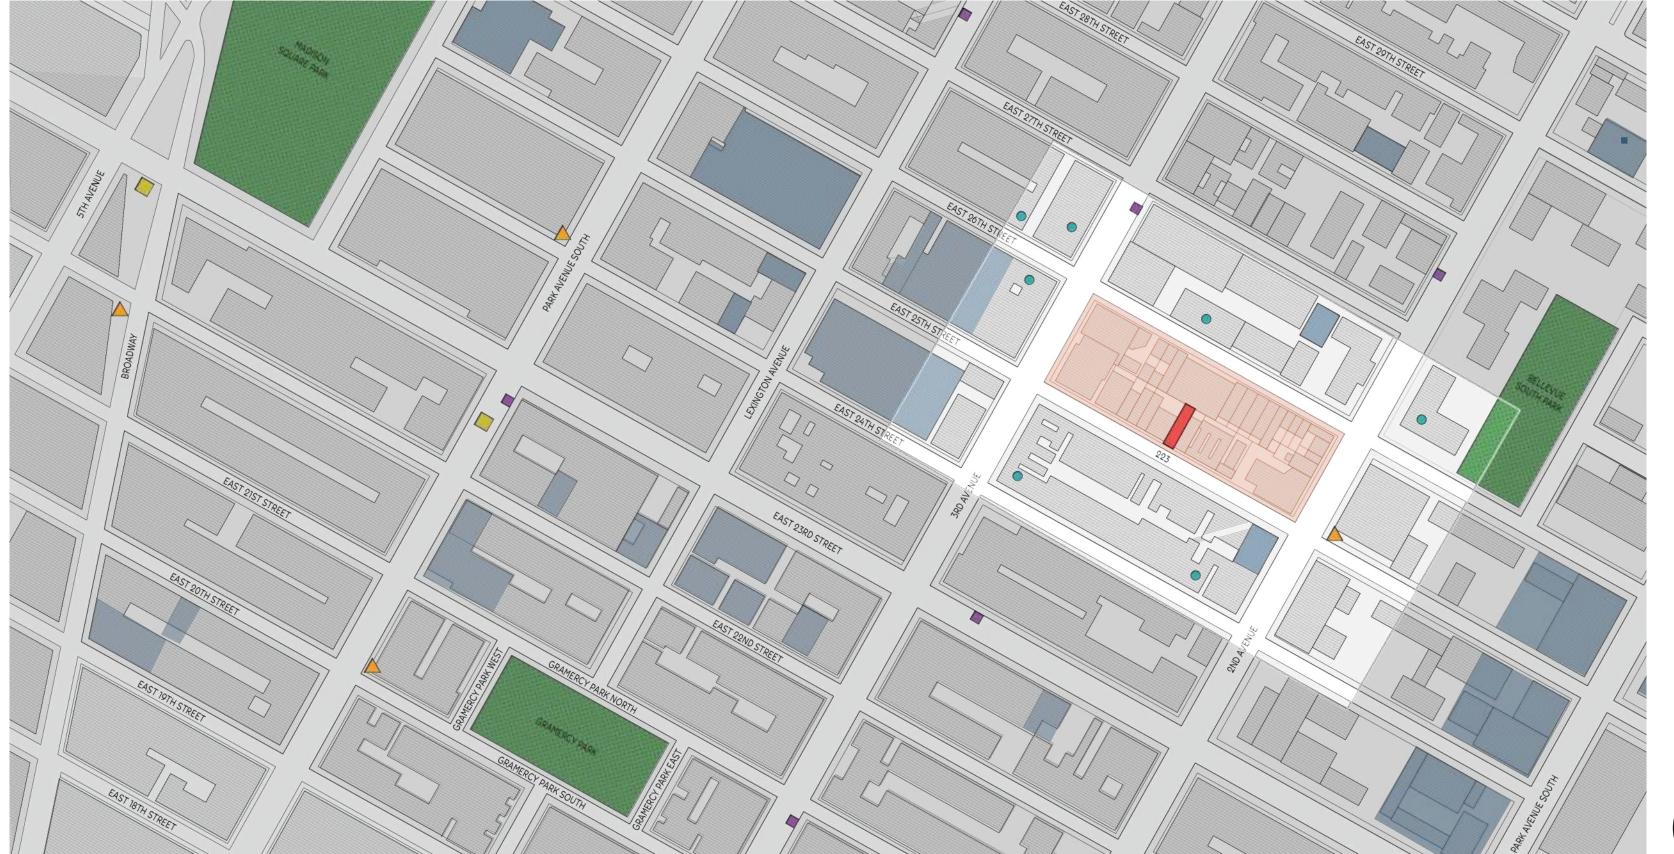
SITE PLAN / CONTEXT

1. PLOT PLAN
(PROPOSED)
2. SITE PLAN/ CONTEXT

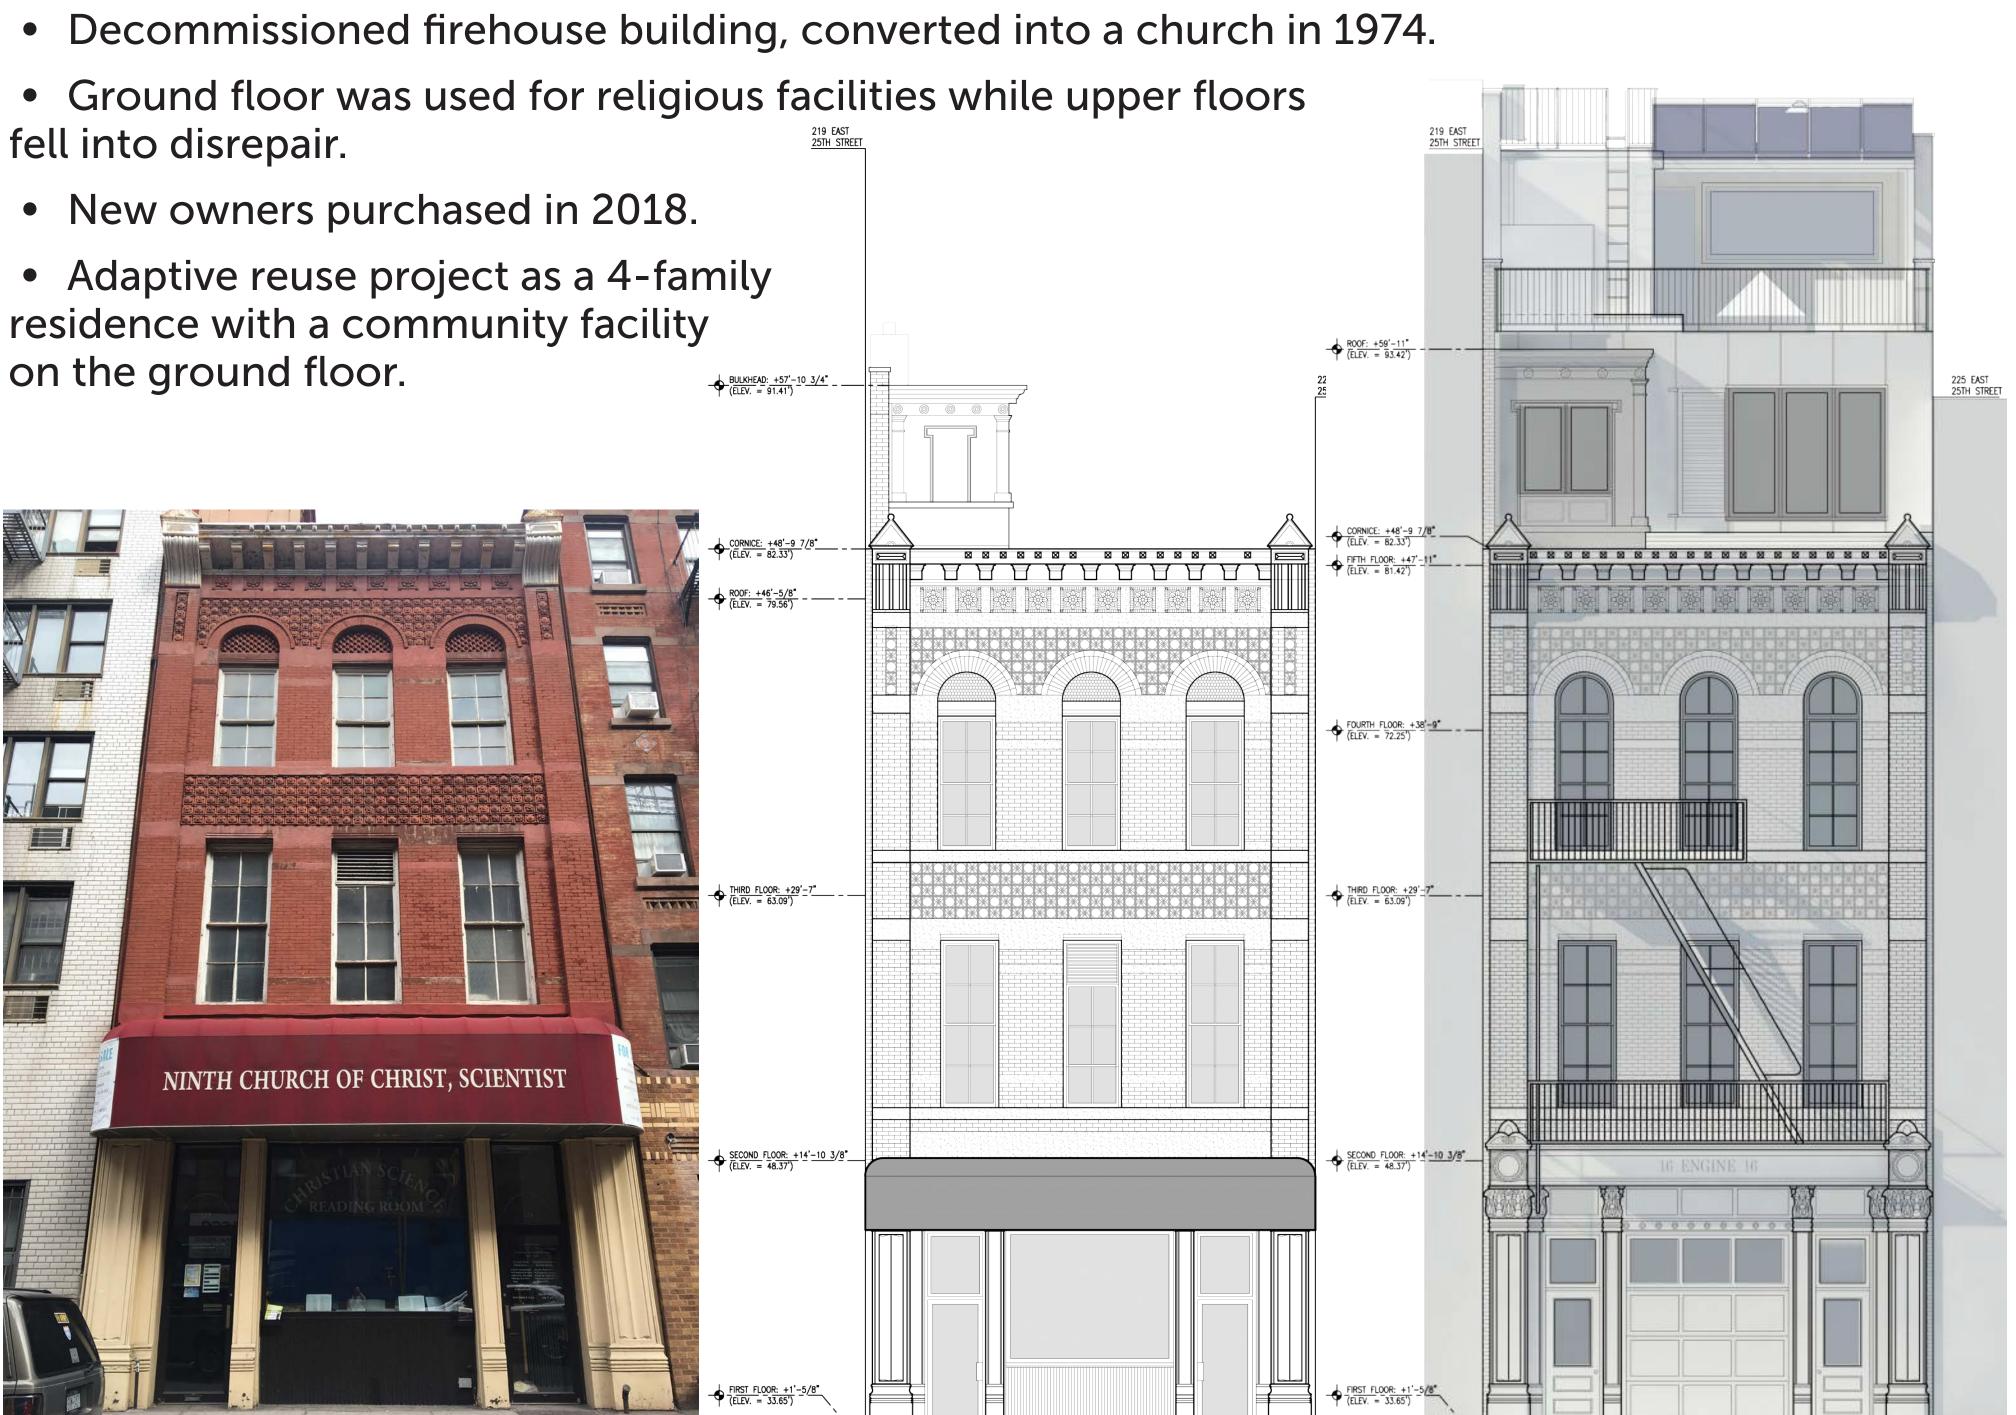
FRONT FACADE ELEVATIONS

I. EXISTING FRONT
FACADE PHOTO
(SOUTH FACING)
2. EXISTING FRONT

(SOUTH FACING)

FACADE
(SOUTH FACING)
3. PROPOSED FRONT
FACADE

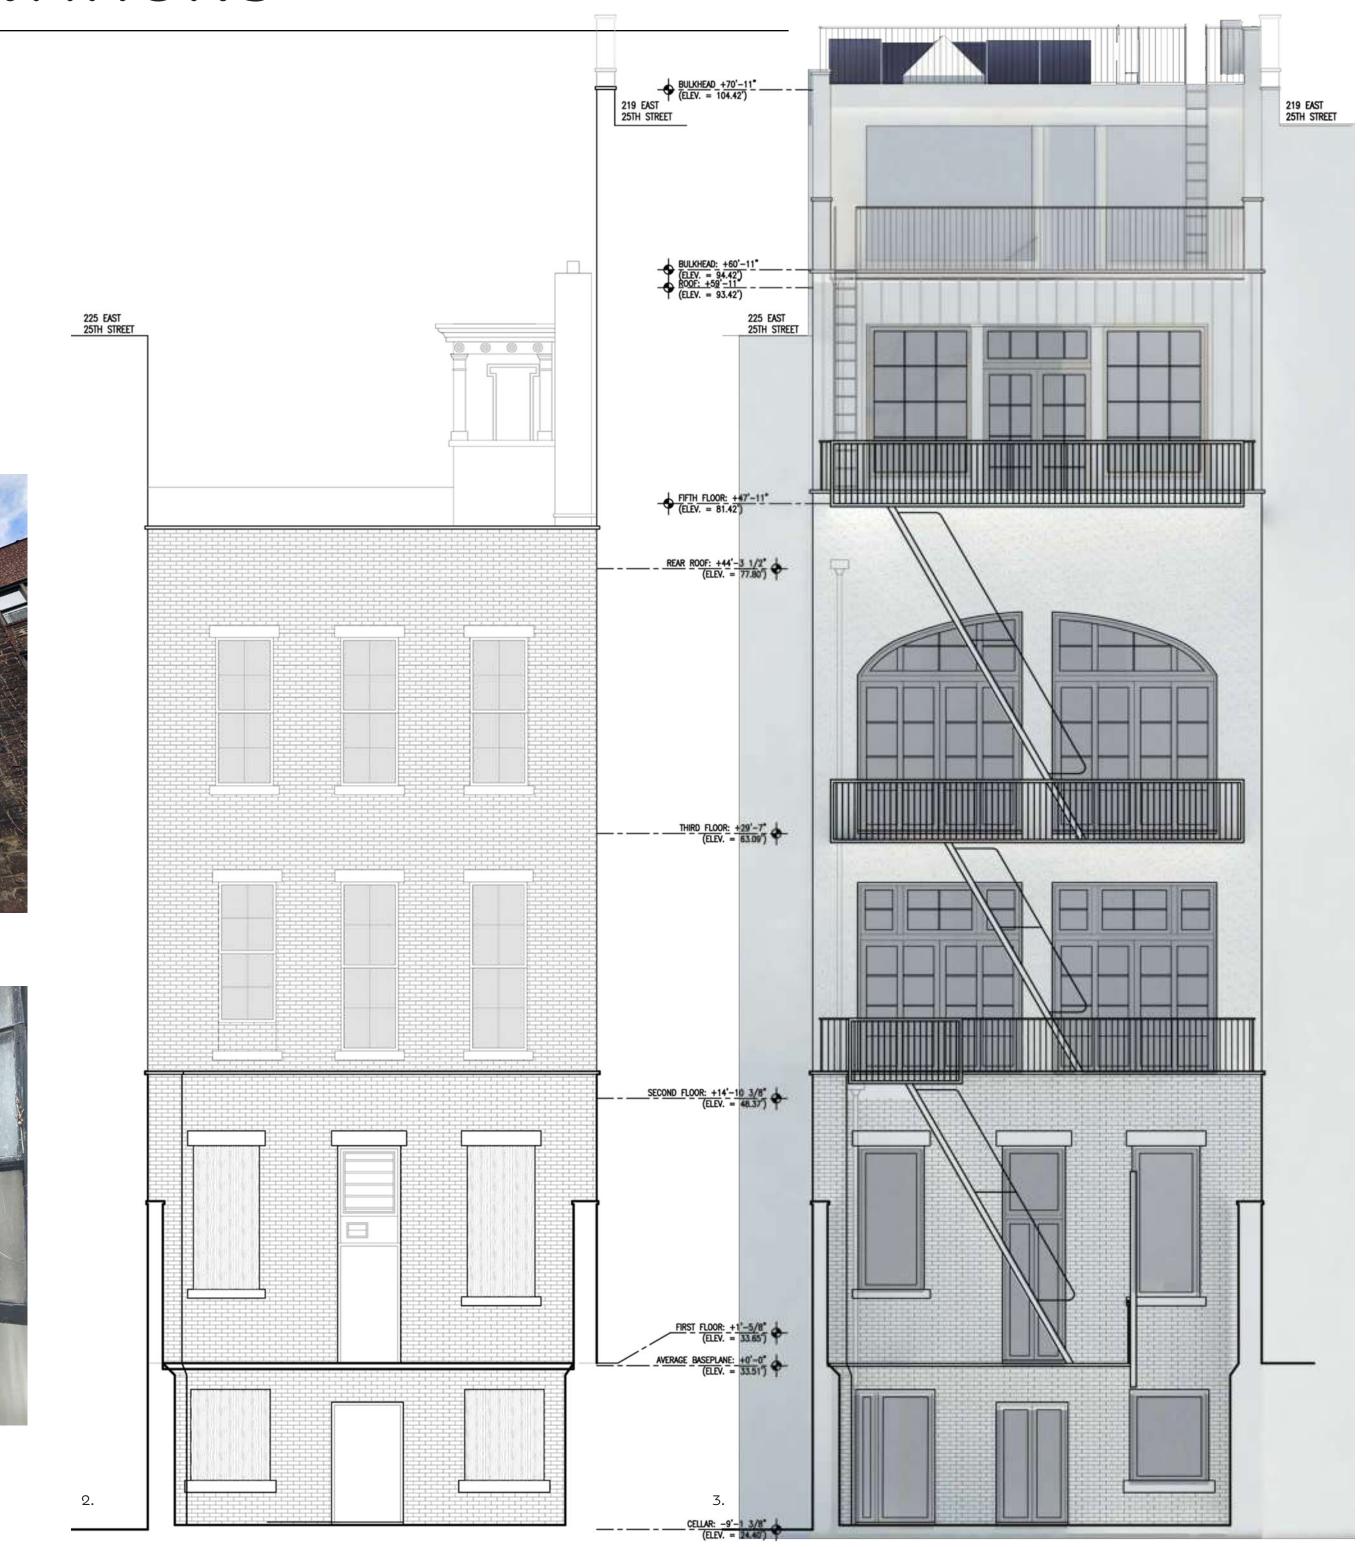
REAR FACADE ELEVATIONS

1. EXISTING REAR FACADE PHOTOS (NORTH FACING)

2. EXISTING REAR FACADE

(NORTH FACING)
3. PROPOSED REAR
FACADE
(NORTH FACING)

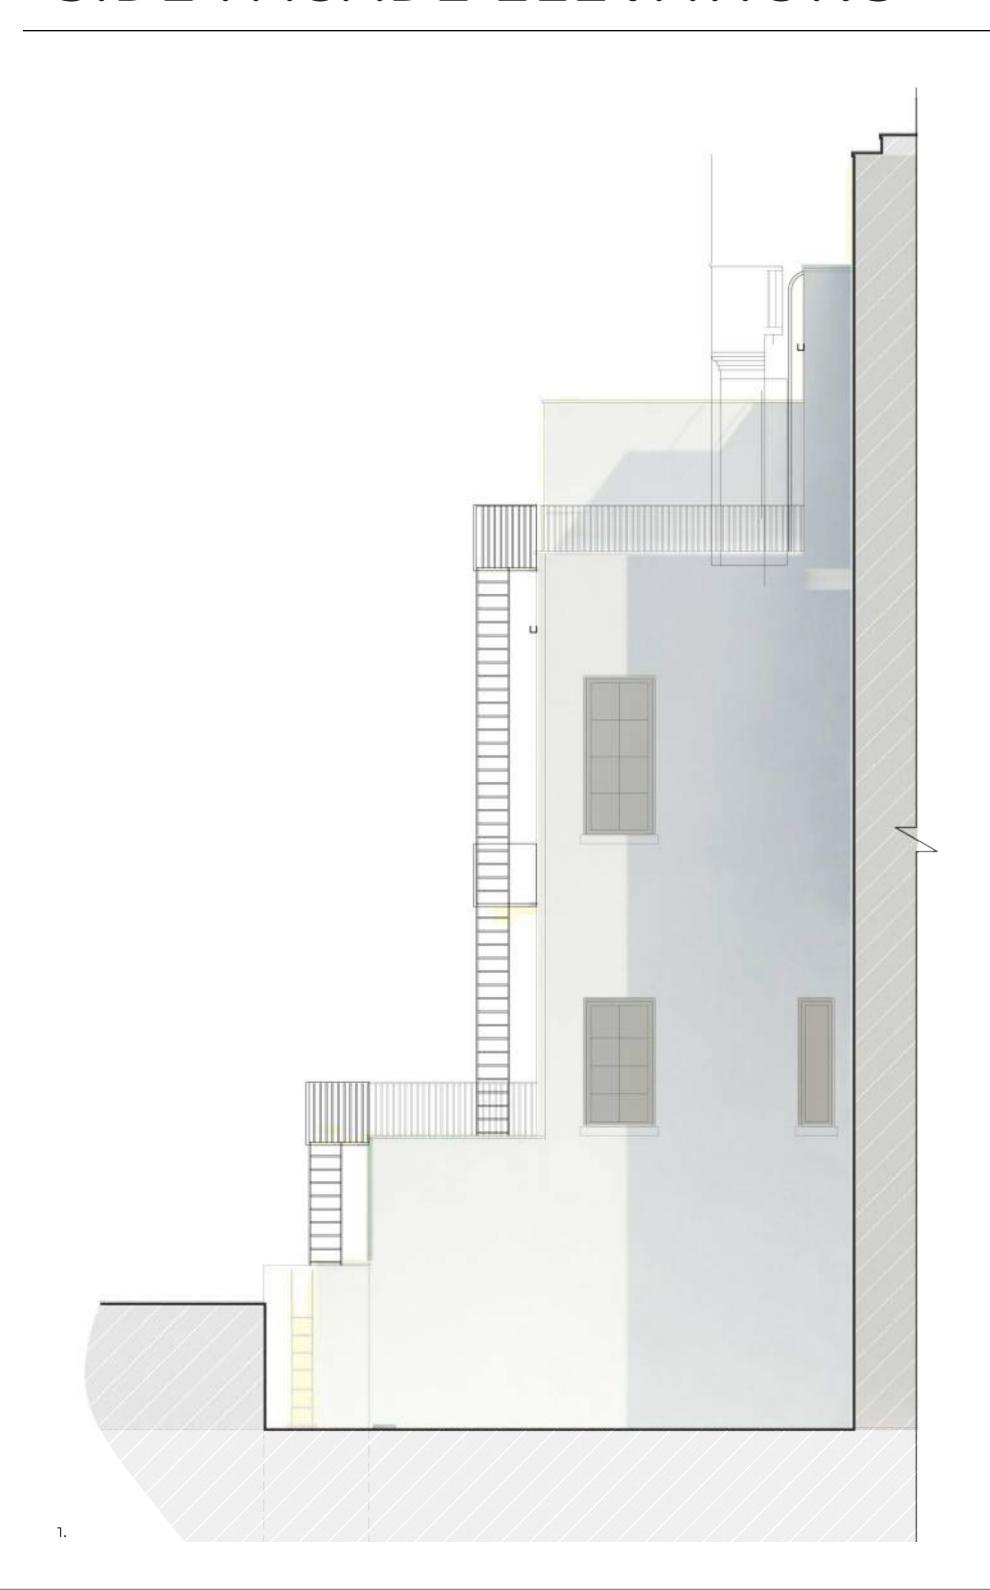
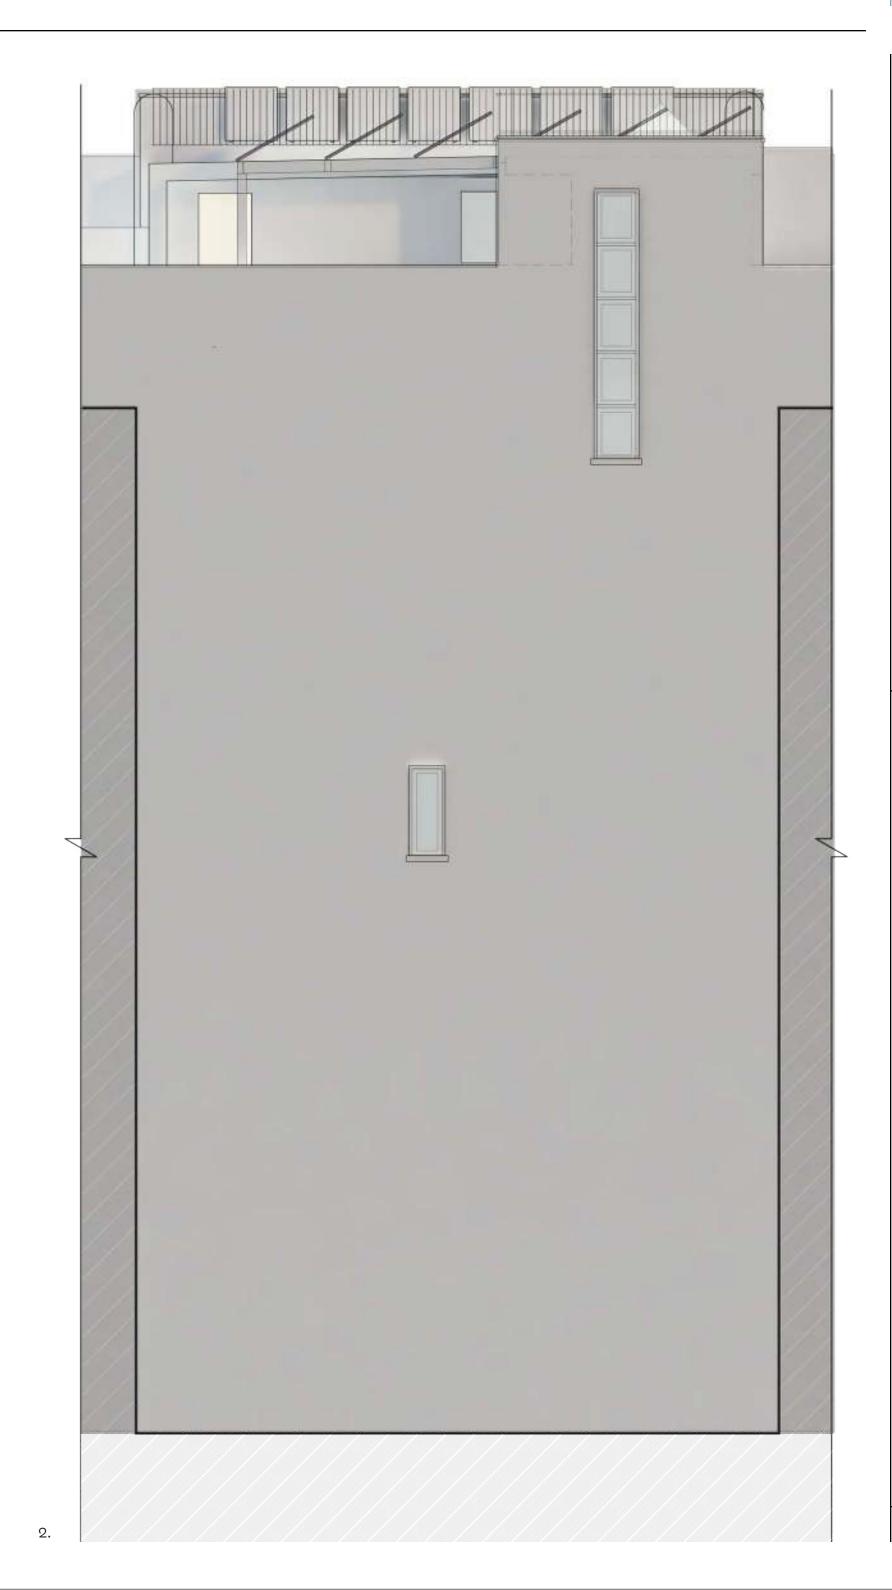
SIDE FACADE ELEVATIONS

WEST REAR FACADE
 EAST FACADE AT
 AIR SHAFT

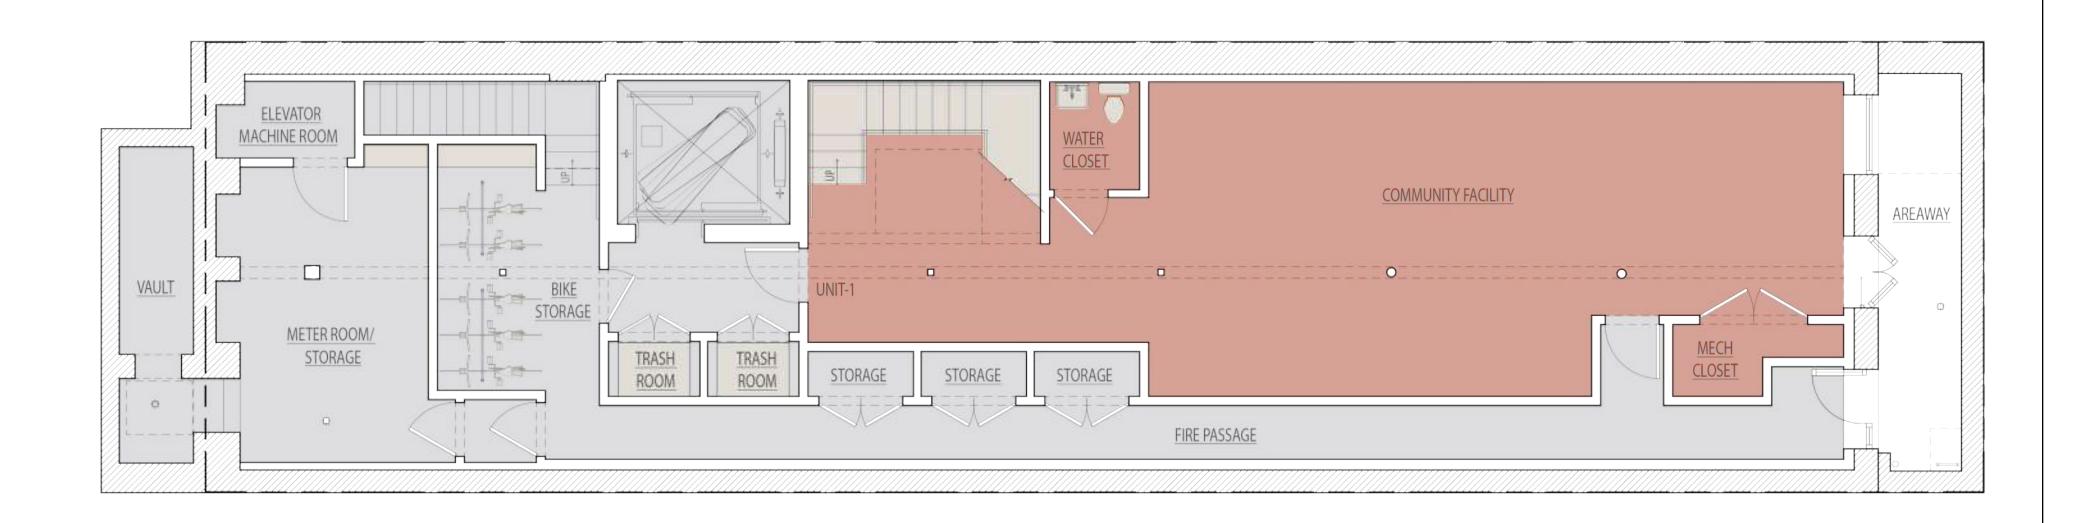
CELLAR + 1ST FLOOR PLANS: COMMUNITY SPACE

1. CELLAR PLAN
2. 1ST FLOOR PLAN
3. CELLAR COMMUNITY
CENTER AREA = 1113SF
4. 1ST FL. COMMUNITY
CENTER AREA = 1400SF

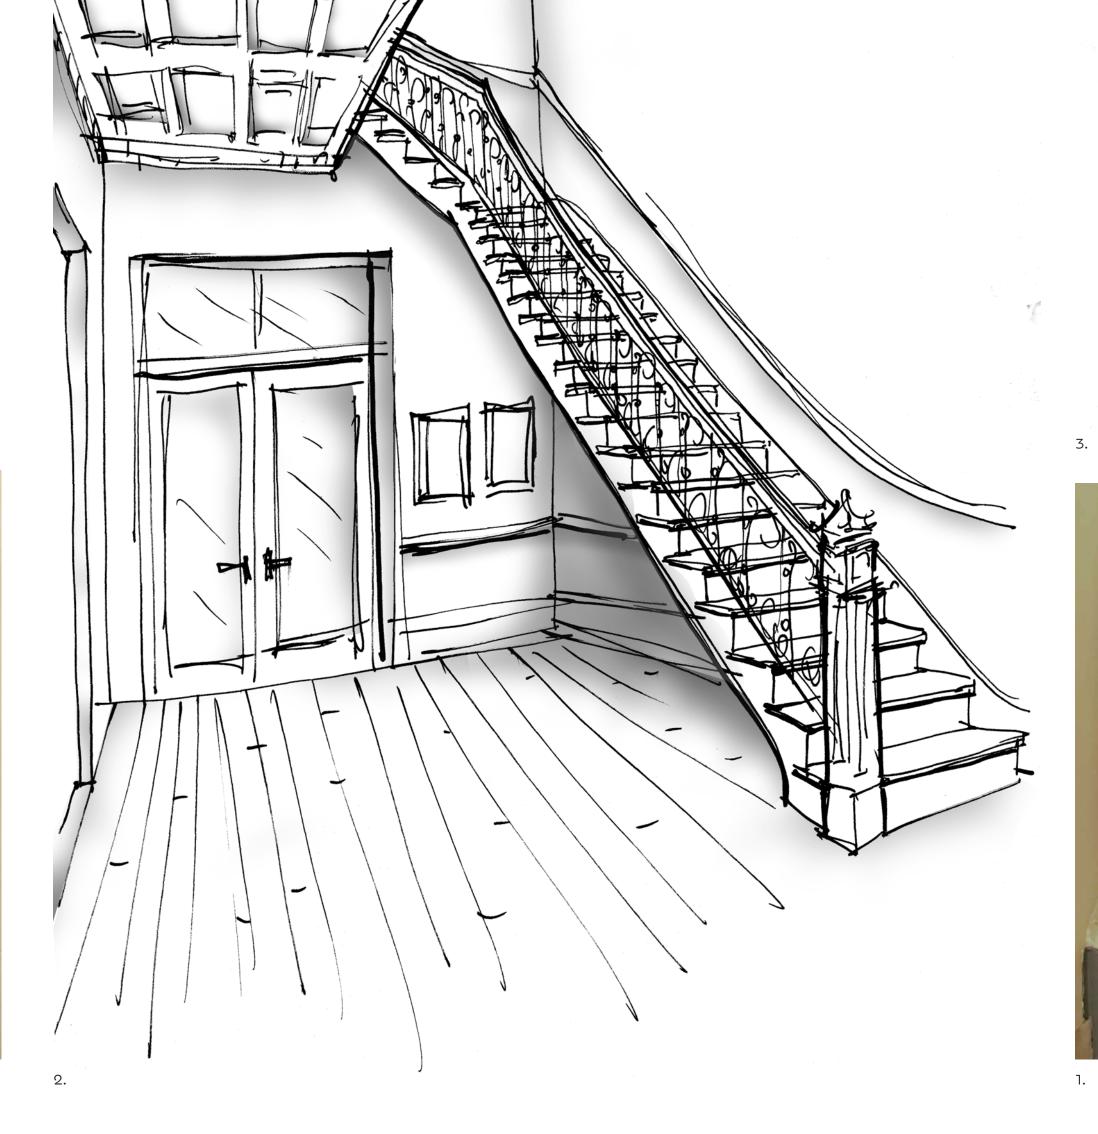
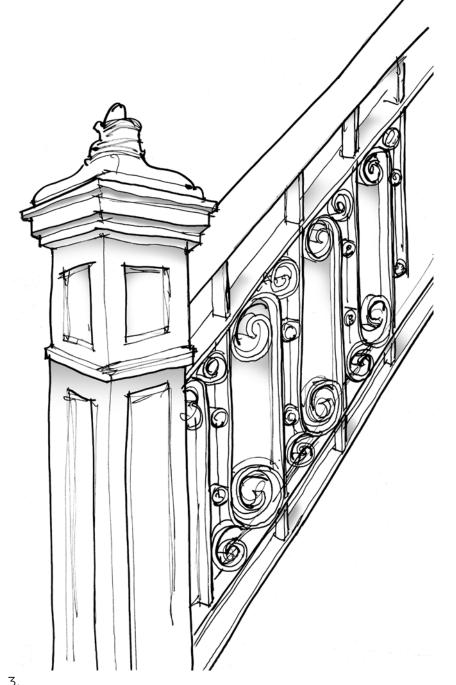
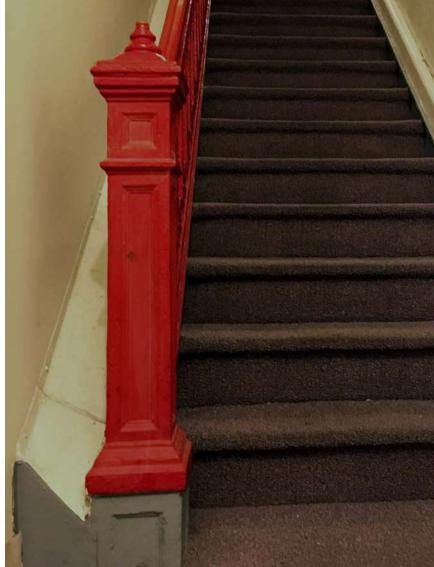
SKETCHES - ENTRY

- 1. EXISTING STEEL
 RAILING AT ENTRY
 2. PROPOSED ENTRY
 STAIR W/ RESTORED
 RAILING
 3. RESTORED STEEL
 RAILING

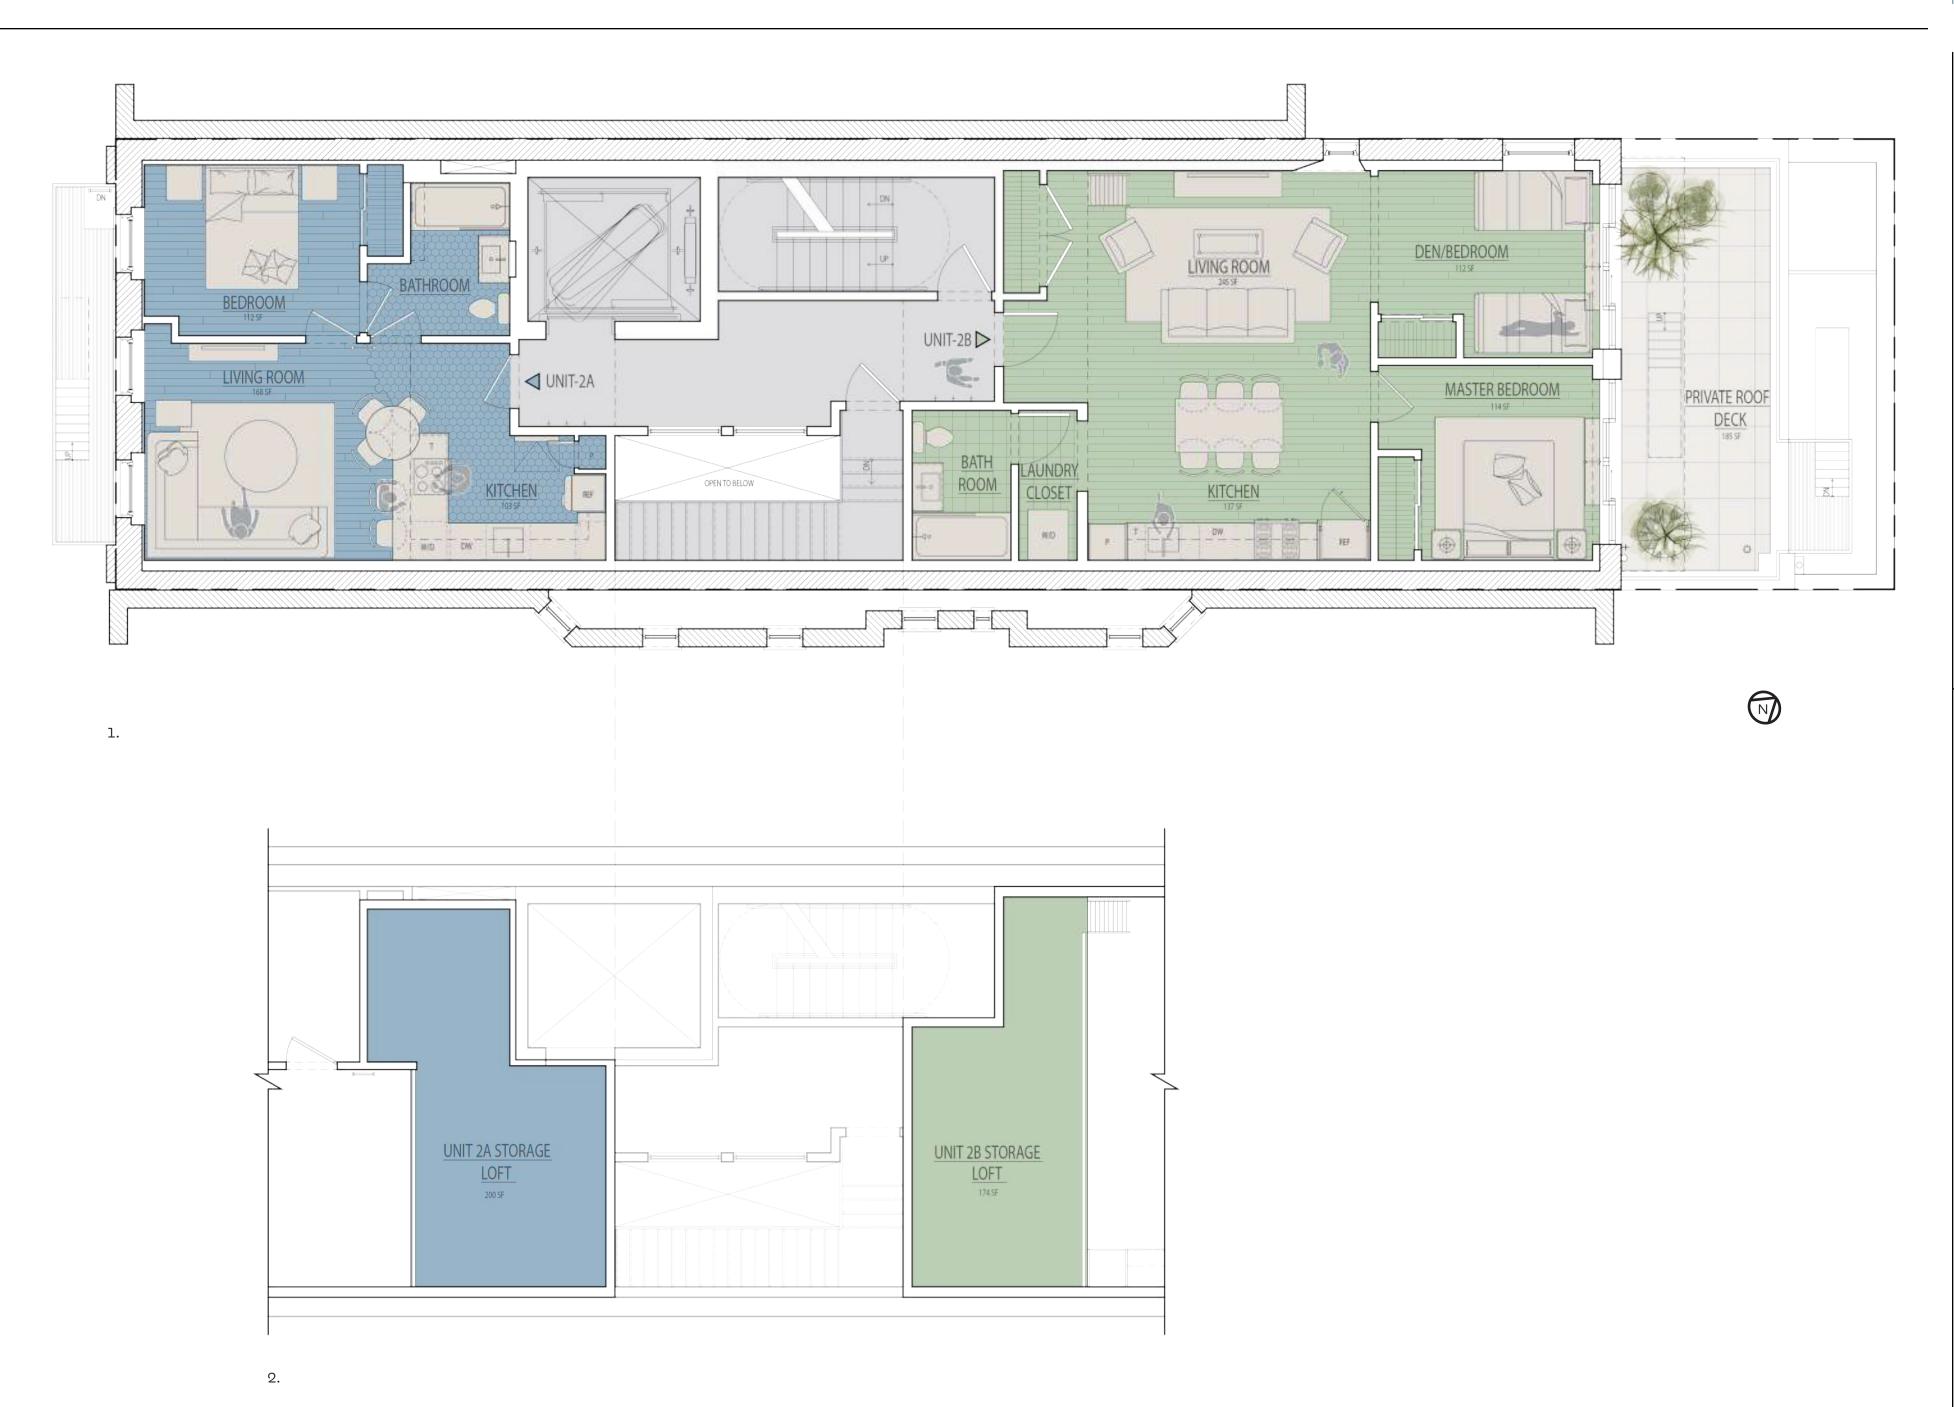
2ND FLOOR + LOFT PLANS: UNITS 2A + 2B

1. 2ND FLOOR: UNITS 2A + 2B 2. UNITS 2A + 2B STORAGE LOFTS

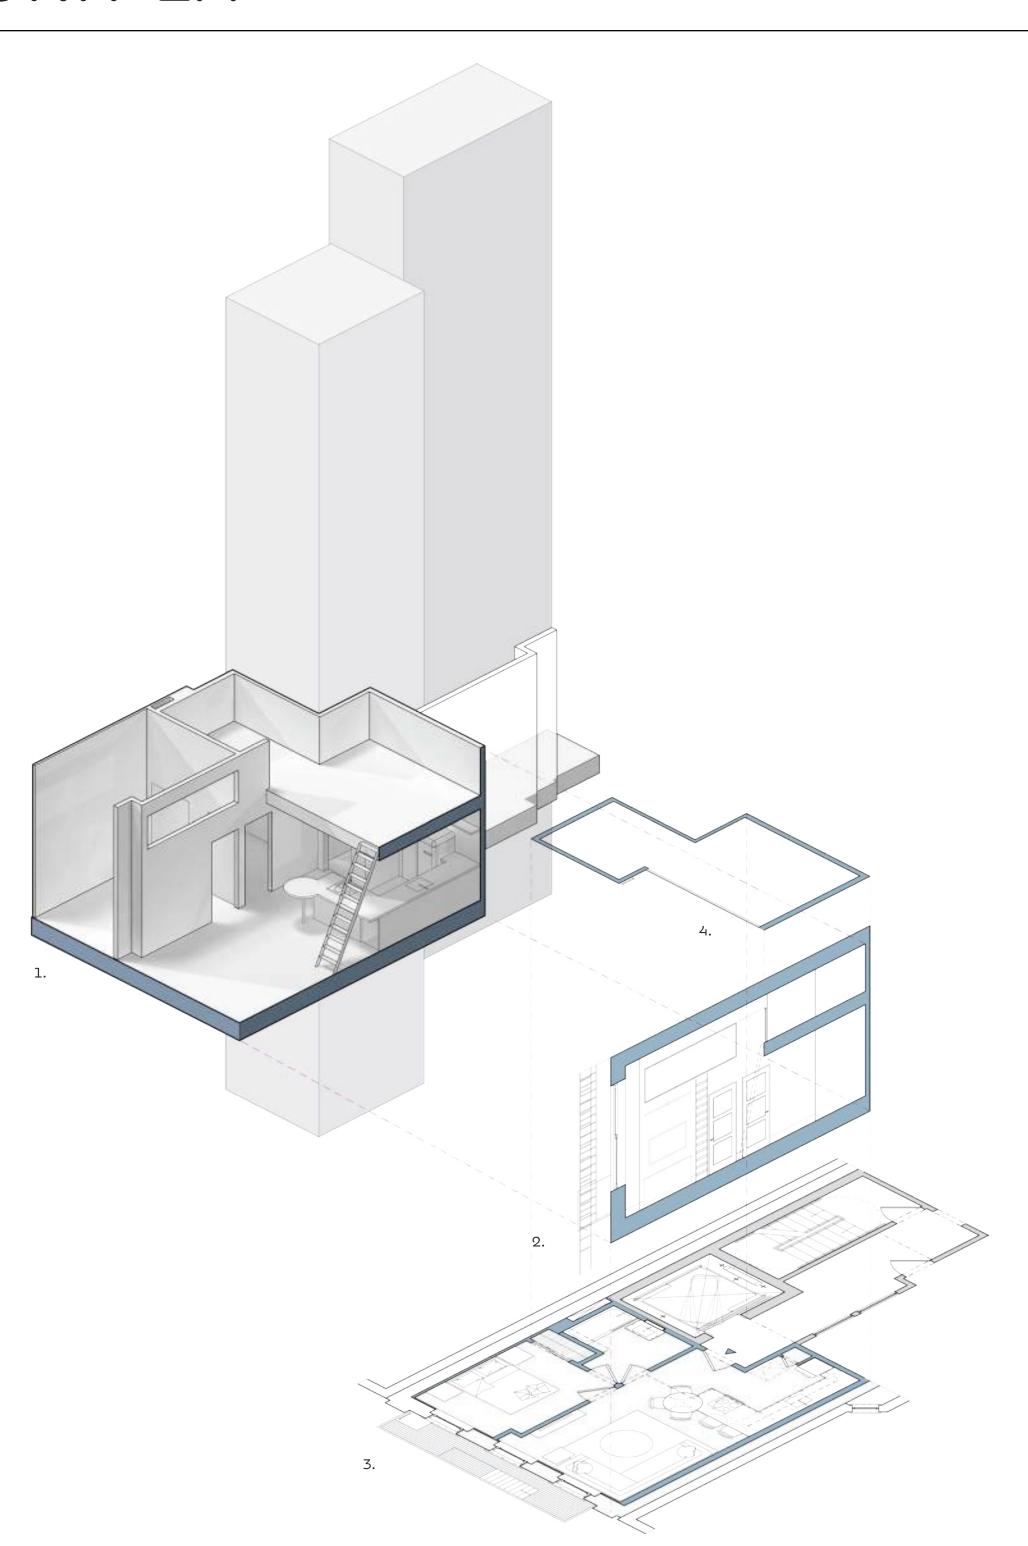
UNIT 2A

- 1. AXON 2. SECTION
- 3. 2NDFLOOR PLAN
- 4. LOFT FLOOR PLAN

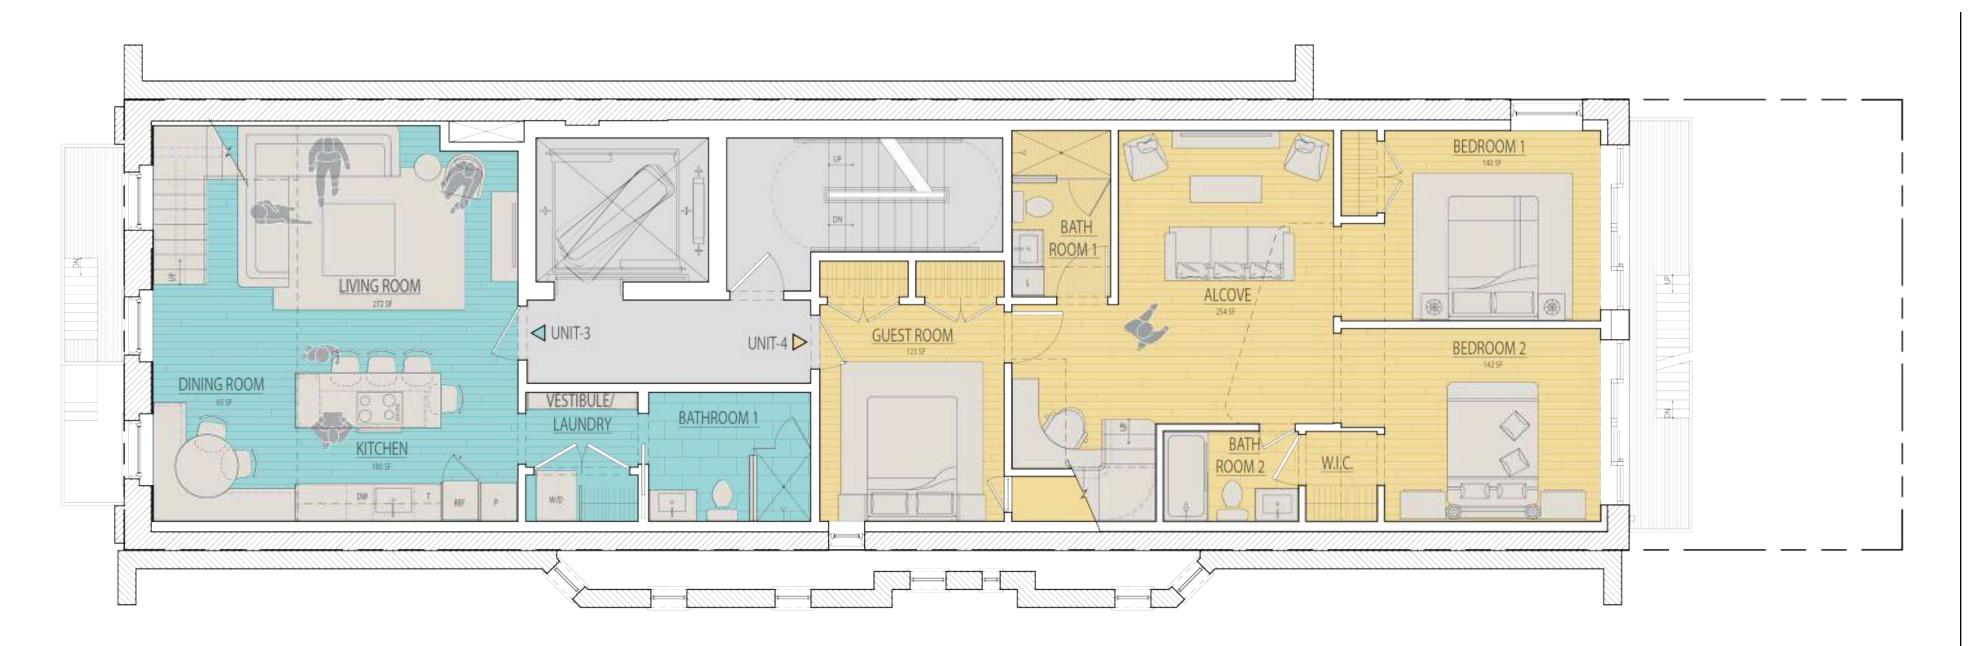
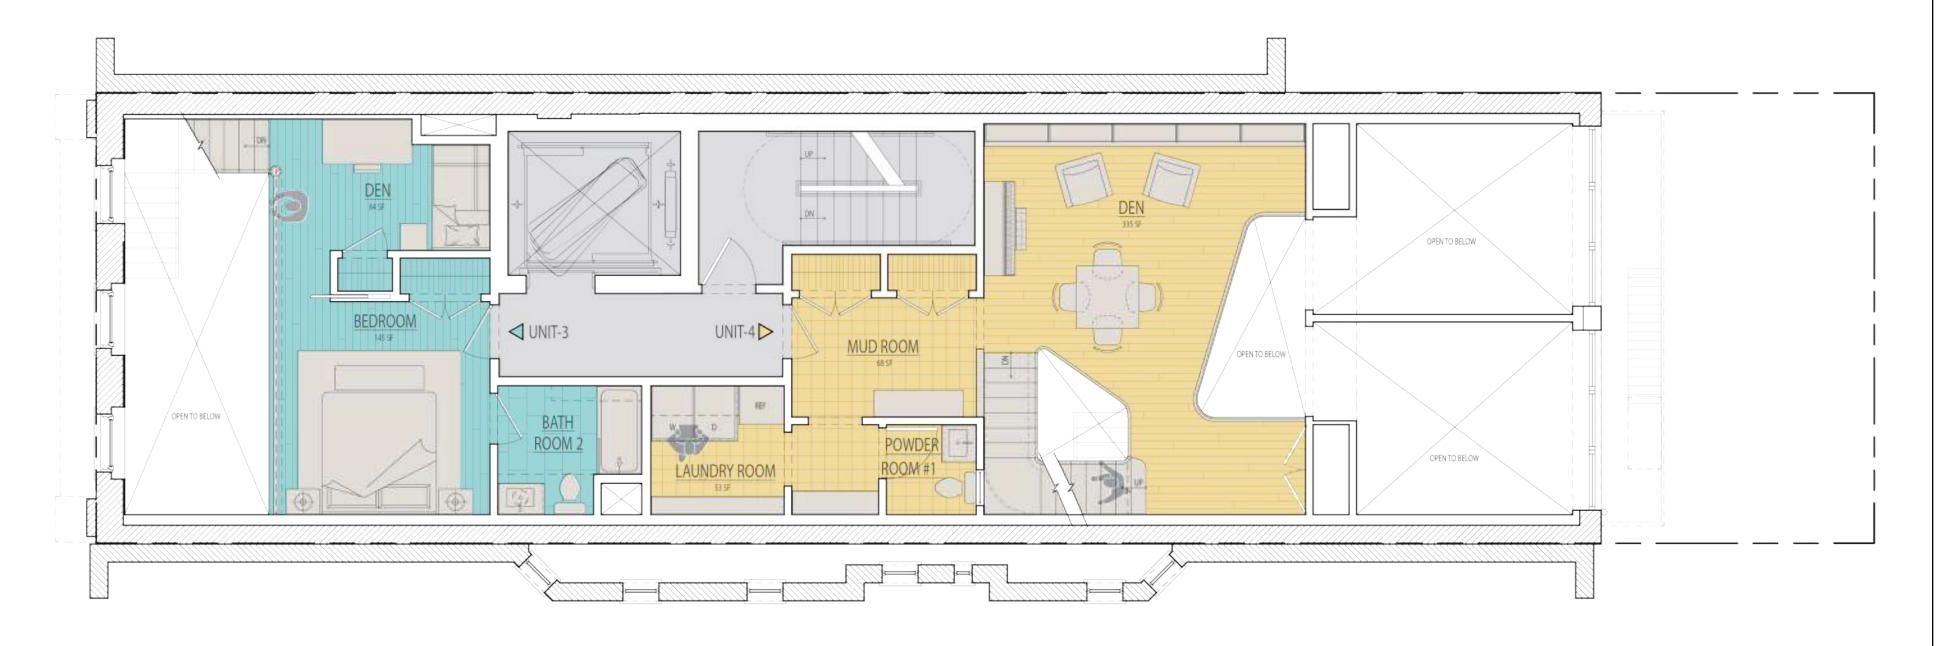
3RD + 4TH FLOOR PLANS: UNITS 3 + 4

1. 3RD FLOOR: UNITS 3 AND 4 2. 4TH FLOOR: UNITS 3 AND 4
