ENGINE 16

223 EAST 25TH STREET MANHATTAN, NY

MICHAEL INGUI, RA
Certified Passive House Designer
AMY FAILLA, RA
Certified Passive House Designer

BAXT INGUI - COMPLETED PASSIVE PROJECTS

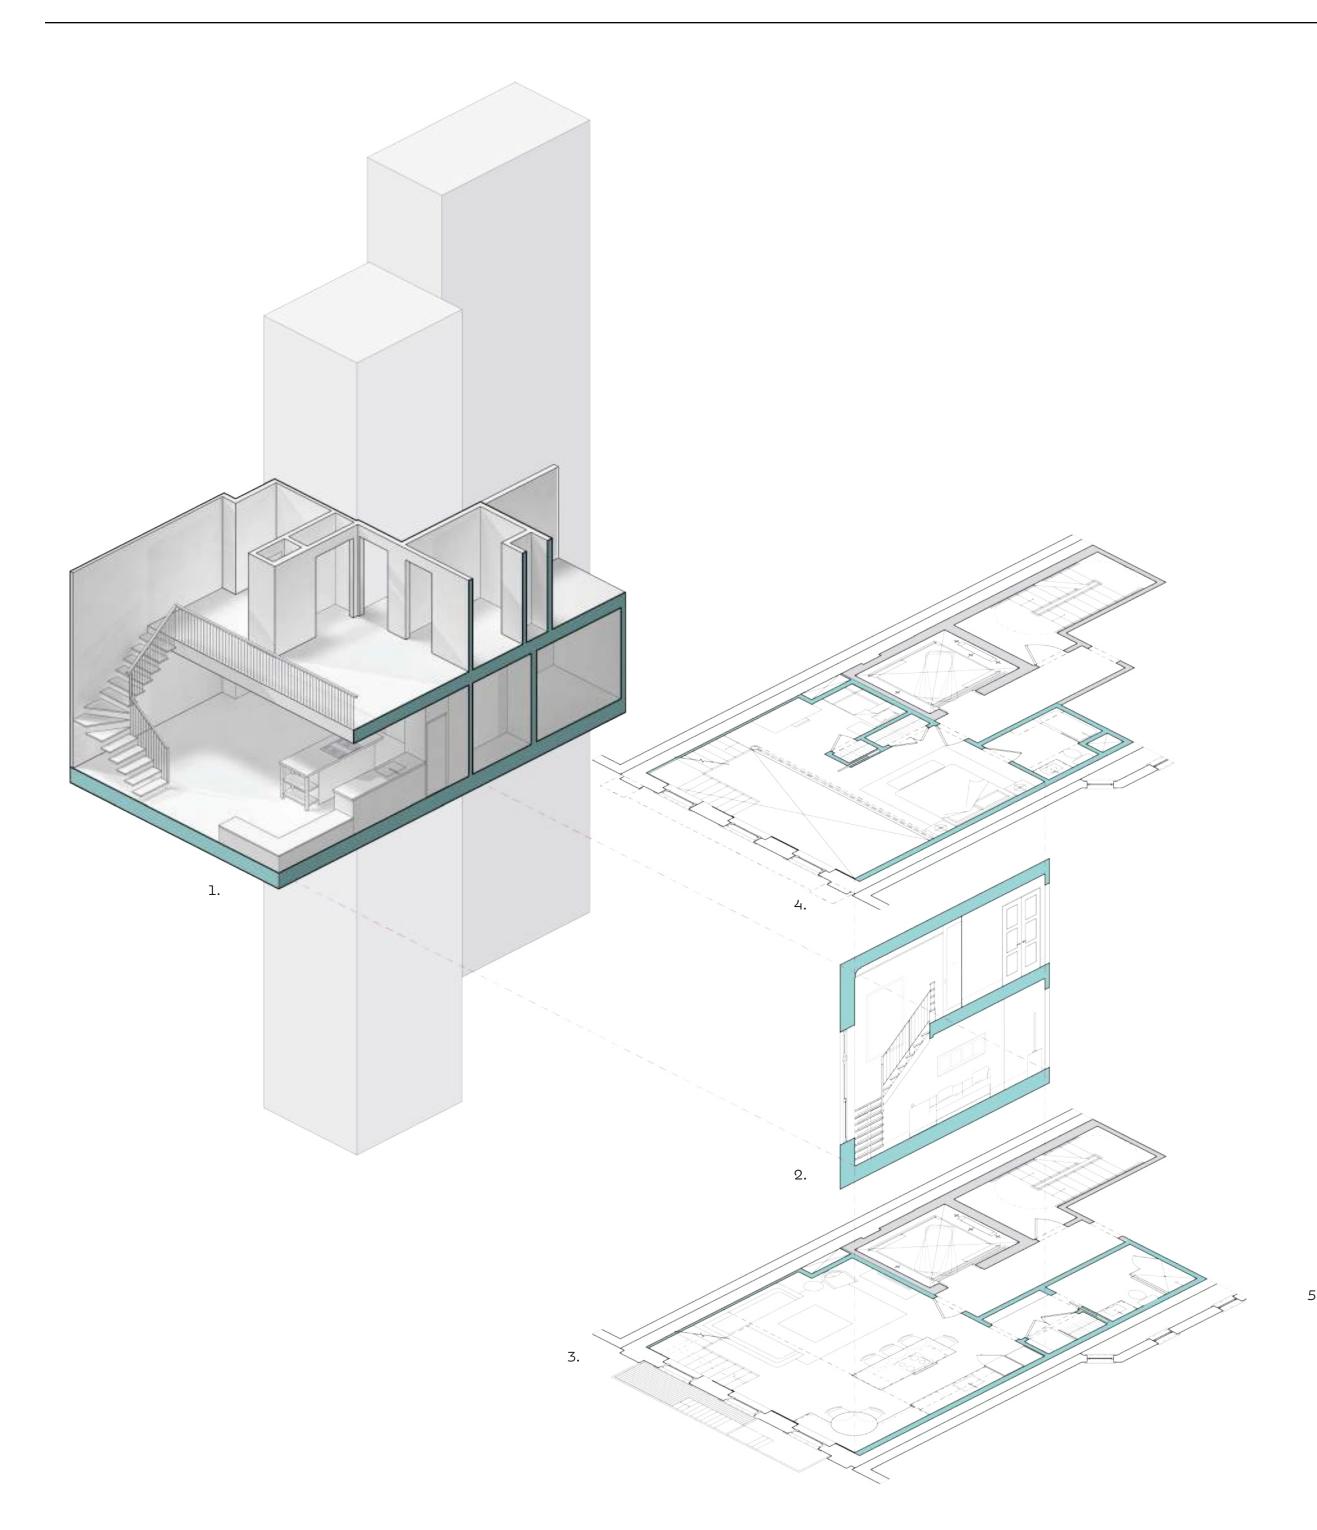
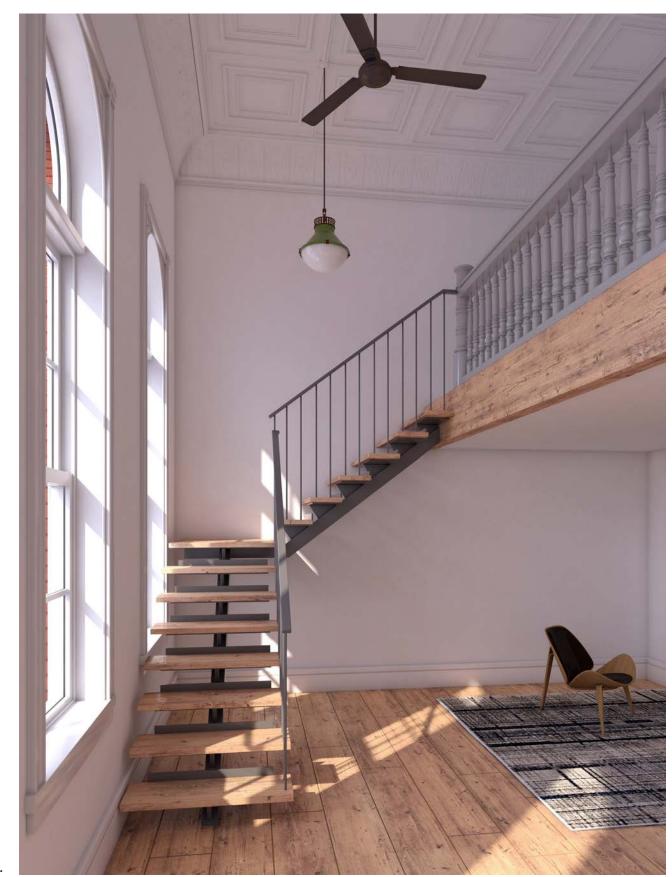
UNIT 3 DUPLEX

- AXON
 SECTION
- 3. 3RD FLOOR PLAN
- 4. 4TH FLOOR PLAN
- 5. RENDERING OF STAIR/LOFT

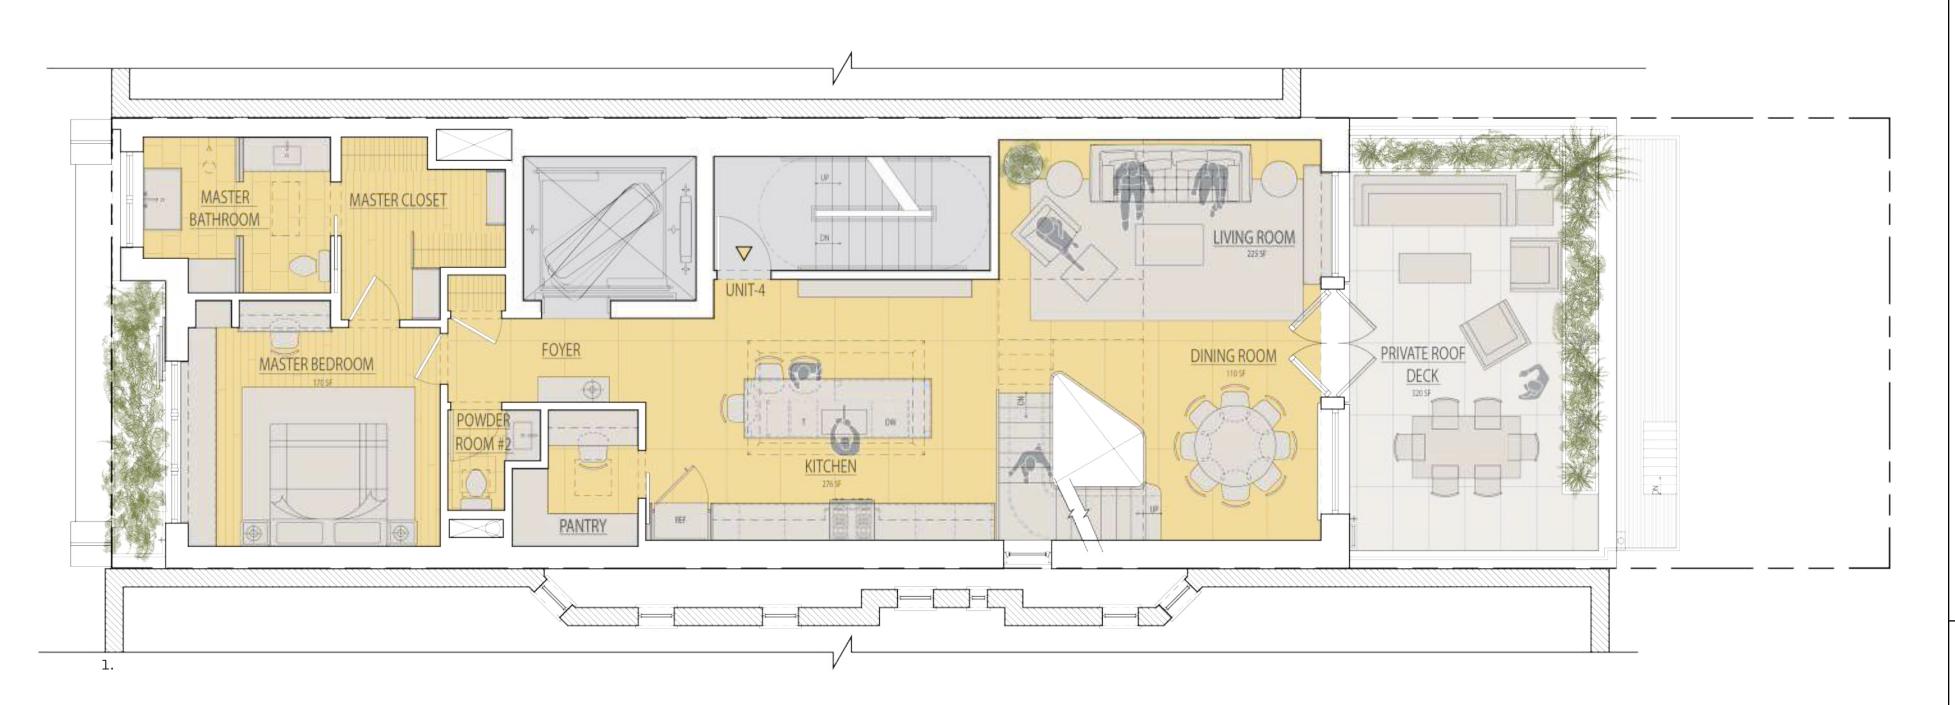
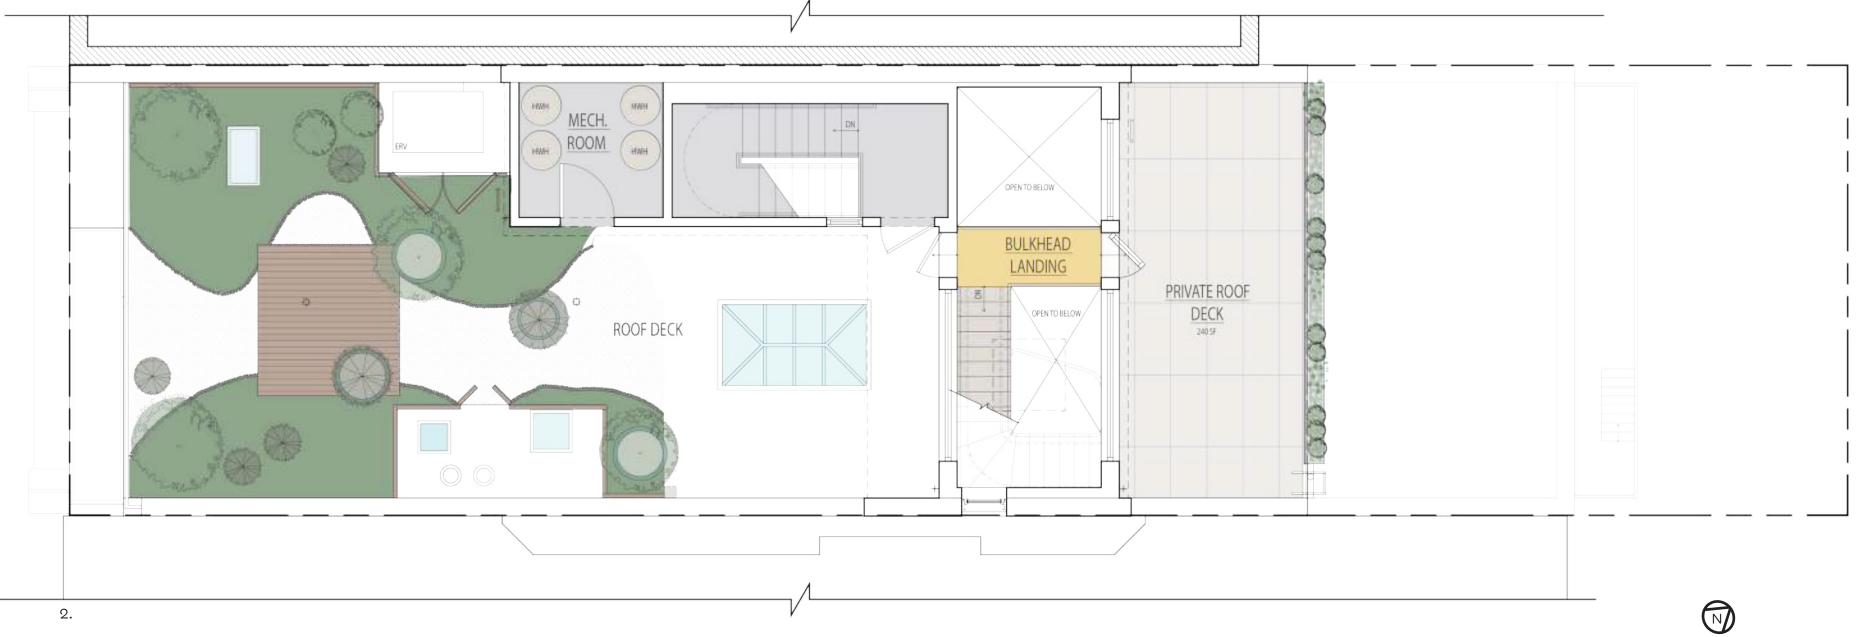
5TH FLOOR + ROOF PLANS: UNIT 4 & SHARED ROOF

1. 5TH FLOOR: UNIT 4 2. BULKHEAD/ROOF: UNIT 4 + SHARED ROOF

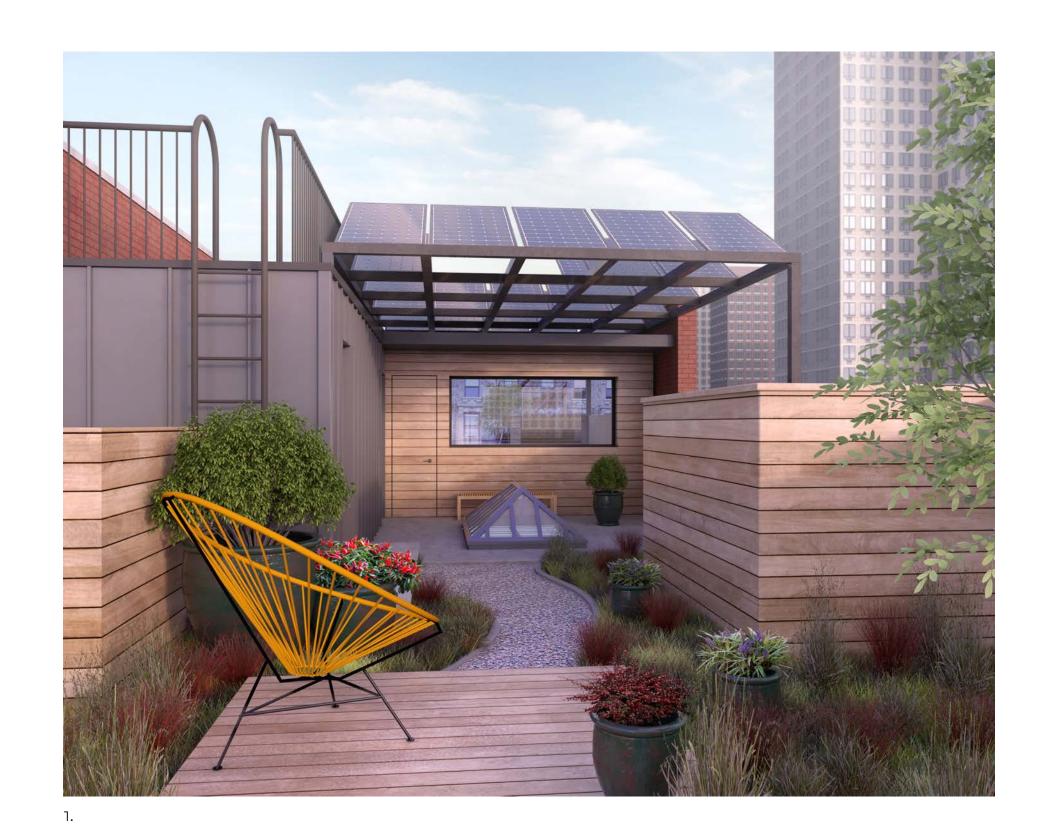
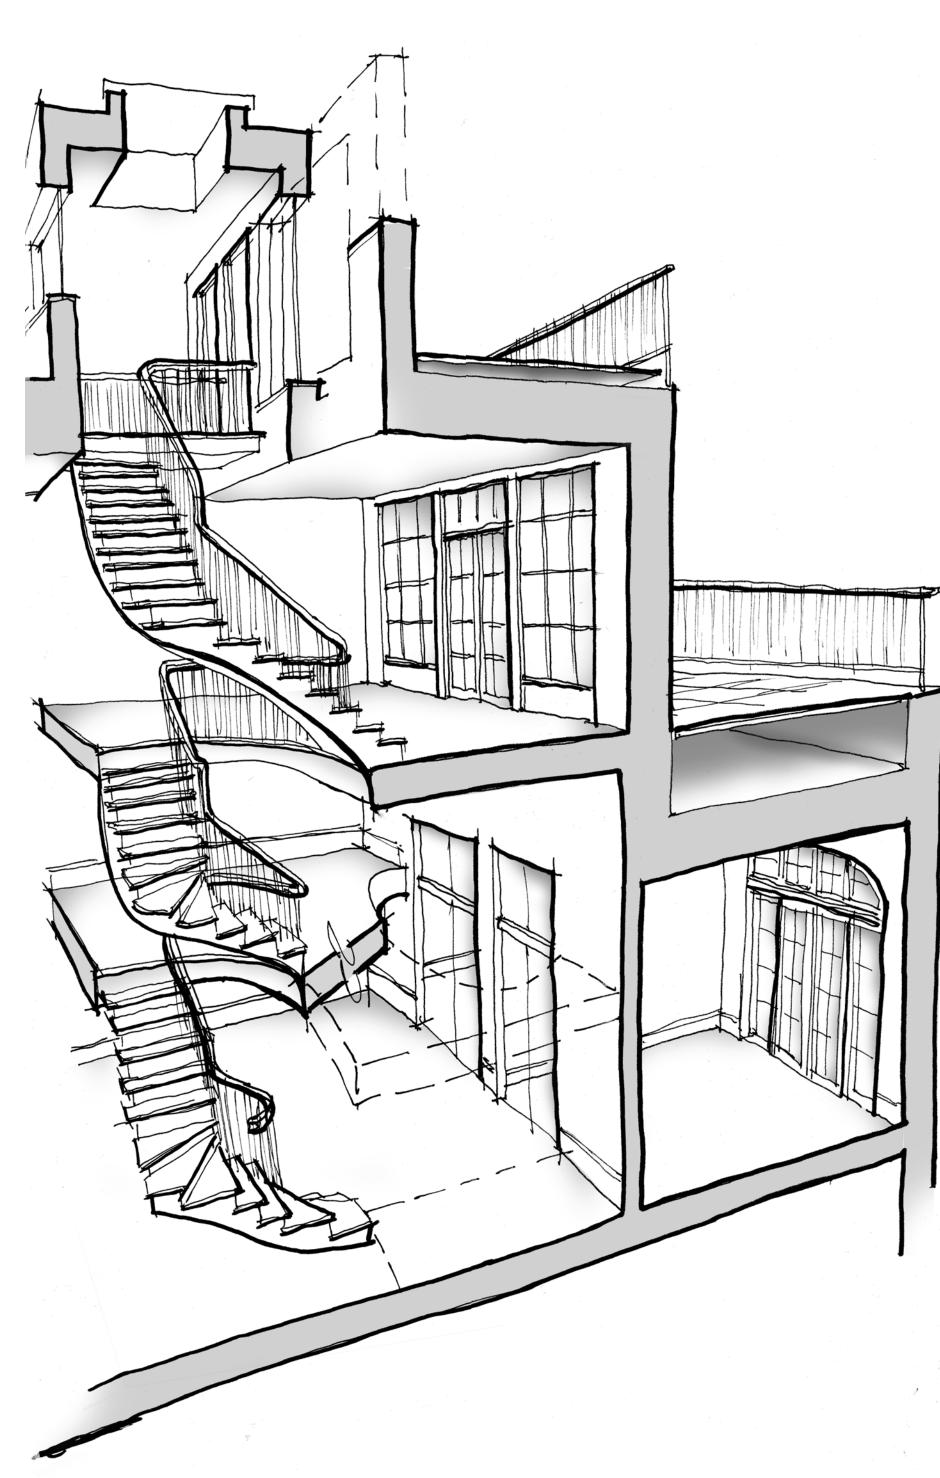
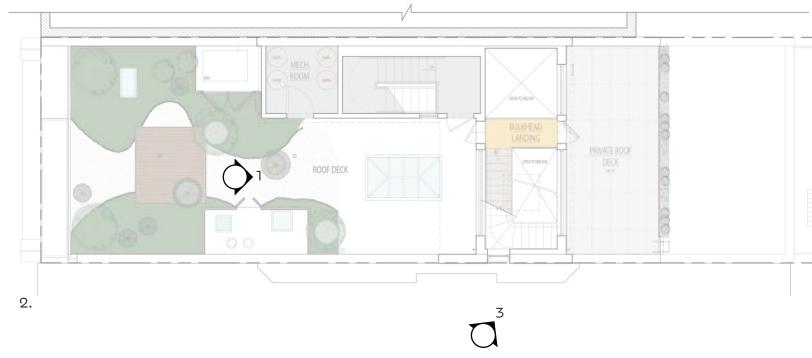
SKETCH + RENDERING

- 1. ROOF KEY PLAN 2. FRONT ROOF DECK
- RENDERING
 3. UNIT 4 STAIR SKETCH

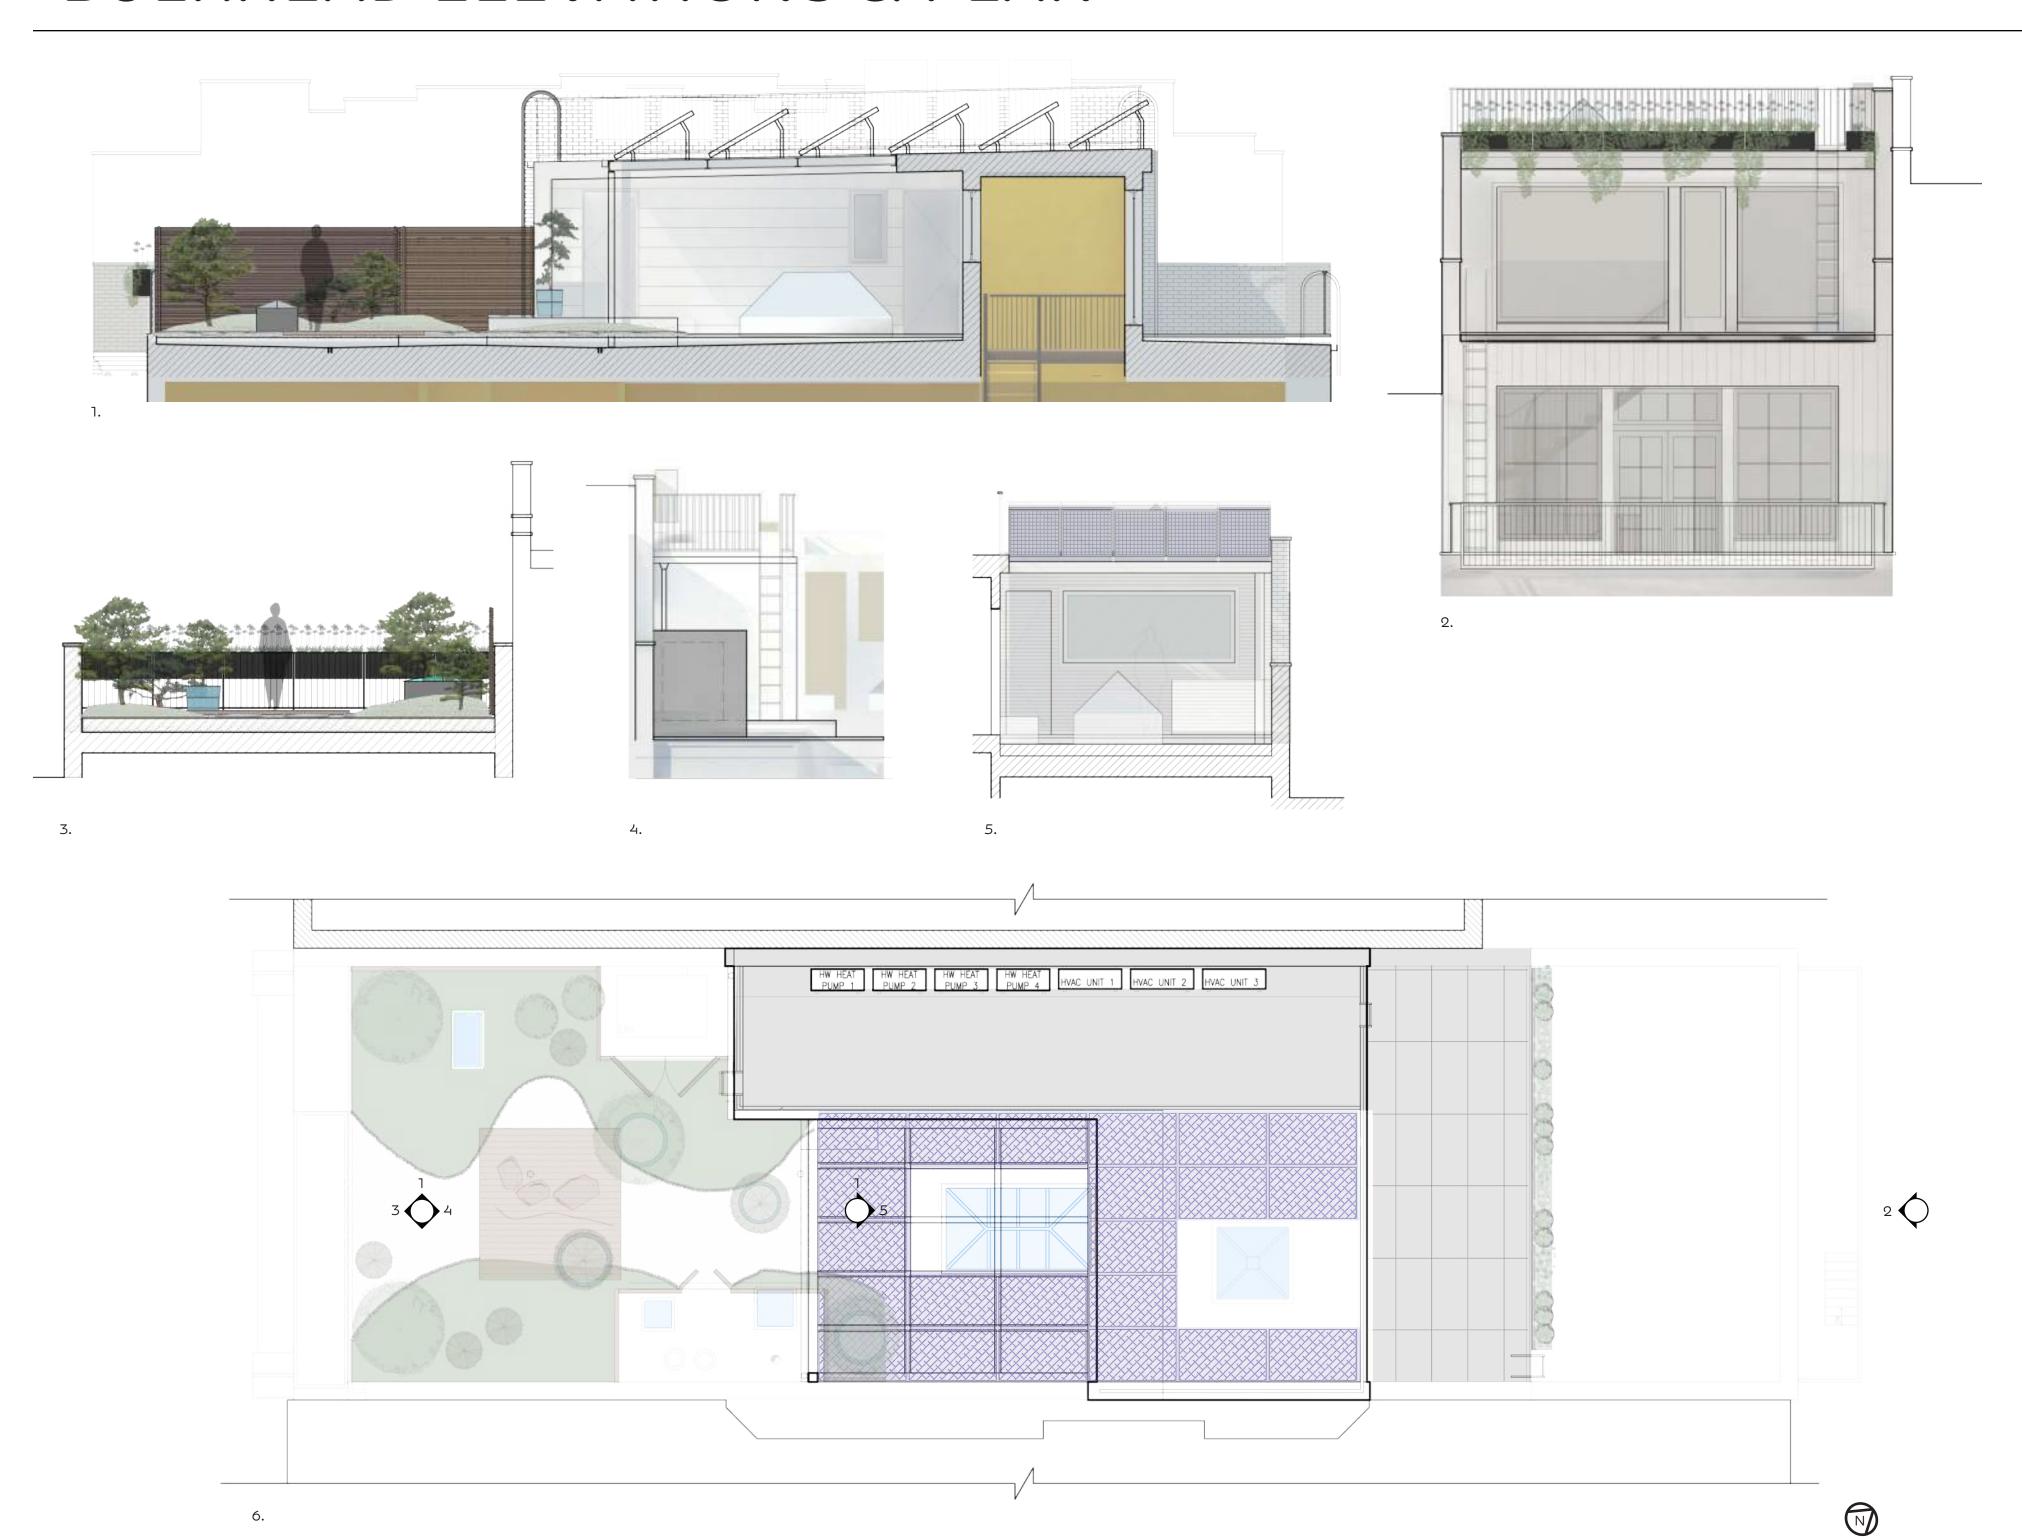
BULKHEAD ELEVATIONS & PLAN

- 1. EAST BULKHEAD ELEVATION & SECTION (FACING WEST)
- 2. NORTH BULKHEAD ELEVATION (FACING NORTH)3. FRONT ROOF DECK
- RAILING (FACING SOUTH) 4. SOUTH BULKHEAD
- ELEVATION
 (FACING NORTH)
 5. SOUTH BULKHEAD
- ELEVATION (FACING NORTH)
- 6. BULKHEAD ROOF PLAN

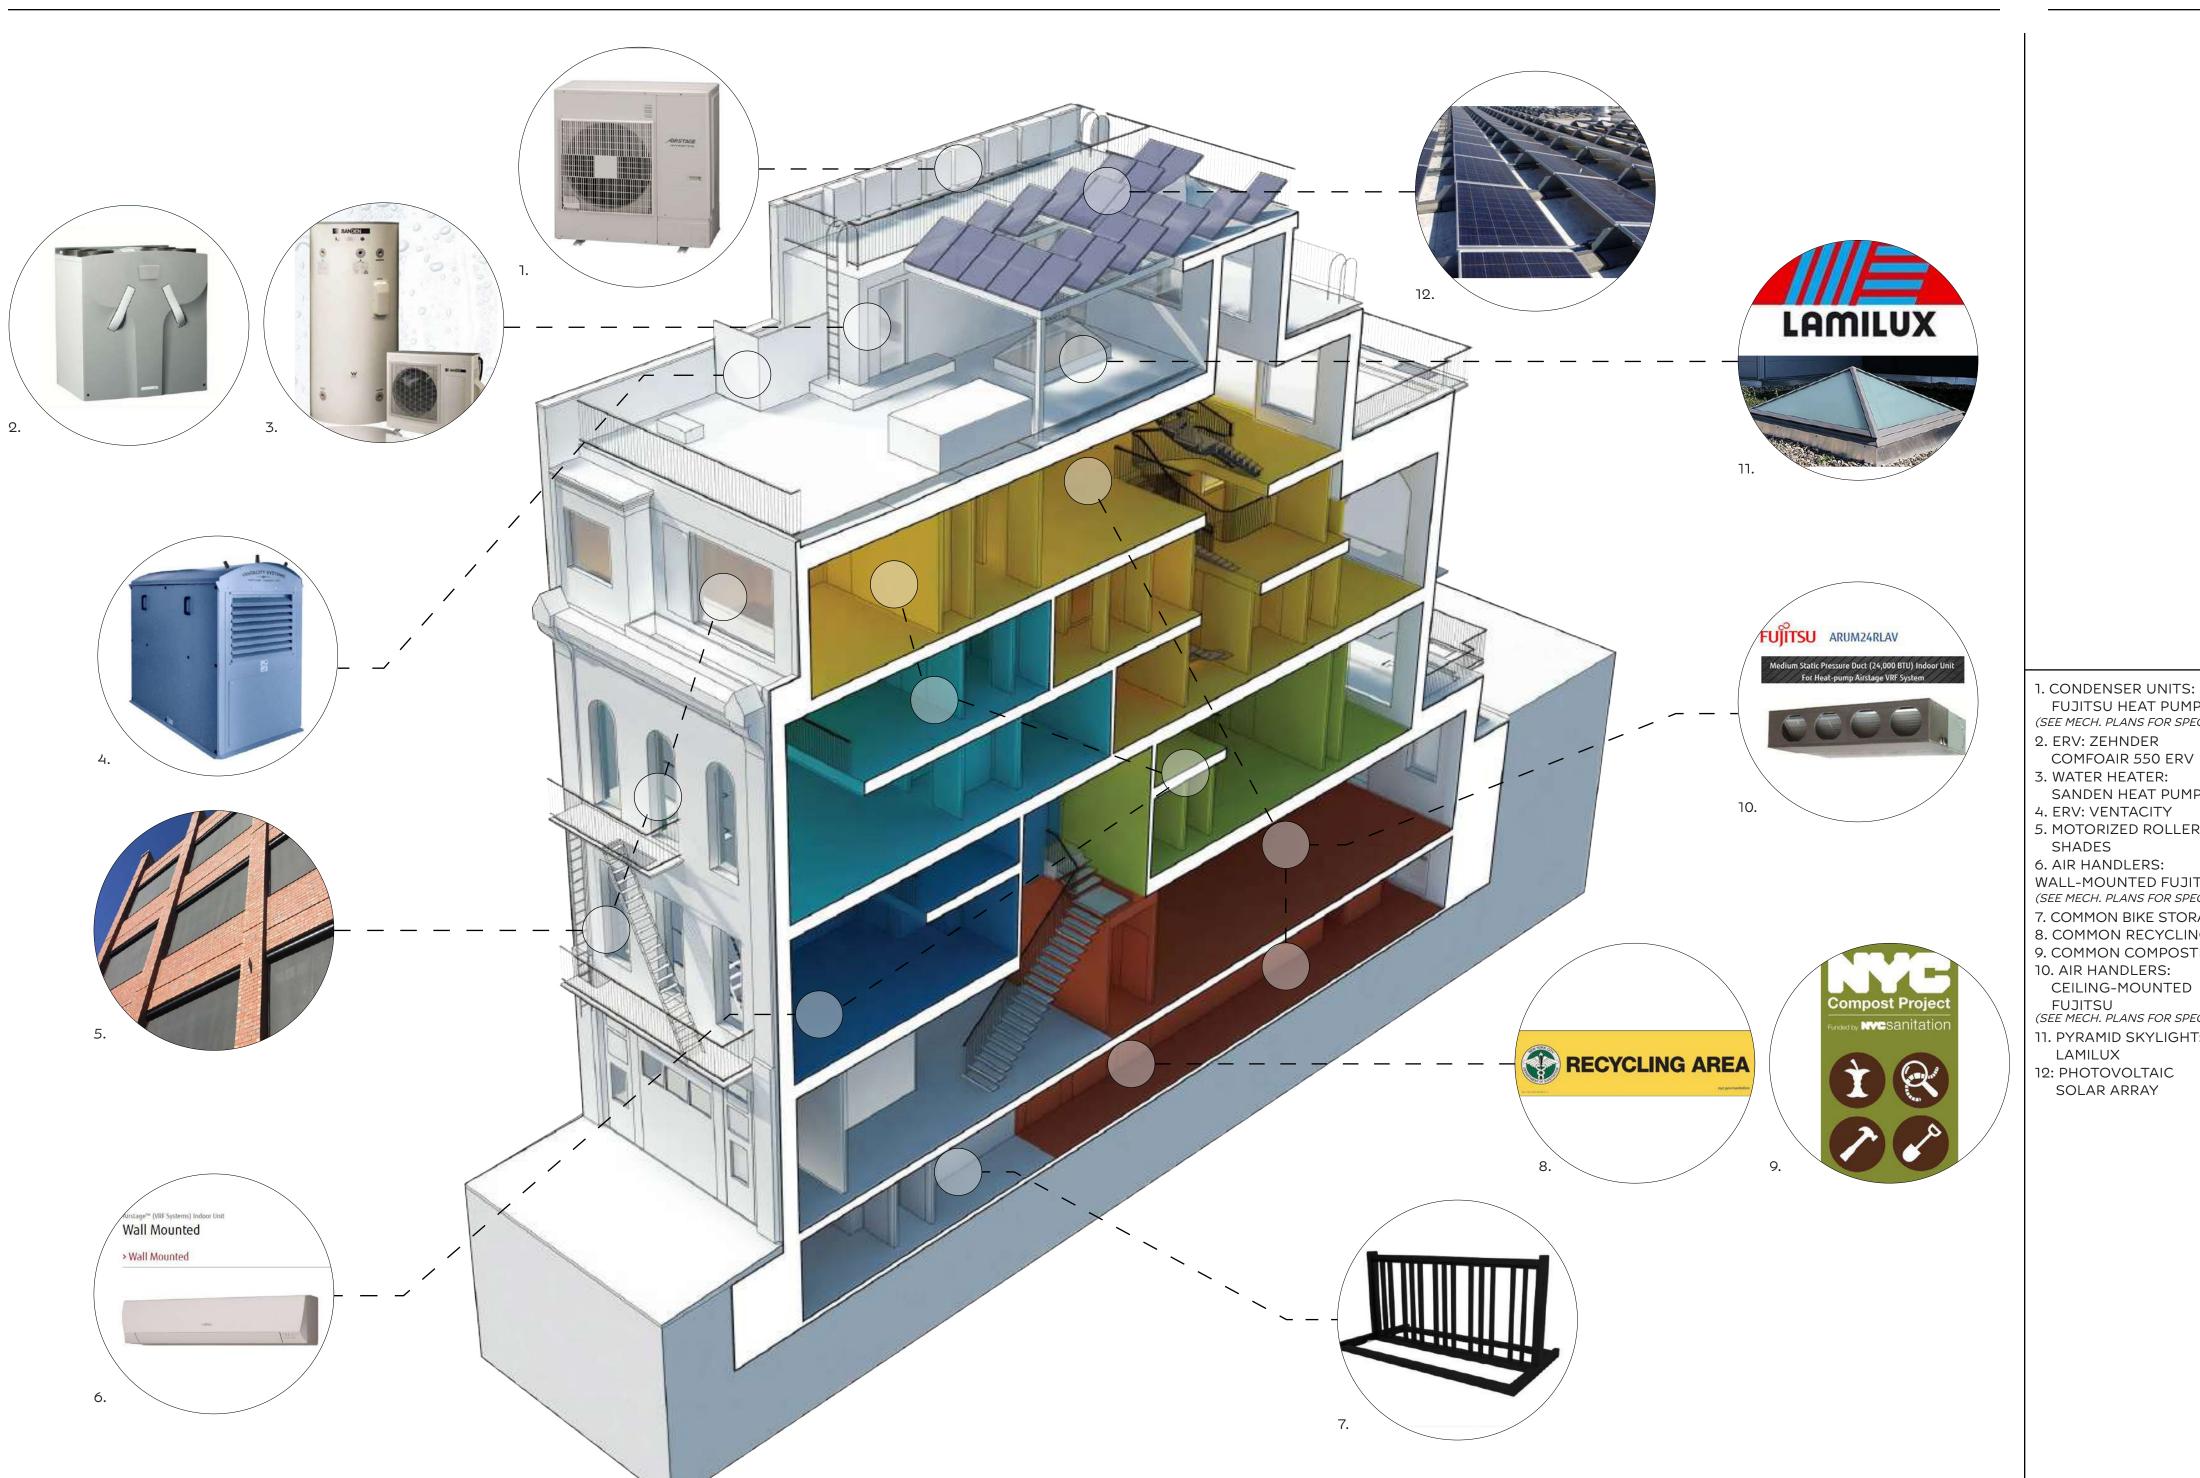
MECHANICAL UNITS + AMENITIES

FUJITSU HEAT PUMPS (SEE MECH. PLANS FOR SPECS)

COMFOAIR 550 ERV

3. WATER HEATER: SANDEN HEAT PUMP 4. ERV: VENTACITY

WALL-MOUNTED FUJITSU (SEE MECH. PLANS FOR SPECS) 7. COMMON BIKE STORAGE 8. COMMON RECYCLING 9. COMMON COMPOSTING

CEILING-MOUNTED FUJITSU (SEE MECH. PLANS FOR SPECS)

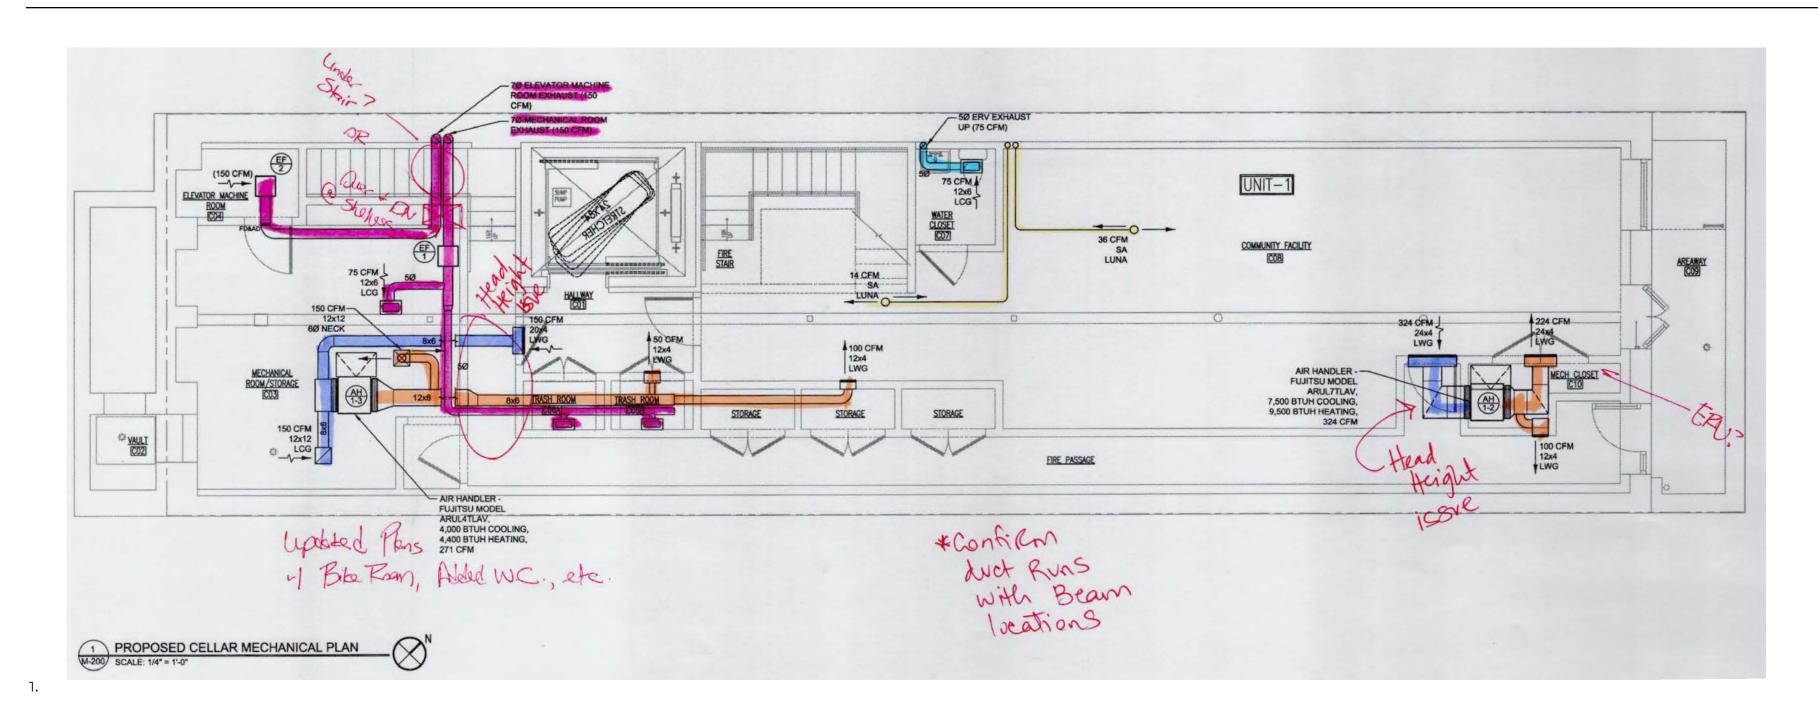
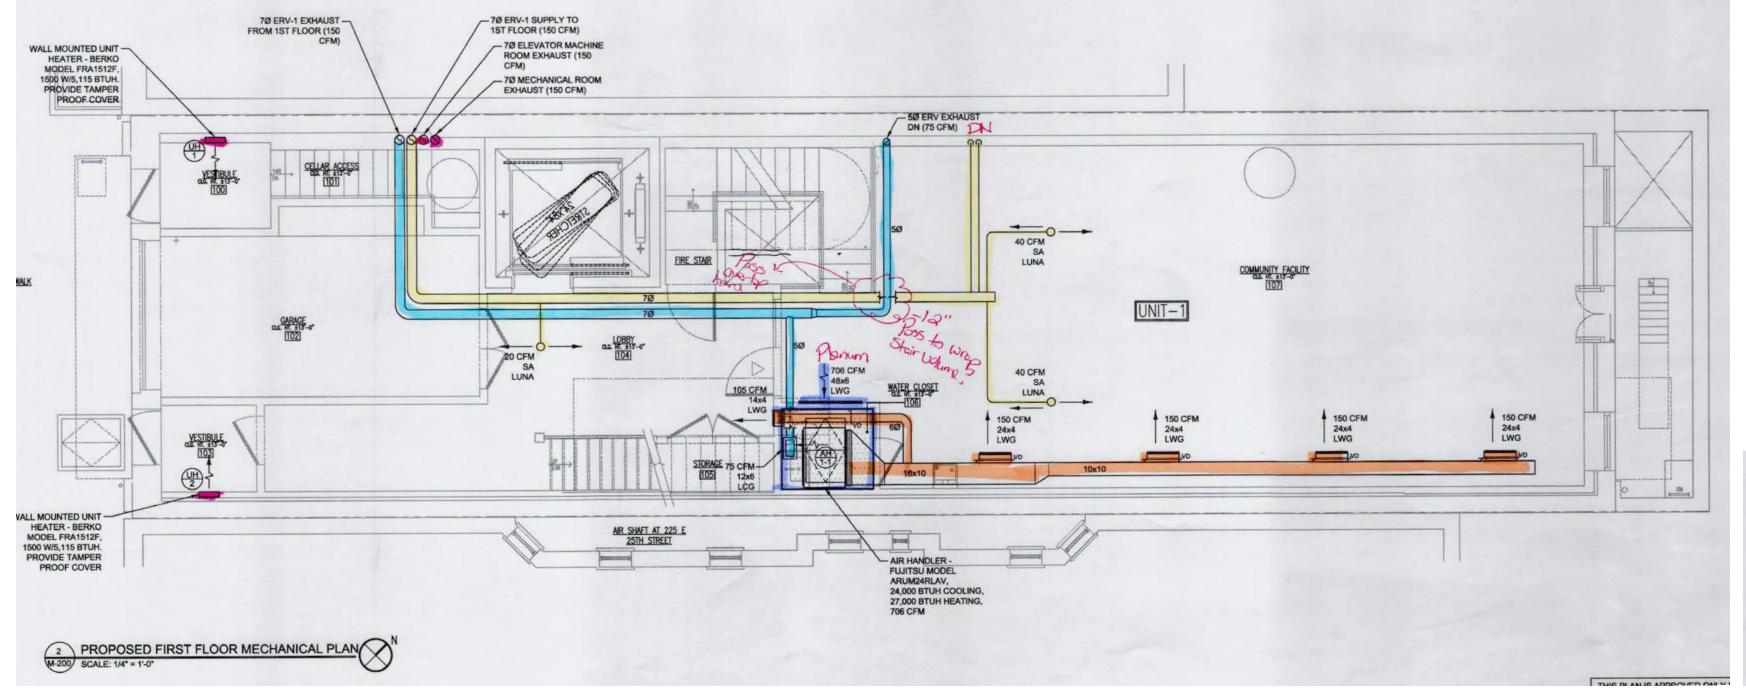
MECHANICAL PLANS: CELLAR + 1ST FLOOR

1. CELLAR FLOOR 2. 1ST FLOOR

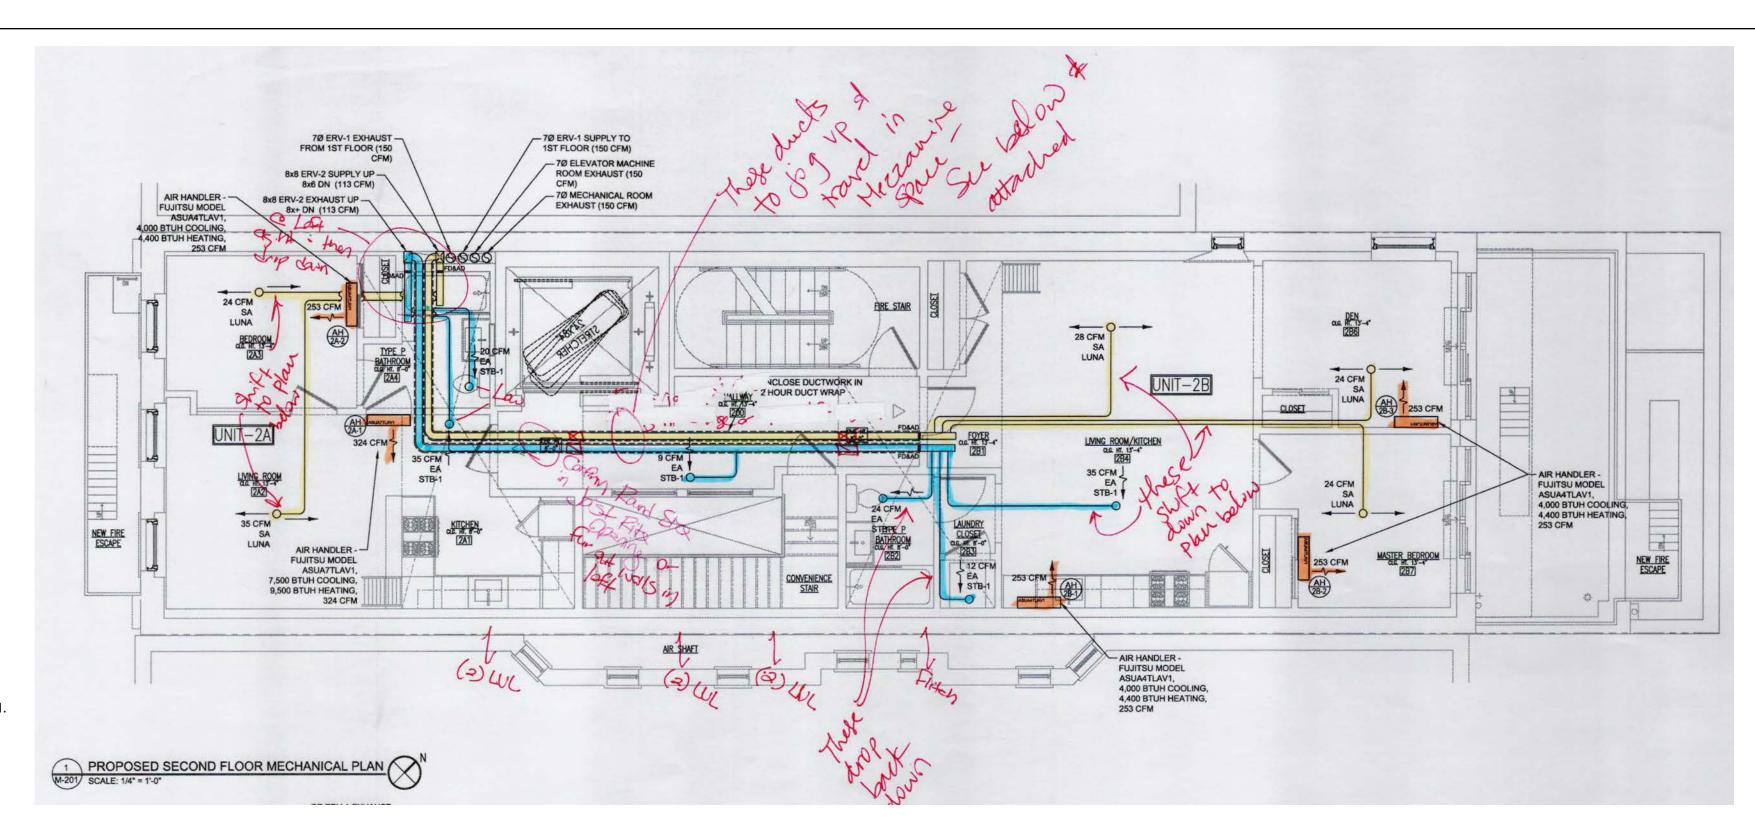
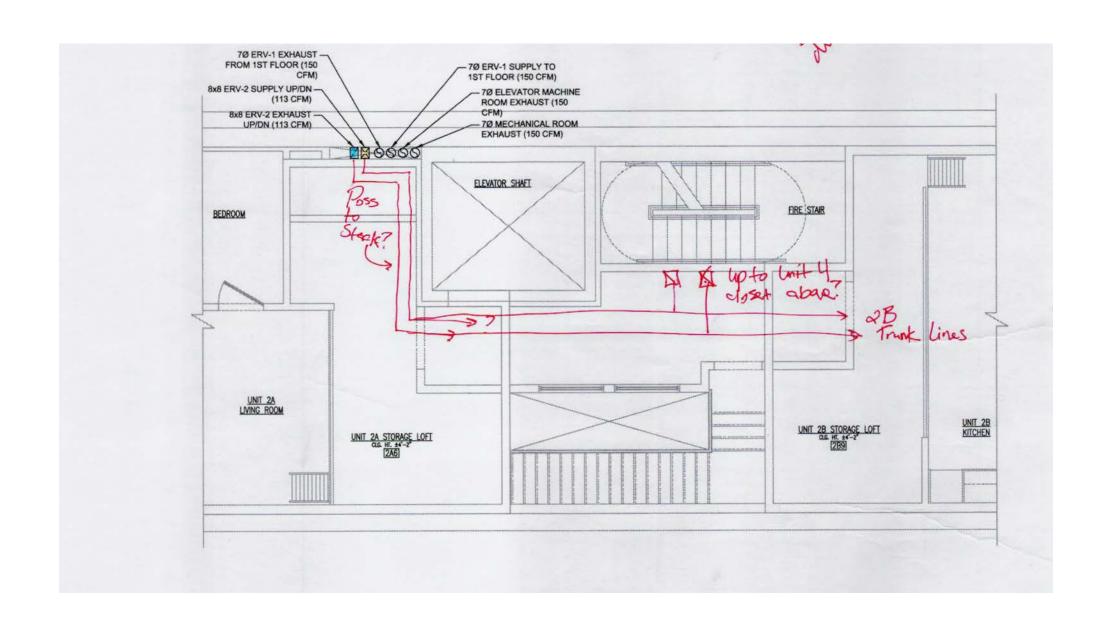
MECHANICAL PLANS: 2ND FLOOR + LOFT

1. 2ND FLOOR 2. 2ND FLOOR LOFTS

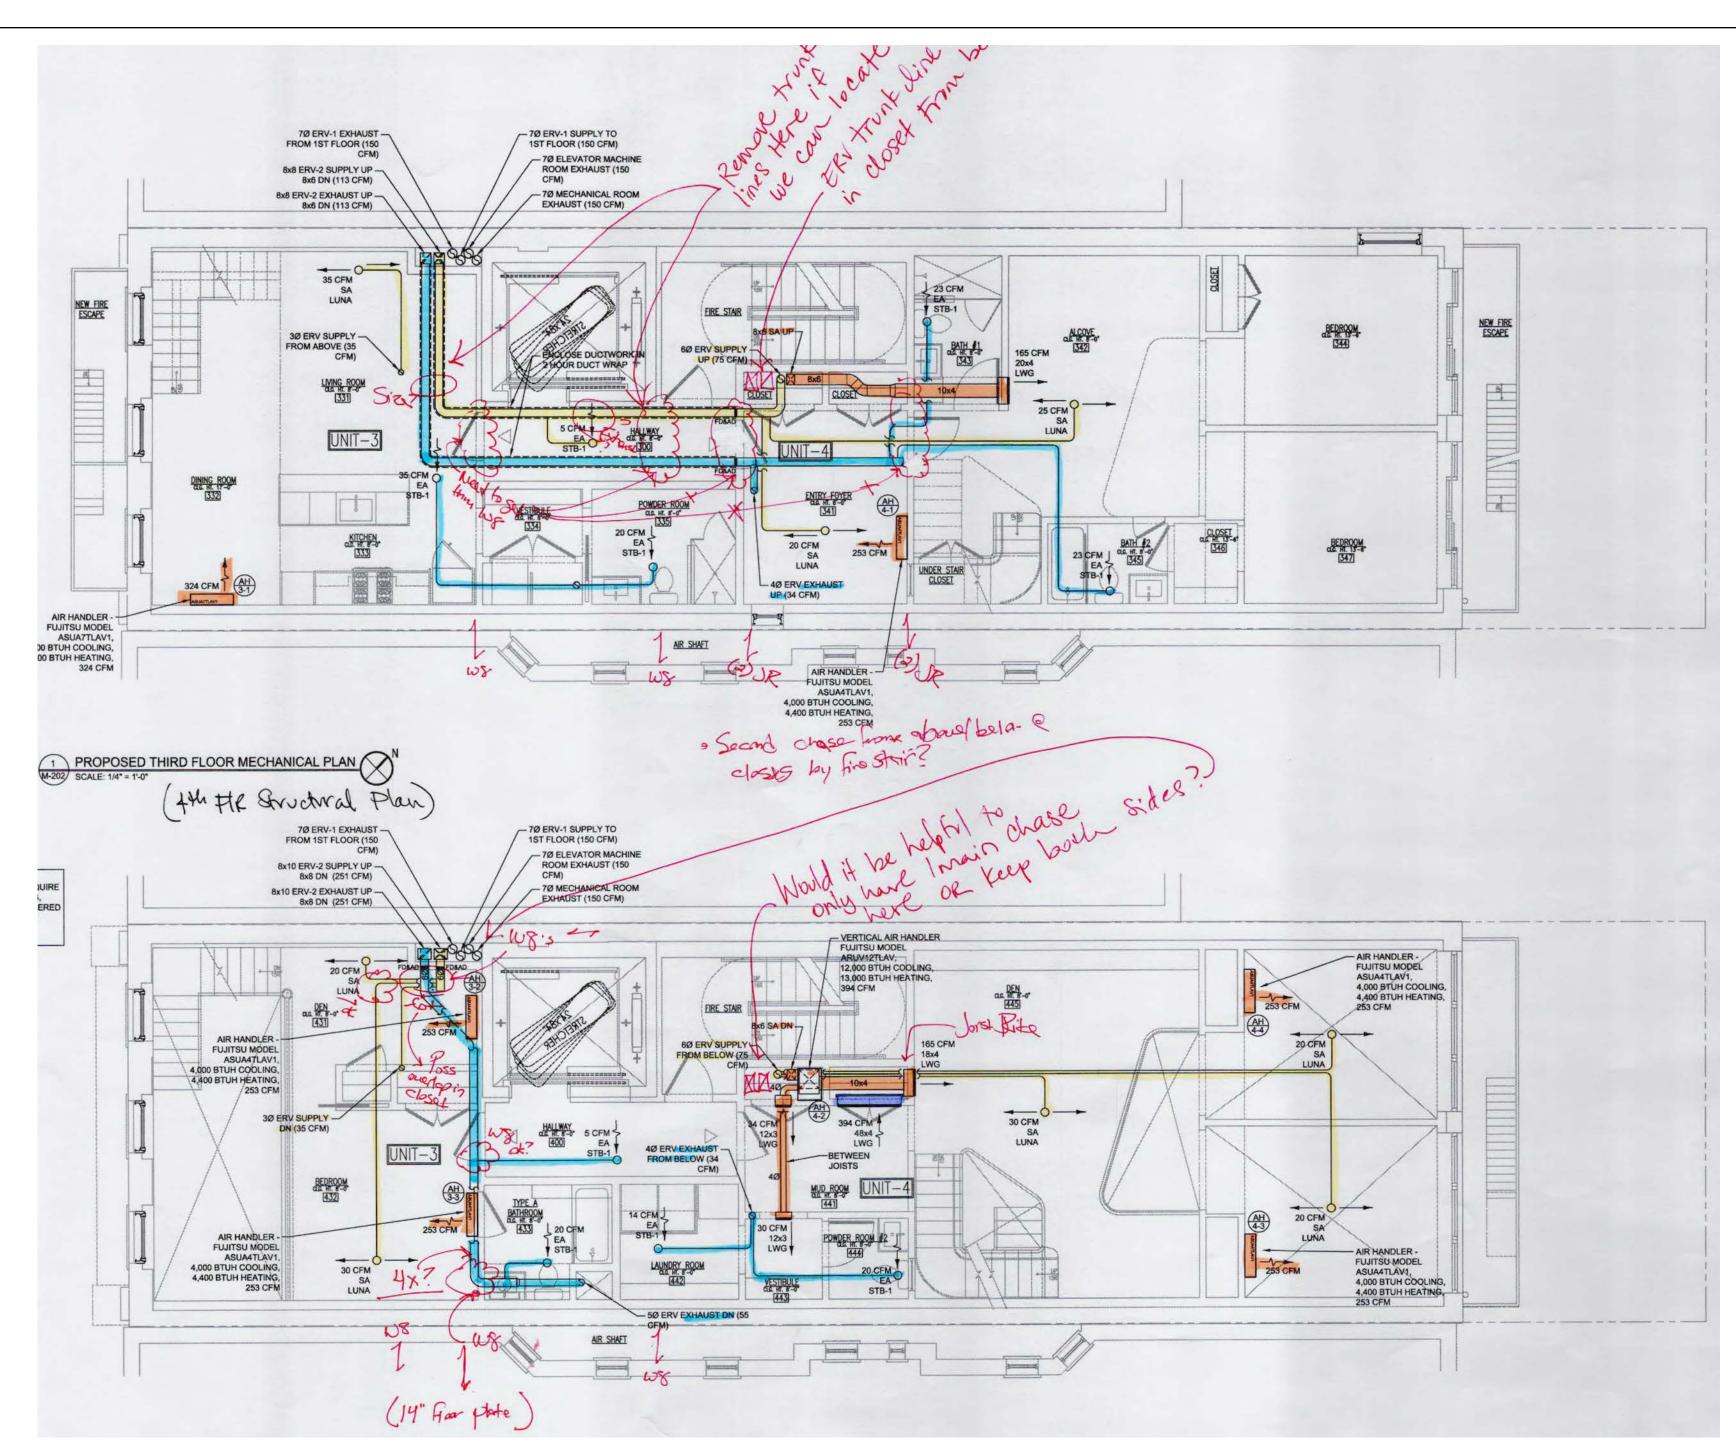
MECHANICAL PLANS: 3RD + 4TH FLOOR

1. 3RD FLOOR 2. 4TH FLOOR
