ENGINE 16

223 EAST 25TH STREET MANHATTAN, NY

MICHAEL INGUI, RA
Certified Passive House Designer
AMY FAILLA, RA
Certified Passive House Designer

BAXT INGUI - COMPLETED PASSIVE PROJECTS

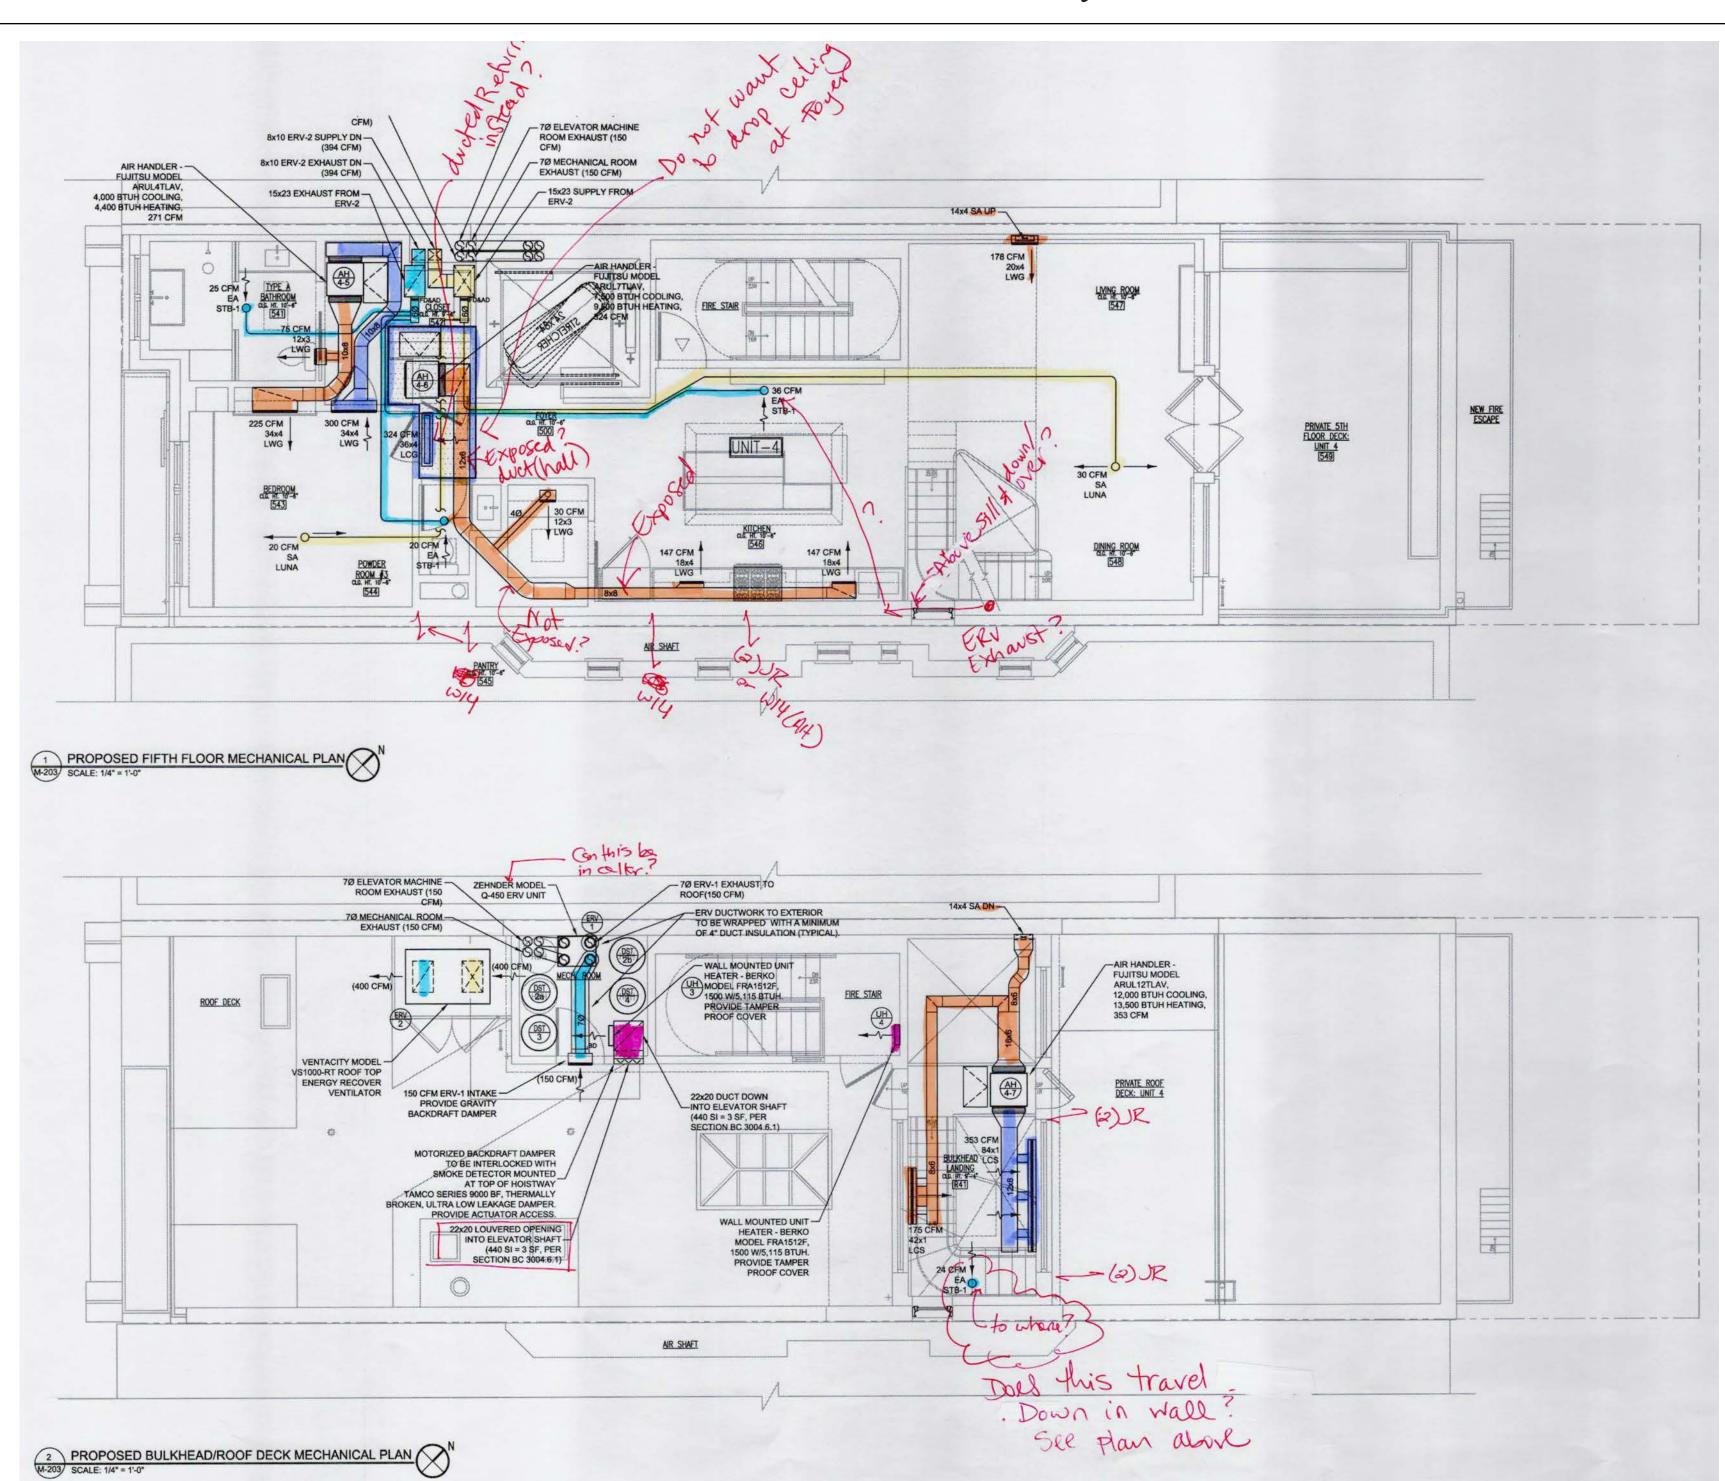
MECHANICAL PLANS: 5TH FLOOR, BULKHEAD & ROOF

1. 5TH FLOOR 2. BULKHEAD + ROOF

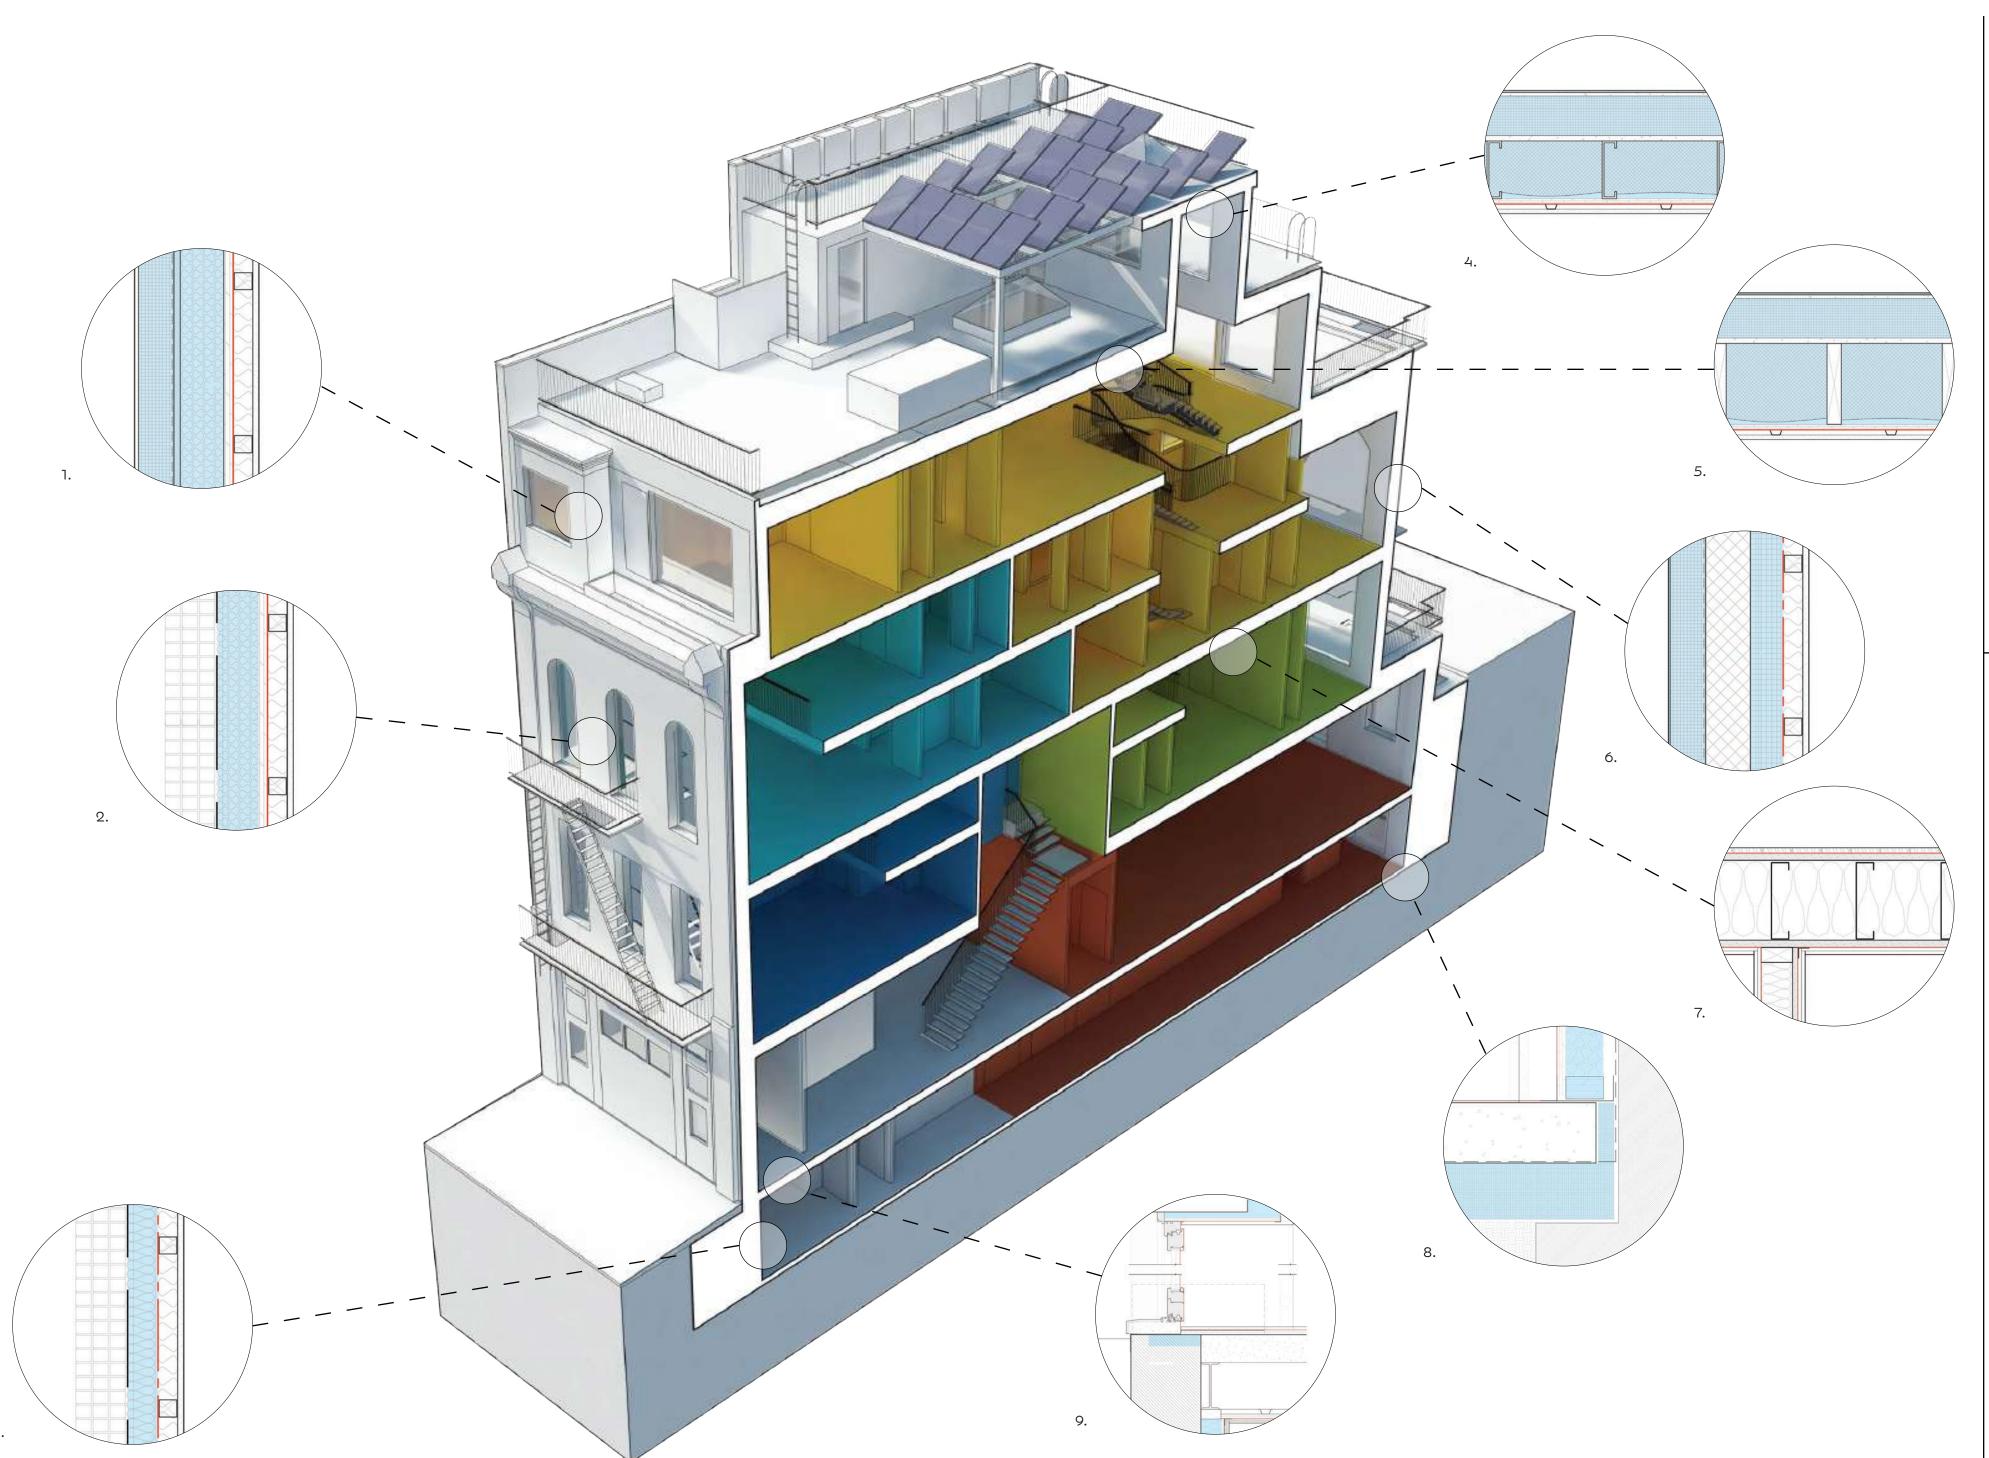
TYPICAL WALL + FLOOR ASSEMBLIES

- 1. WALL TYPE #7: NEW STEEL STUD WALL W/ EXTERIOR FOAM
- 2. WALL TYPE #4: EXISTING MASONRY WALL W/ CELLULOSE INSULATION
- 3. WALL TYPE #5:
 EXISTING MASONRY
 WALL W/ STEEL STUD
 + MINERAL WOOL
 4. ROOF TYPE #9: NEW
- 4. ROOF TYPE #9: NEW
 METAL JOIST W/
 CELLULOSE INTERIOR
 INSULATION +
 EXTERIOR FOAM
- 5. ROOF TYPE #8: NEW
 WOOD JOIST W/
 CELLULOSE INTERIOR
 INSULATION +
 EXTERIOR FOAM
 6. WALL TYPE #6: NEW
- MASONRY WALL W/
 CELLULOSE INTERIOR
 INSULAITON +
 EXTERIOR FOAM
- 7. UNIT TO UNIT AIR SEALING DETAIL
- 8. CELLAR SLAB DETAIL
 9. VESTIBULE AIR
 SEALING +
 INSULATION DETAIL

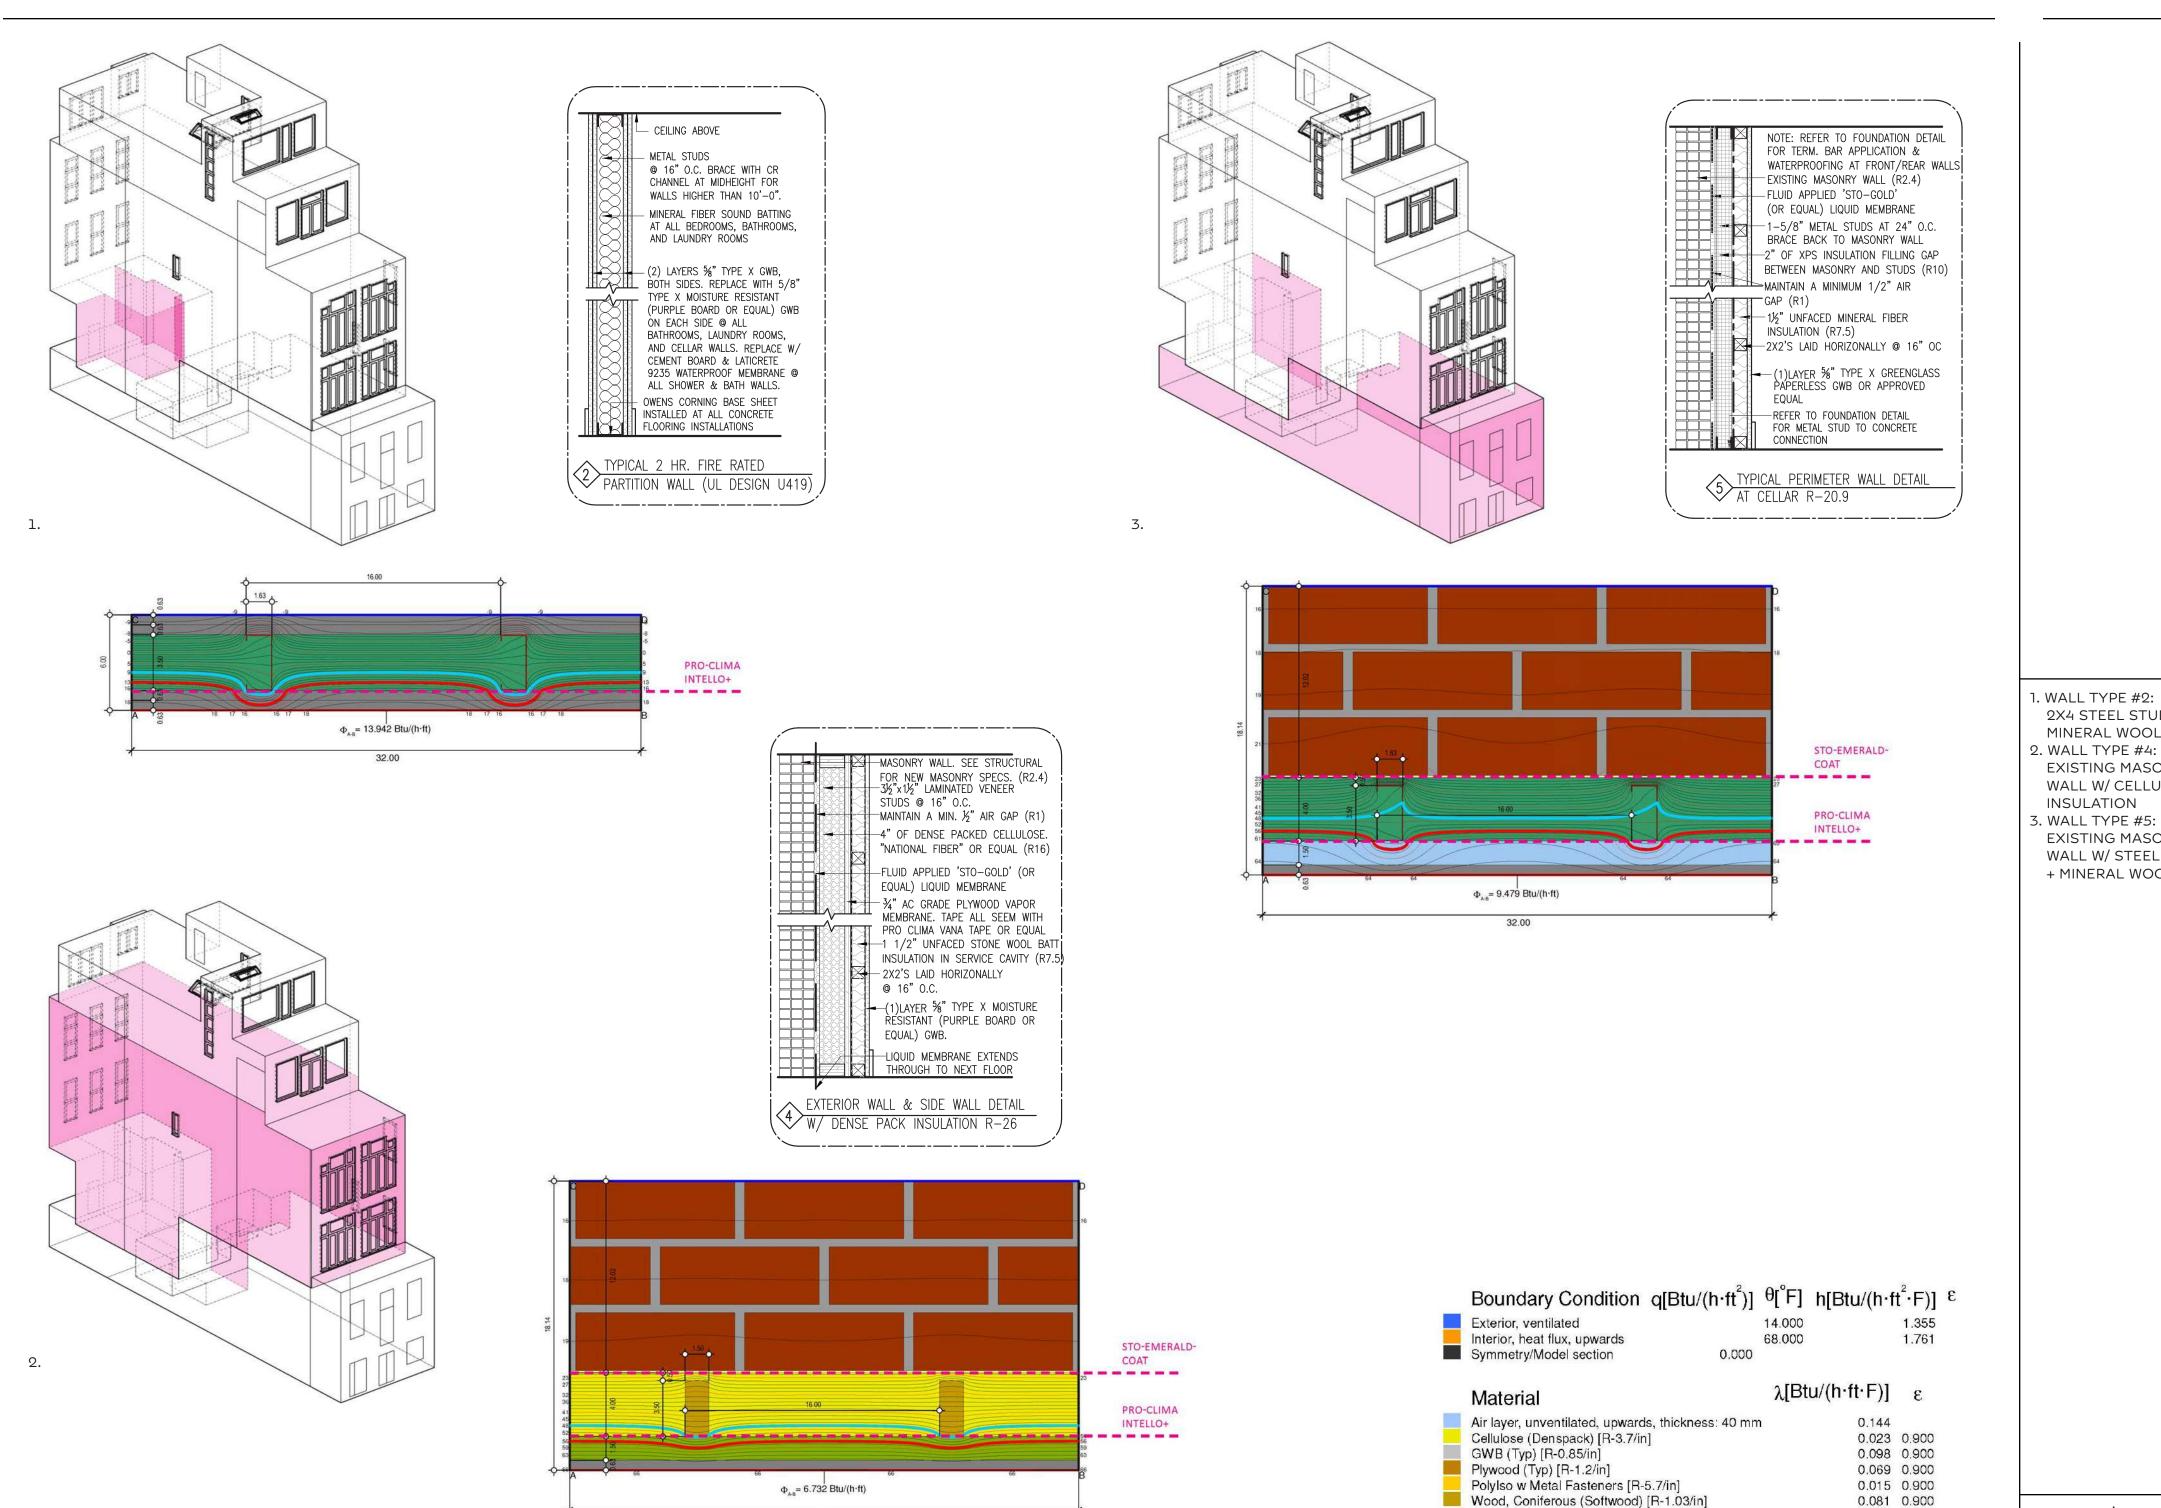
WALL DETAILS

2X4 STEEL STUD W/

MINERAL WOOL BATT

EXISTING MASONRY

WALL W/ CELLULOSE

+ MINERAL WOOL

WALL W/ STEEL STUD

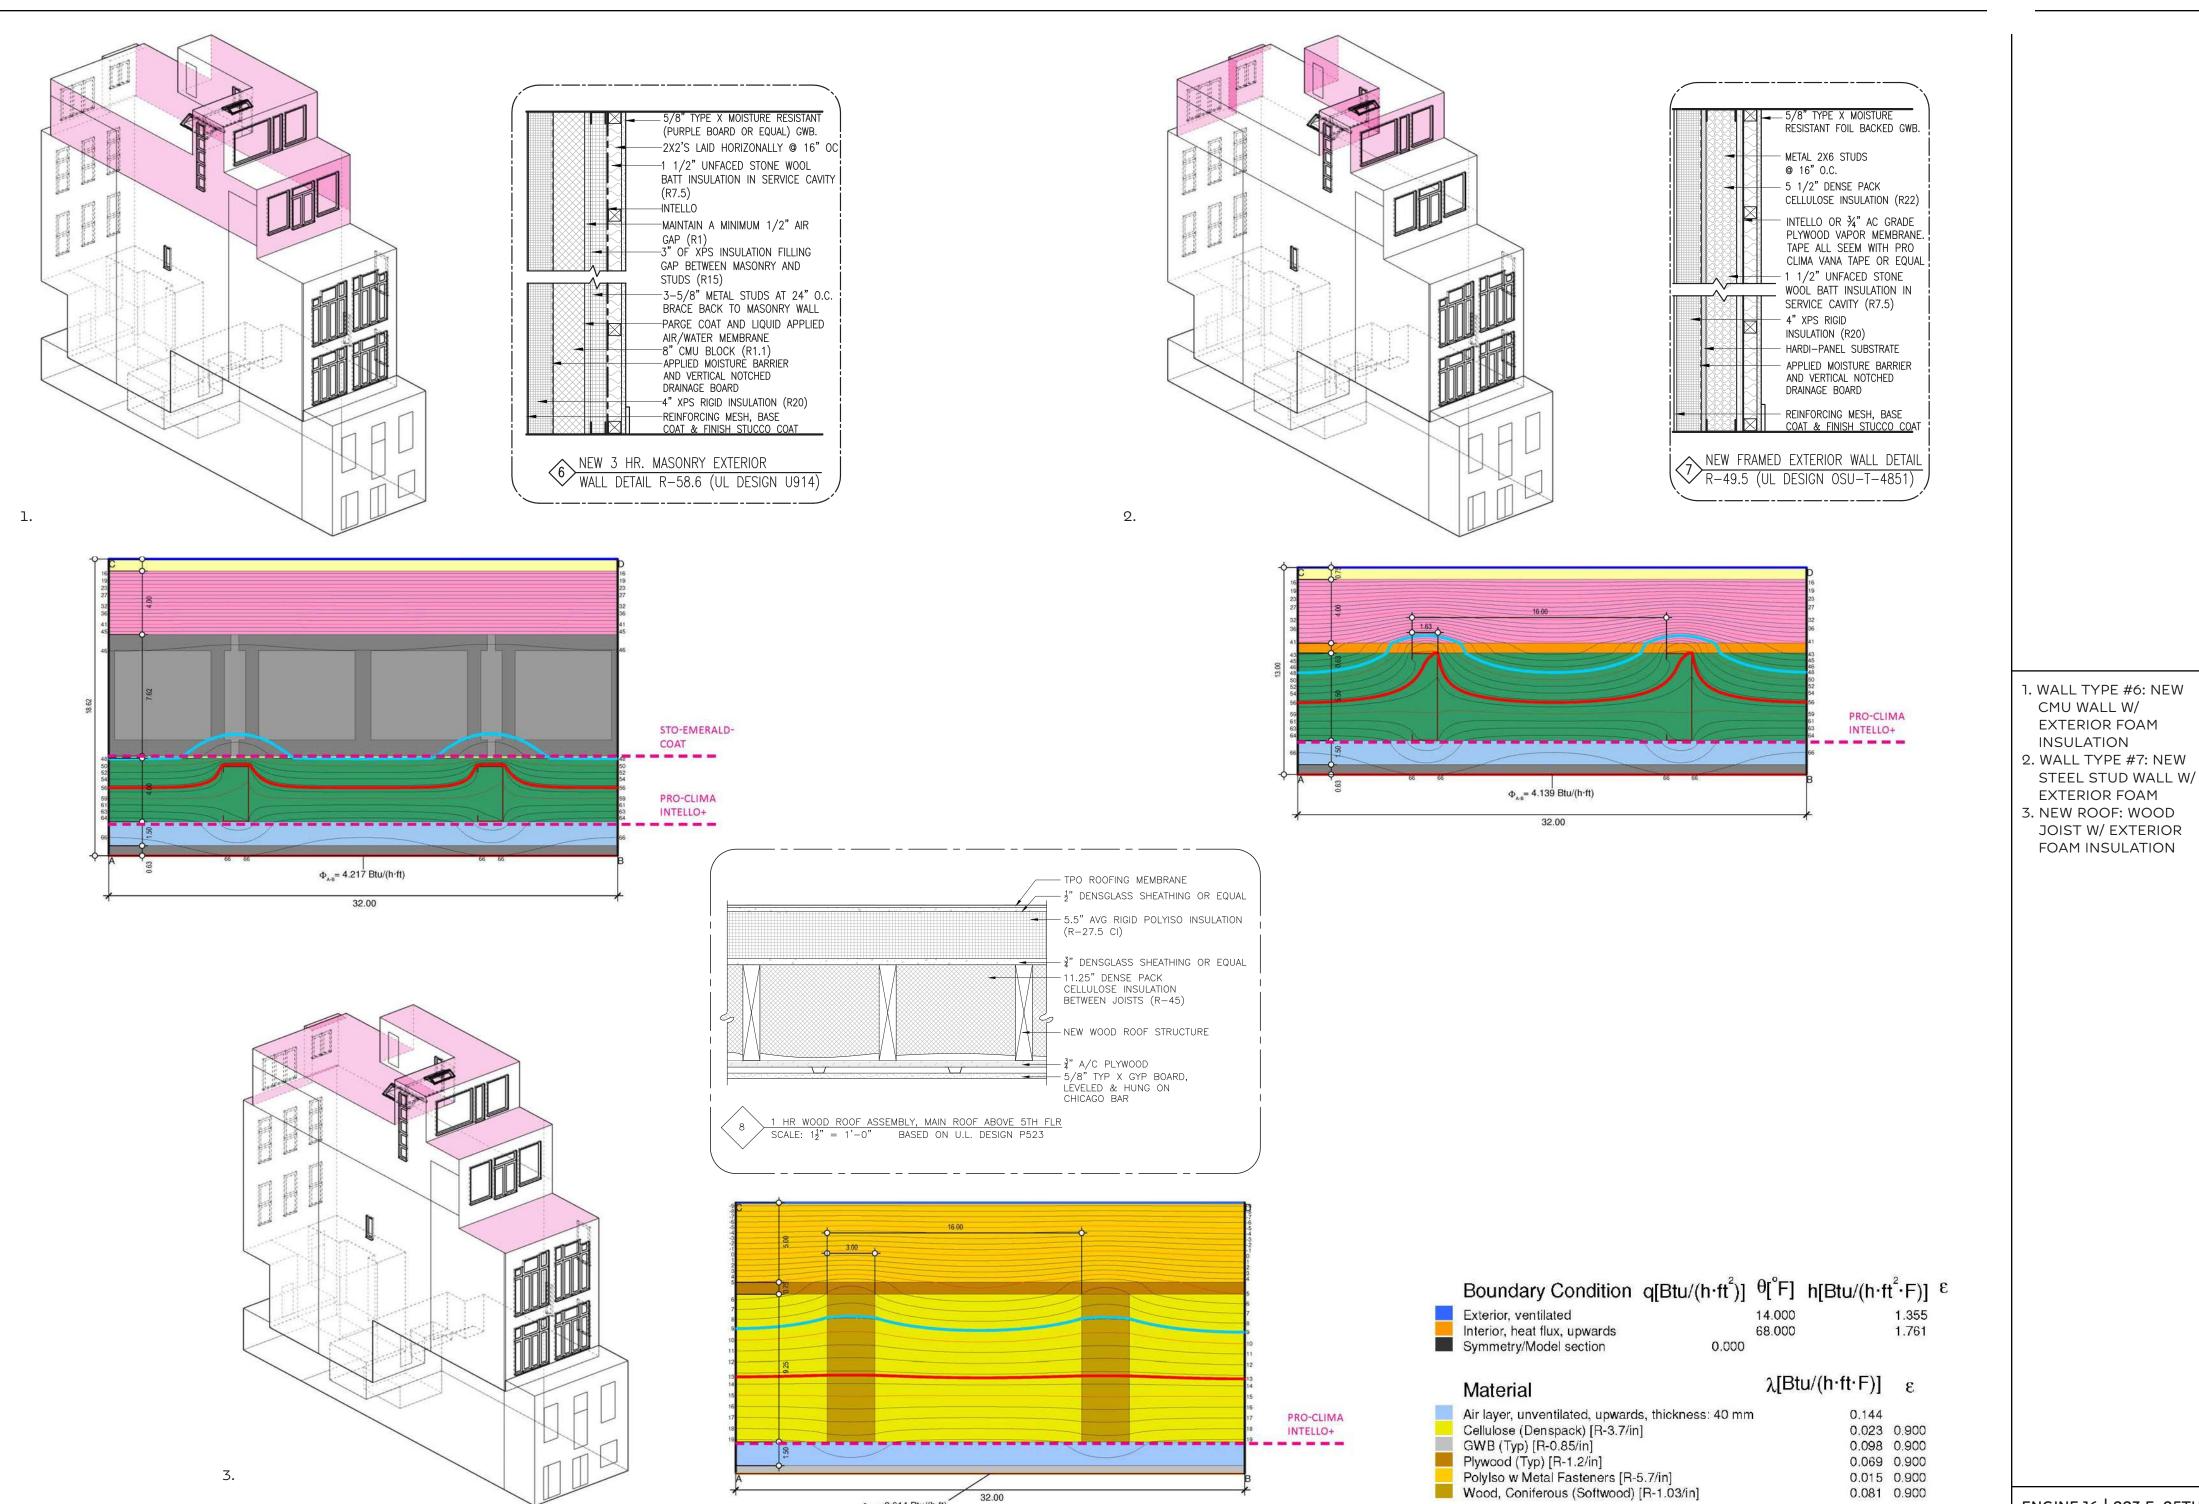
WALL + ROOF DETAILS

Φ_{A-8}= 2.614 Btu/(h·ft)

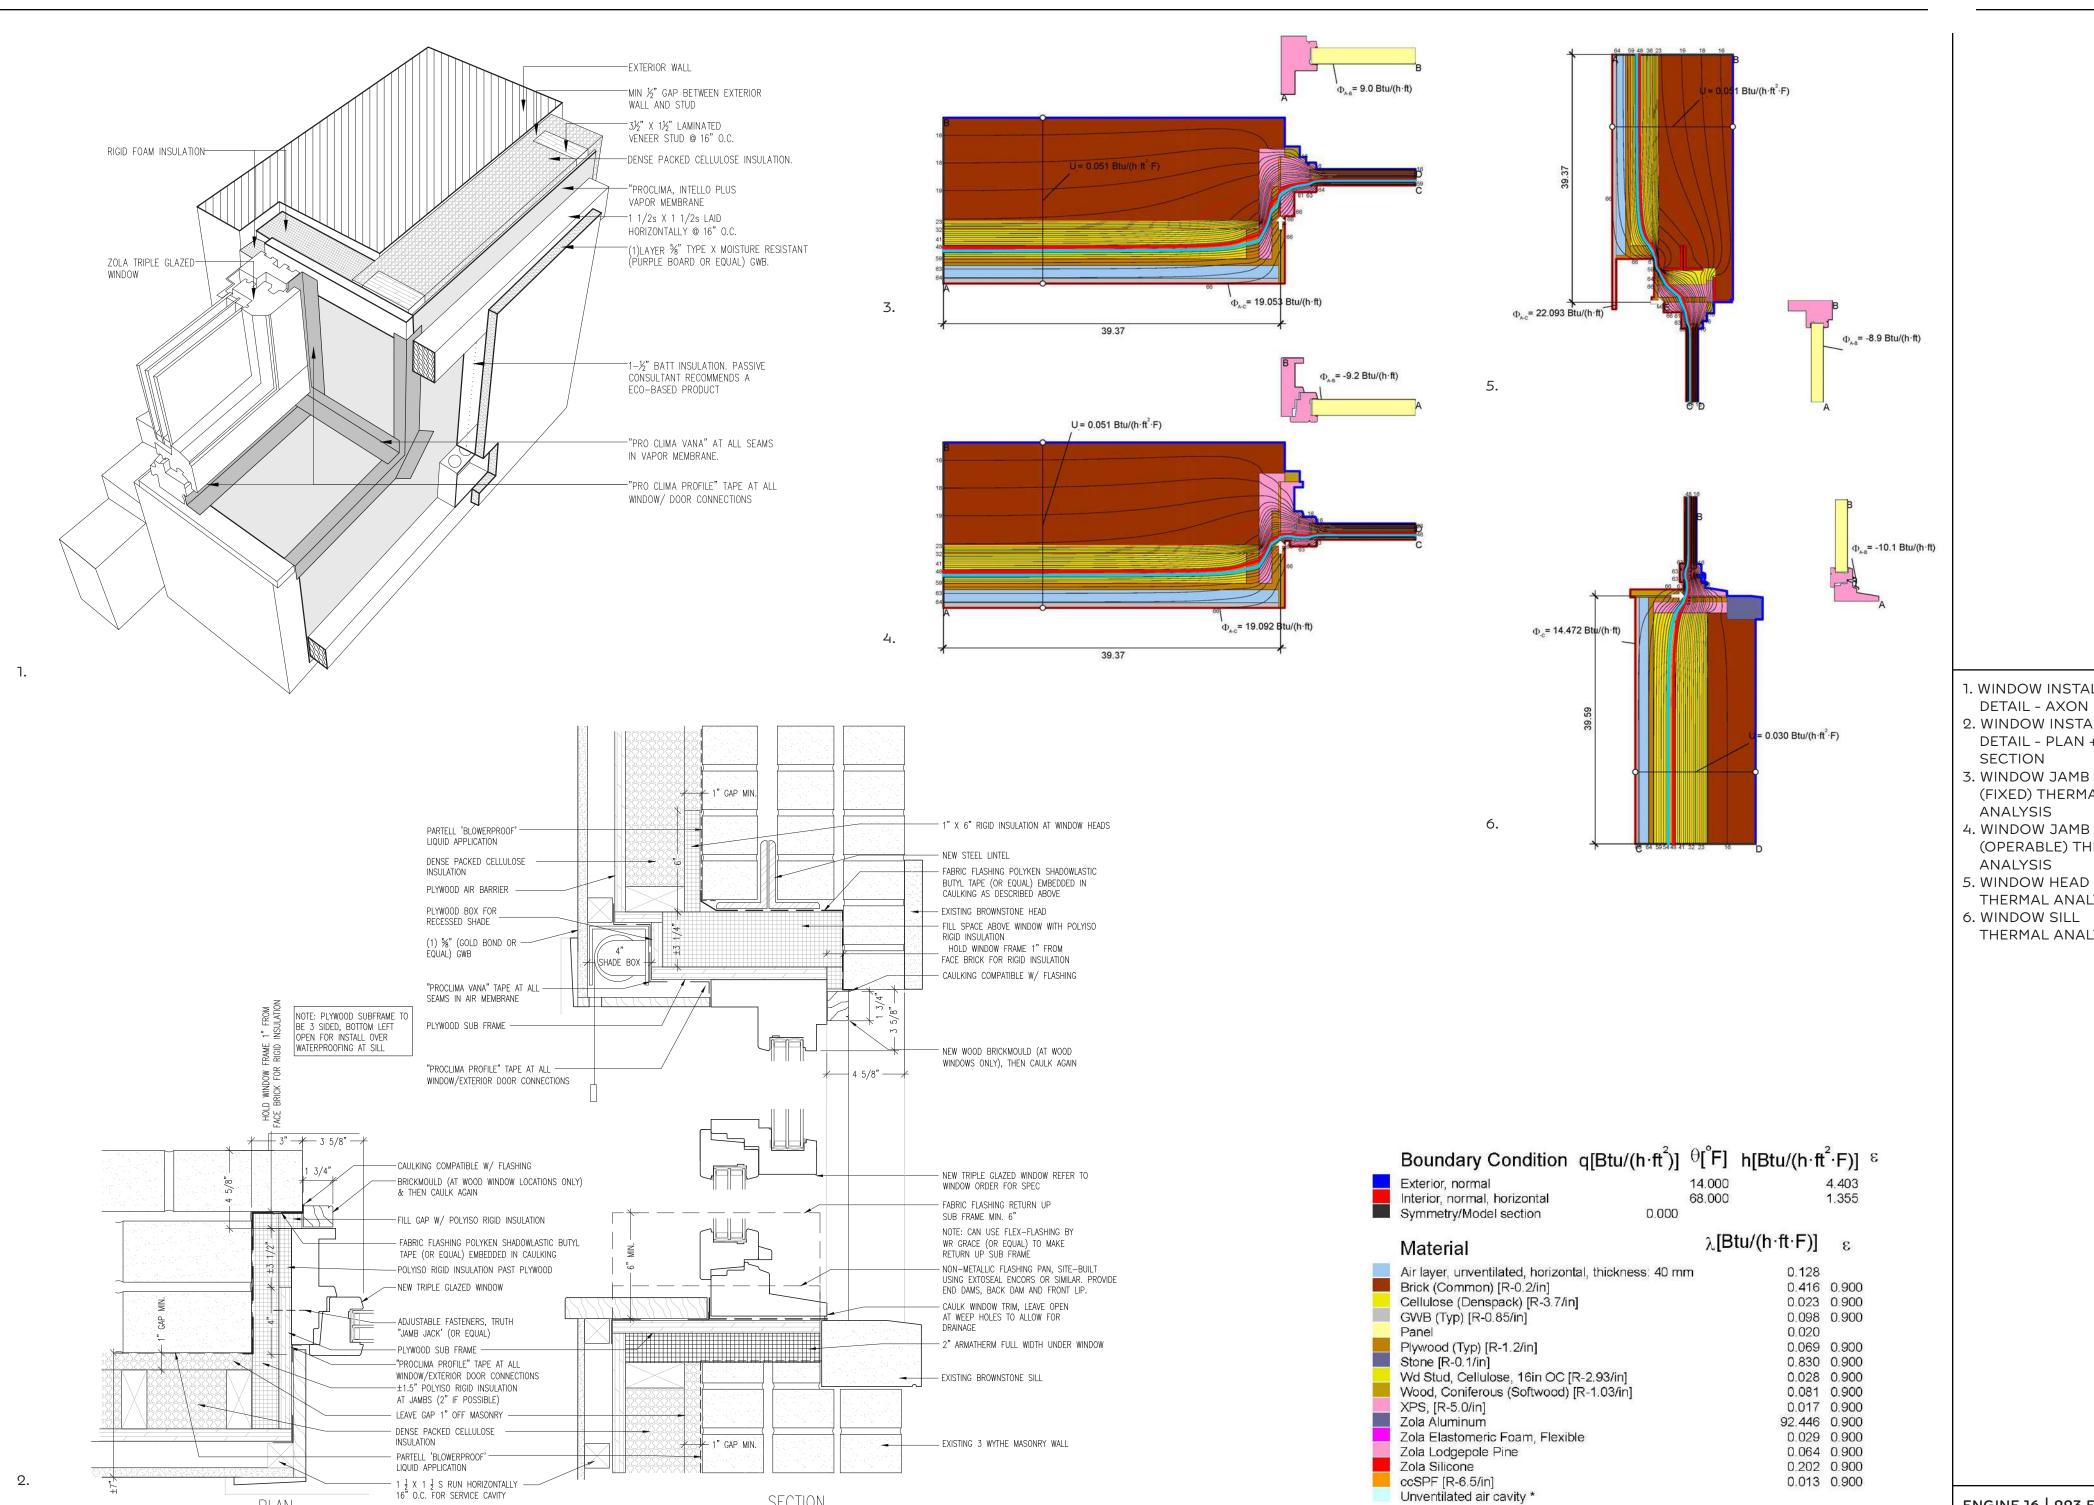
WINDOW DETAILS

- 2. WINDOW INSTALL DETAIL - PLAN +
- 3. WINDOW JAMB (FIXED) THERMAL
- 4. WINDOW JAMB (OPERABLE) THERMAL
- THERMAL ANALYSIS 6. WINDOW SILL THERMAL ANALYSIS

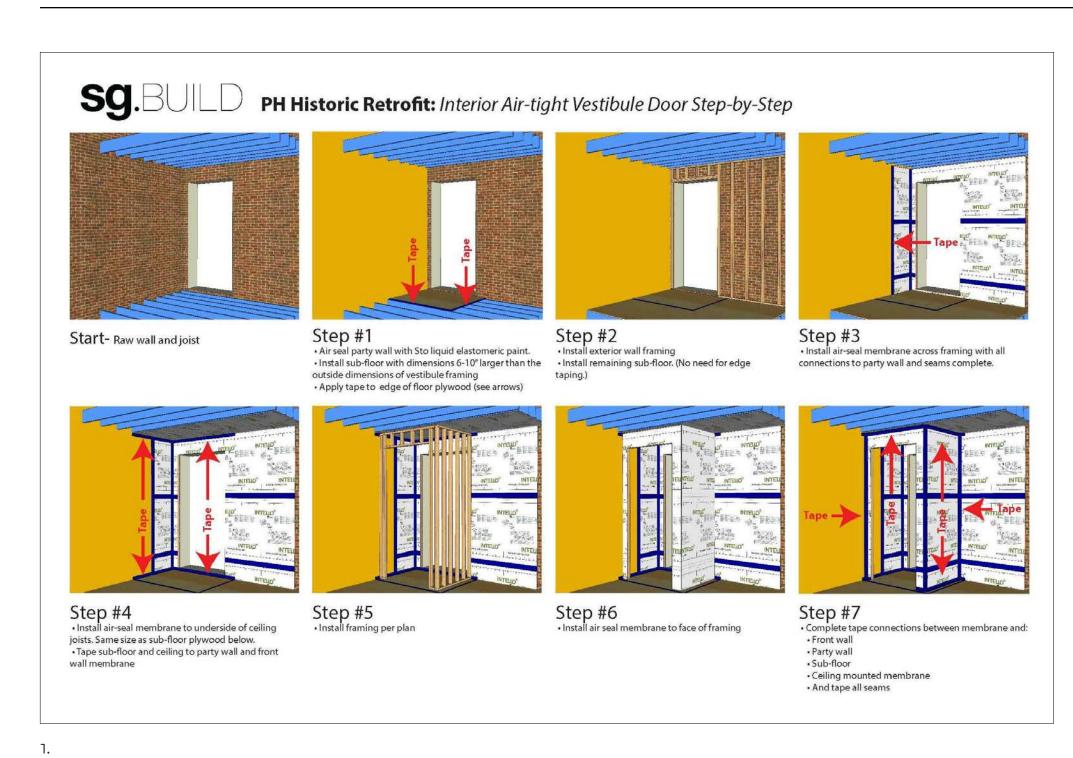
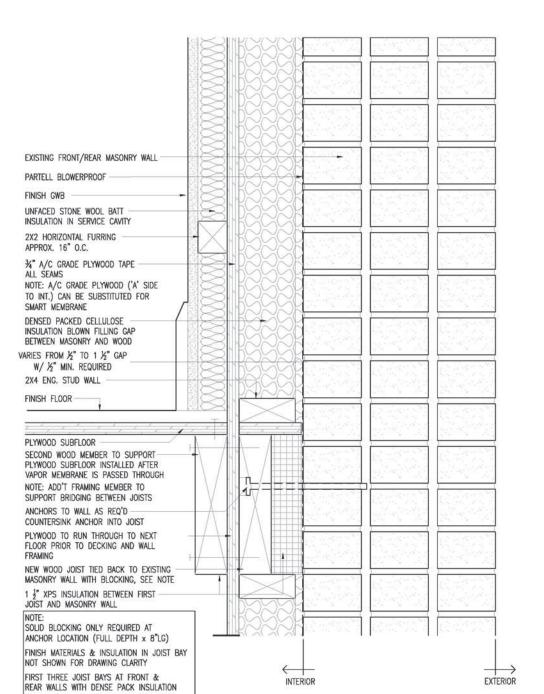
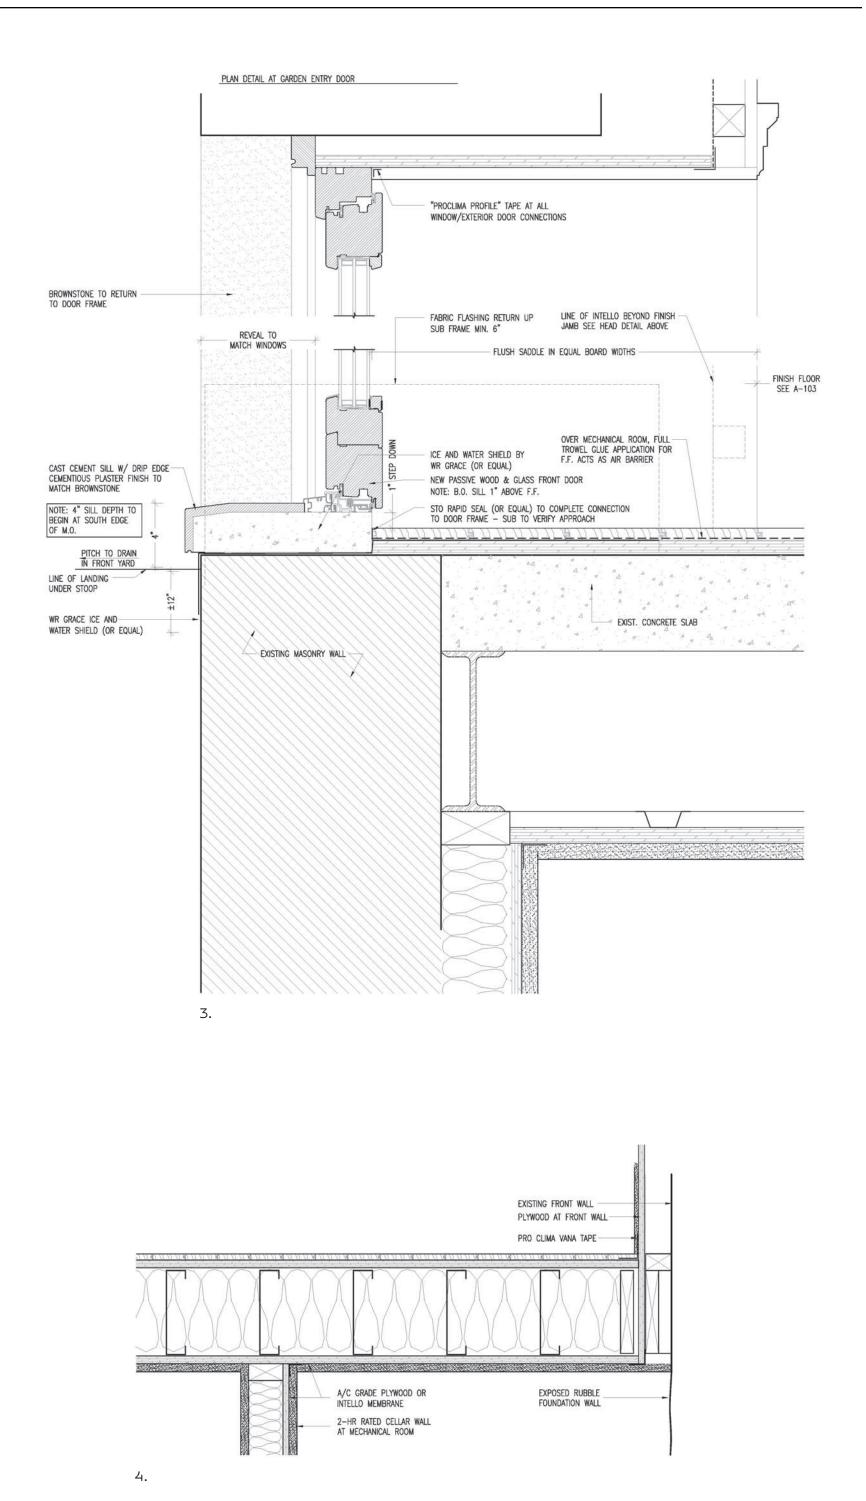
ENTRY RETROFIT AIR SEALING DETAILS

1. VESTIBULE AIR-TIGHTNESS DIAGRAM

2. FRONT + REAR WALL SECTION DETAIL - AIR SEALING AROUND FIRST FLOOR JOIST

3. ENTRY DOOR + VESTIBULE DETAIL

VESTIBULE DETAIL
4. AIR-SEALING DETAIL
BETWEEN FLOORS
THAT SEPARATE

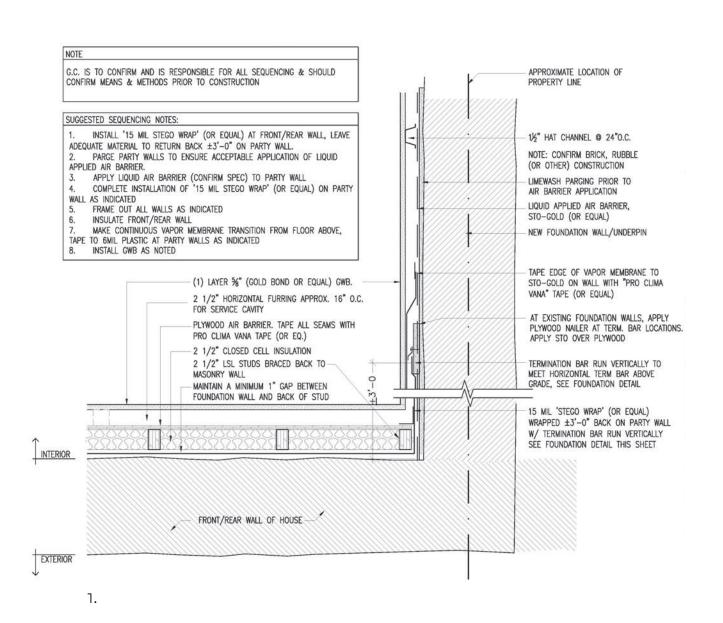
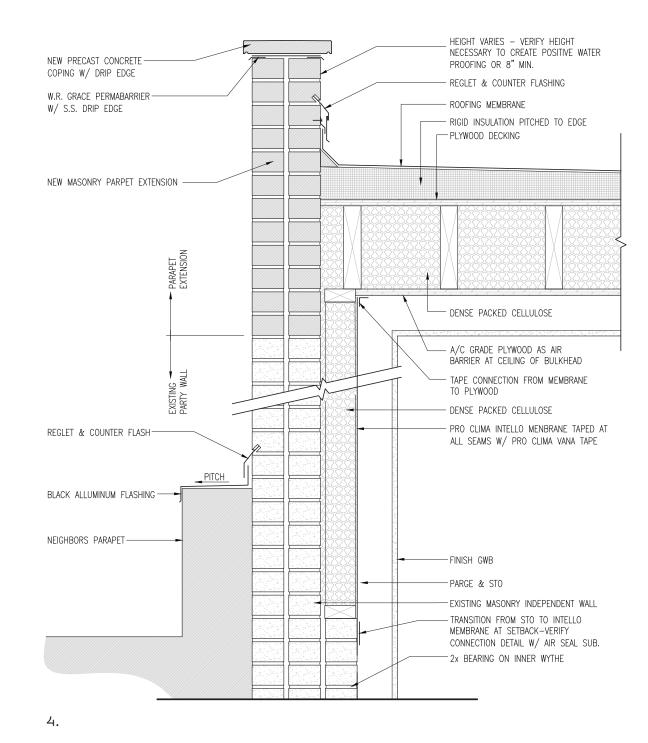
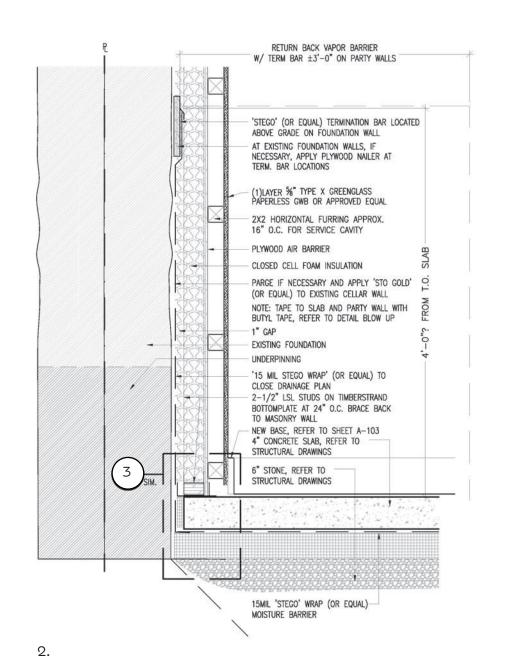
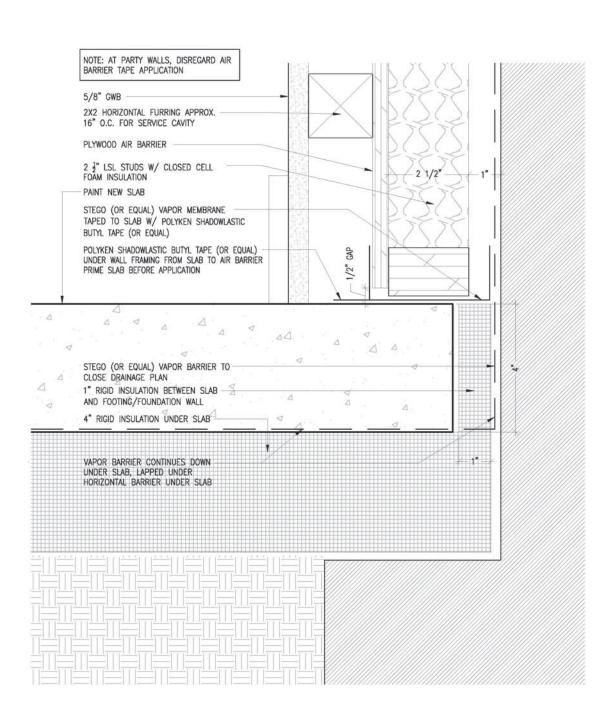
MASONRY RETROFIT DETAILS

NOTE:
THIS ENSURES INTERIOR PARTITIONS ON PERIMETER
CAN BE FRAMED W/O INTERUPTION FROM
INSULATION & PASSIVE ENVELOPE INSTALLATION

- 1. BELOW GRADE FOUNDATION WALL PLAN DETAIL
- FOUNDATION WALL
 SECTION
 3 RELOW GRADE SLAR

- 3. BELOW GRADE SLAB/ WALL SECTION DETAIL 4. PARTY WALL ROOF
- + PARAPET SECTION DETAIL
- 5. PIPE PENETRATION @ ROOF DETAIL
- 6. PARTY WALL / ROOF CONNECTION DETAIL

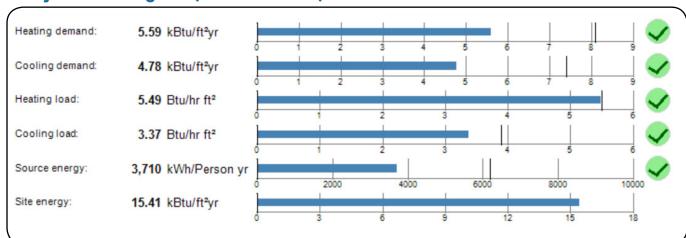
Project As Designed (PHIUS+2018)

As Designed:

- PHIUS+ 2018 certification
- Offsite Photovoltaics to satisfy source energy requirement
- Heat recovery ventilation system
- No post-occupancy monitoring

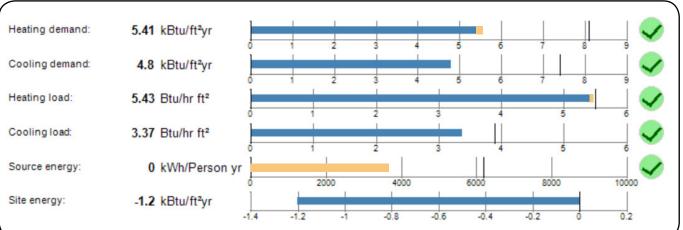
As Improved:

- PHIUS+ 2018 + Source Zero
- Offsite Photovoltaics + Maximum Onsite Photovoltaic roof array
- Upgrade to ERV
- Post-occupancy monitoring protocol
 - Site Sage electricity use
 - Temperature / RH sensors
- Information Broadcasting protocol

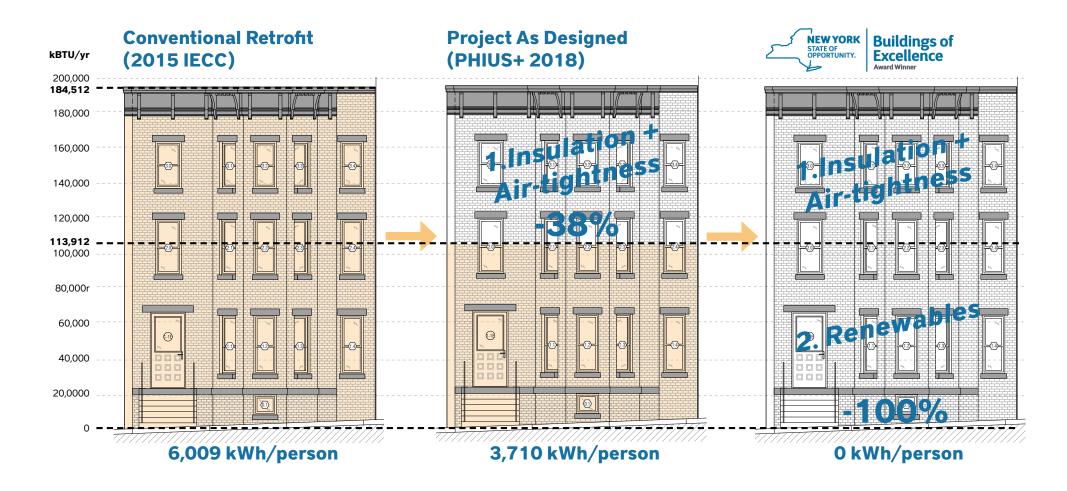
Step 1: Insulation & Air-tightness Annual Heating Demand

Conventional Retrofit Project As Designed (2015 IECC) (PHIUS+ 2018) kBTU/vr 51,122 50,000 45.000 **Insulation Levels Insulation Levels** - R49 Ceiling - R64 Ceiling 40.000 - R17 Walls - R35 Typ Wall - R30 Floor - R33 Floor 35.000 **Airtightness Airtightness** 30.000 - .06 cfm/ft2 - .4 cfm/ft2 25,000 20.000 15.000 12,744 10.000 5.000 (I) (II)

5.59 kBTU/ft².yr

21.72 kBTU/ft².yr

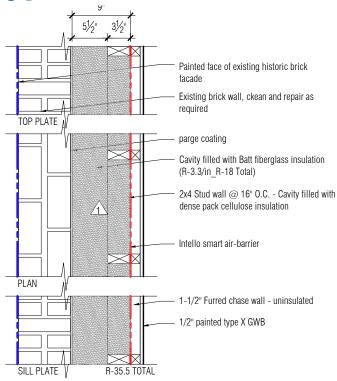
Typical Wall

R35

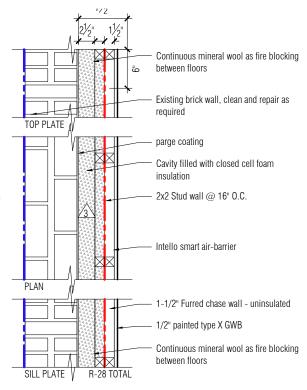
Thin Wall

R28

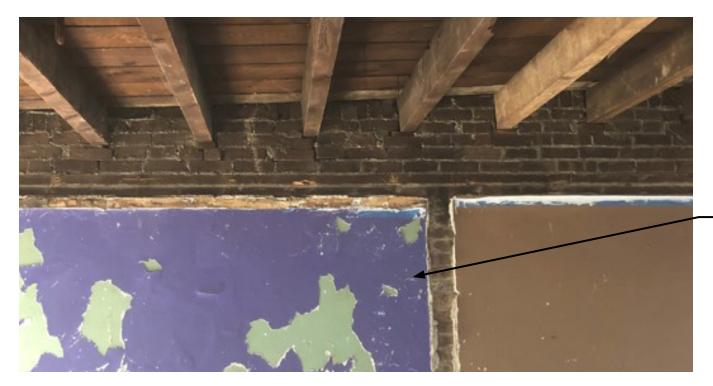
Patches of existing plaster were left

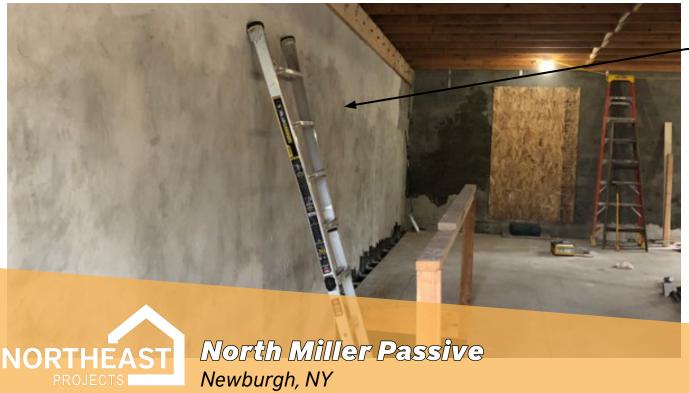
New lime plaster coat

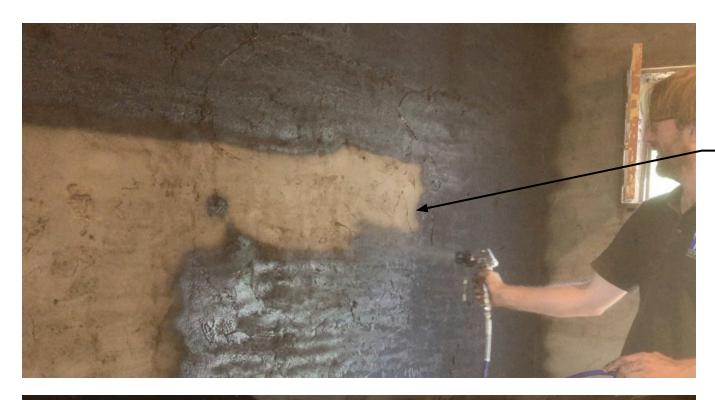
Spray applied Visconn is seamingly the magic solution

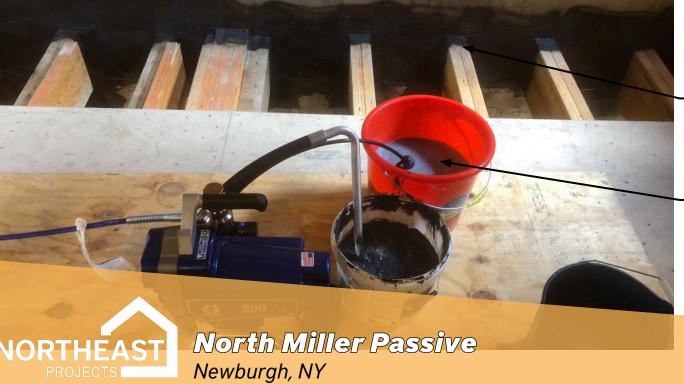
Spray-applied air barrier covers inconsistent surfaces and inside corners easily

Visconn sprays on blue and dries black

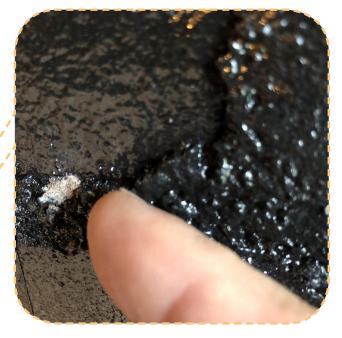
Adhesion on type O plaster-Visconn chips right off

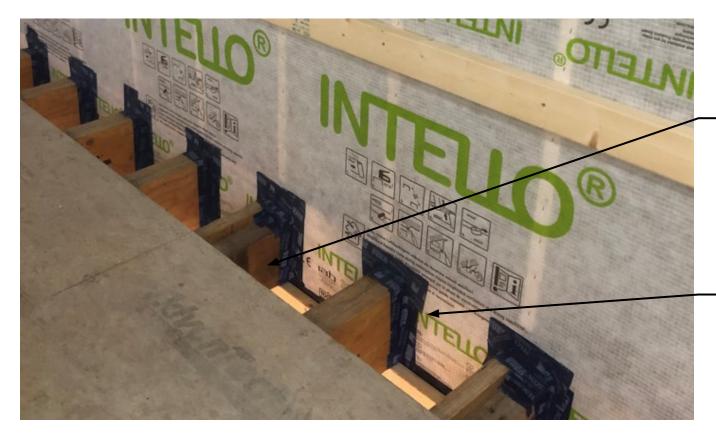
Sistering of two different types of dimensional lumber

Tape origami around pocket beams

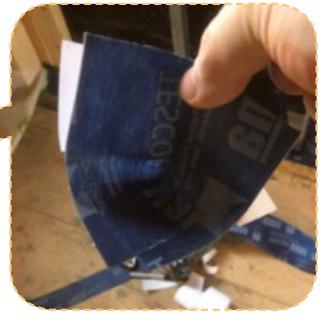
Dissimilar framing members and air-sealing come into conflict
