ENGINE 16

223 EAST 25TH STREET MANHATTAN, NY

MICHAEL INGUI, RA
Certified Passive House Designer
AMY FAILLA, RA
Certified Passive House Designer

BAXT INGUI - COMPLETED PASSIVE PROJECTS

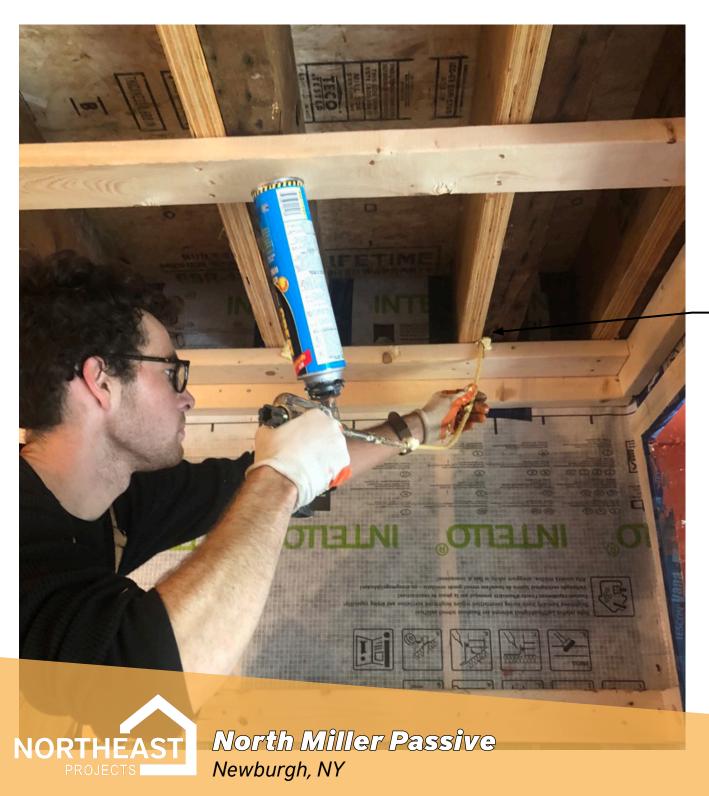
- 3/8" Hole drilled between beams and filled with expanding foam

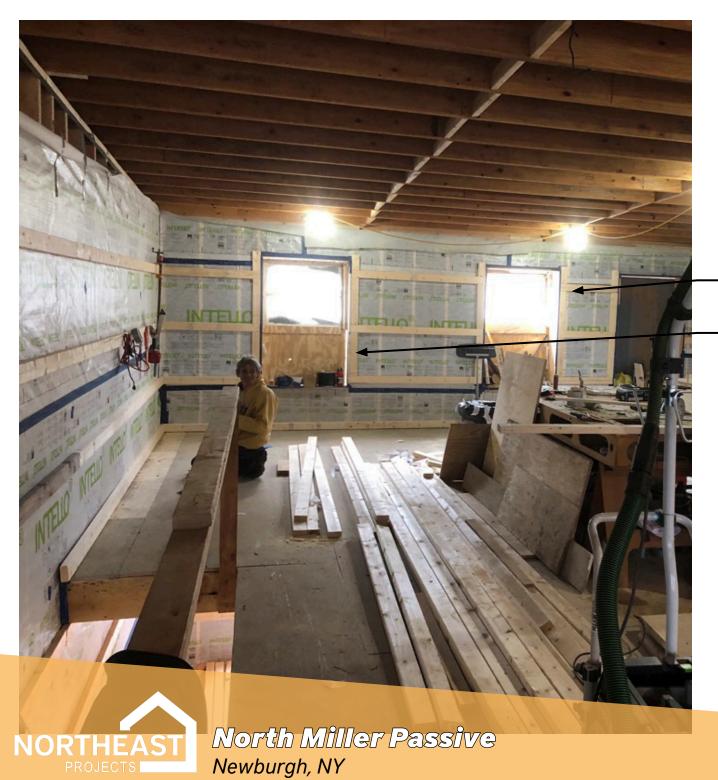
Blower Door 01:

310 cfm total .056 cfm/ft²

· 2x4 strapping installed before first blower door test

Air leaking around 2x4 strapping

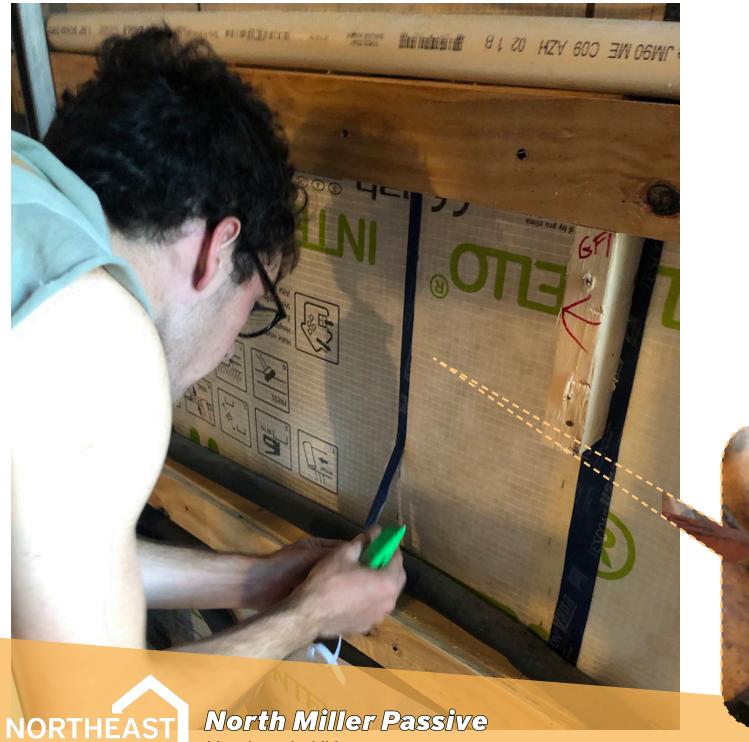
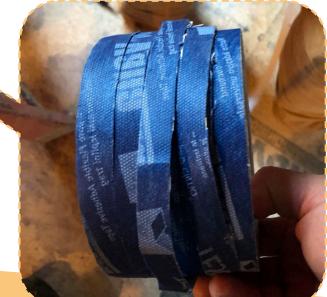
Blower Door 02:

227 cfm total .041 cfm/ft²

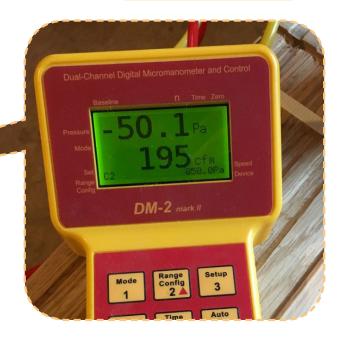
Blower Door 03:

195 cfm total $.035 \text{ cfm/ft}^2$
