Park Avenue Green

Passive High-Rise Affordable Housing

Project Introduction

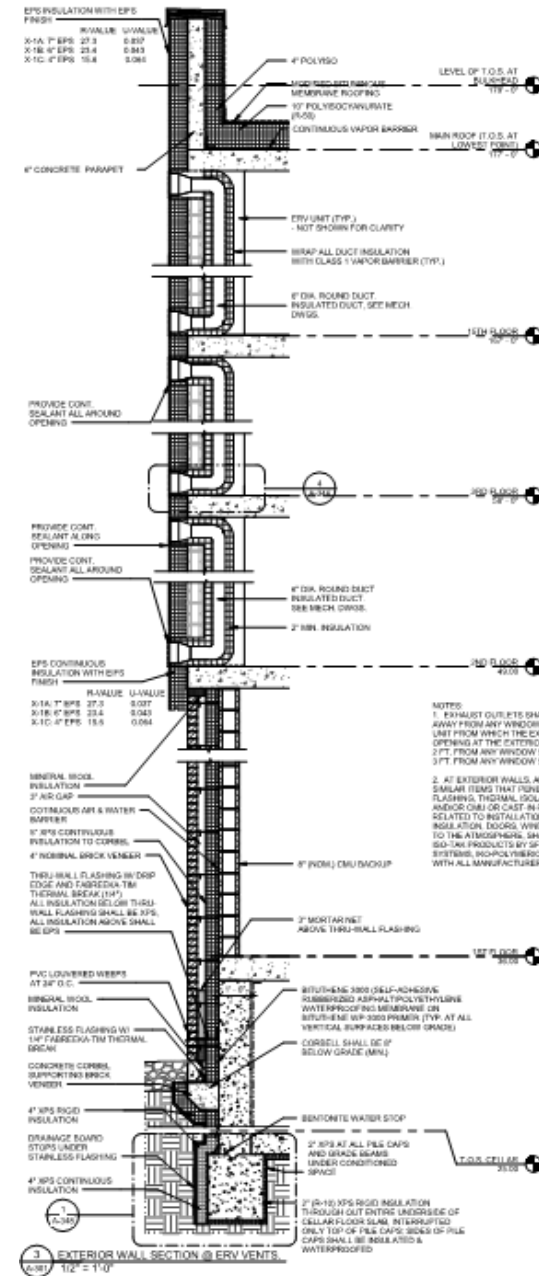
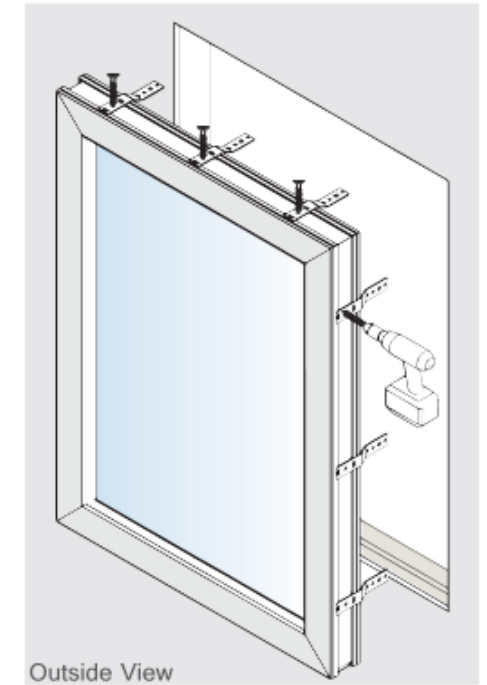
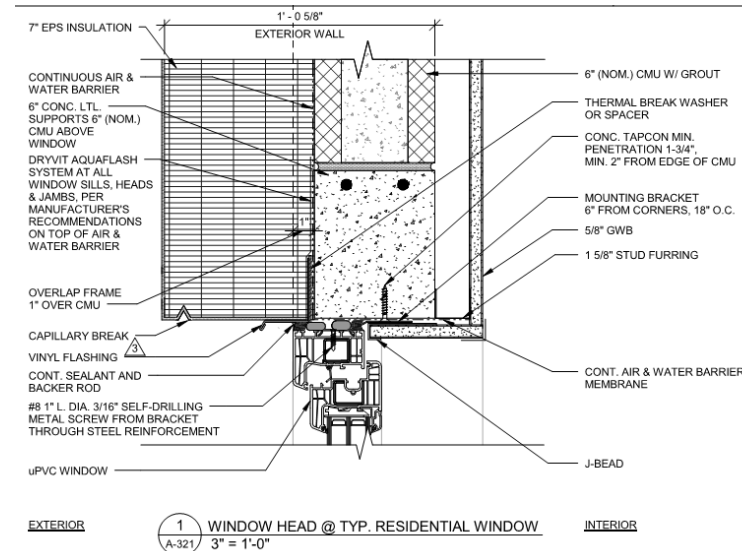
High Performing Building Envelope

- Continuous Insulation with EIFS
 - Air/Wind tightness with EIFS
 - Minimize Thermal Bridging
 - Optimize Solar Gains – Glazing and Shading through high performance, triple glazed uPVC window
 - Indoor Air Quality – Heat/ Moisture Recovery
-
- *Sub-Slab: R-10*
 - *Walls: R-27.3 Cont.*
 - *Roof: R-50 min*
 - *uPVC Window: U-Factor = 0.14 Overall*
 - *UG = 0.088; UF = 0.167*
 - *SHGC = 0.25*
 - *OITC = 28*

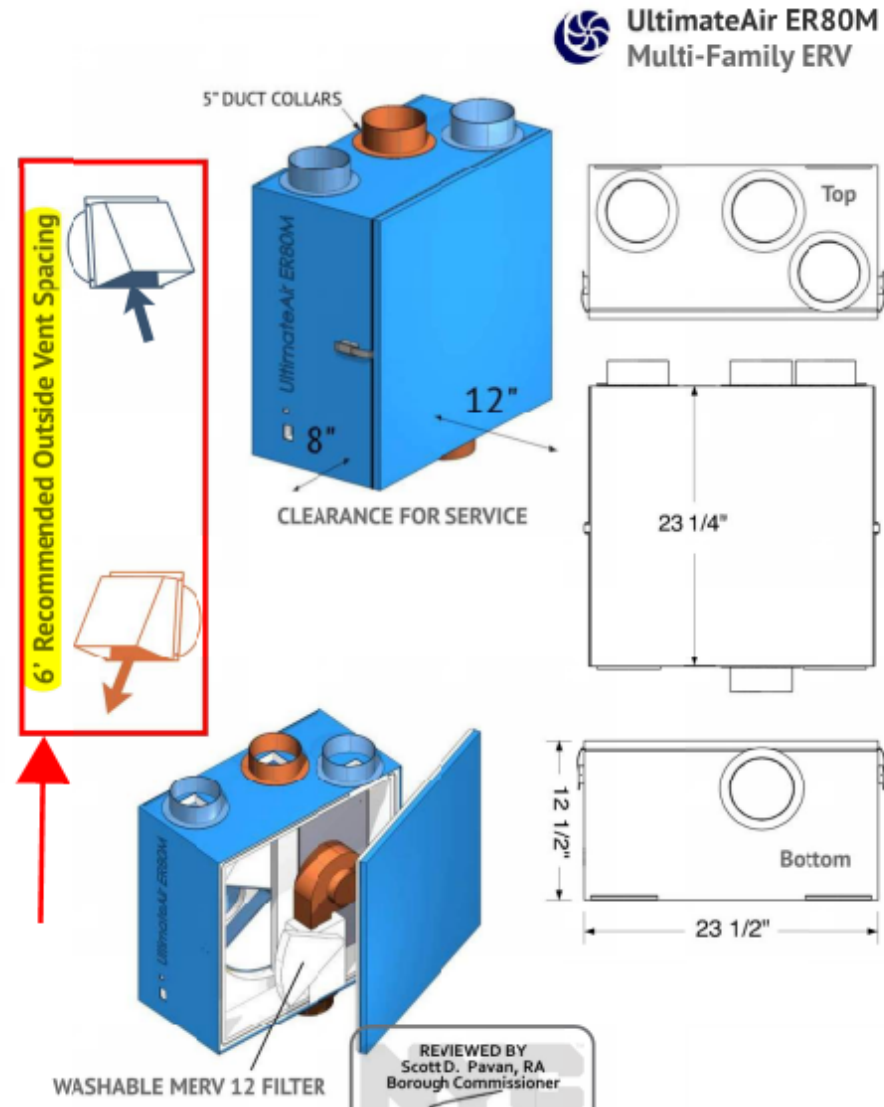
DOB Special Permission Solution

10' distance between
exhaust and supply

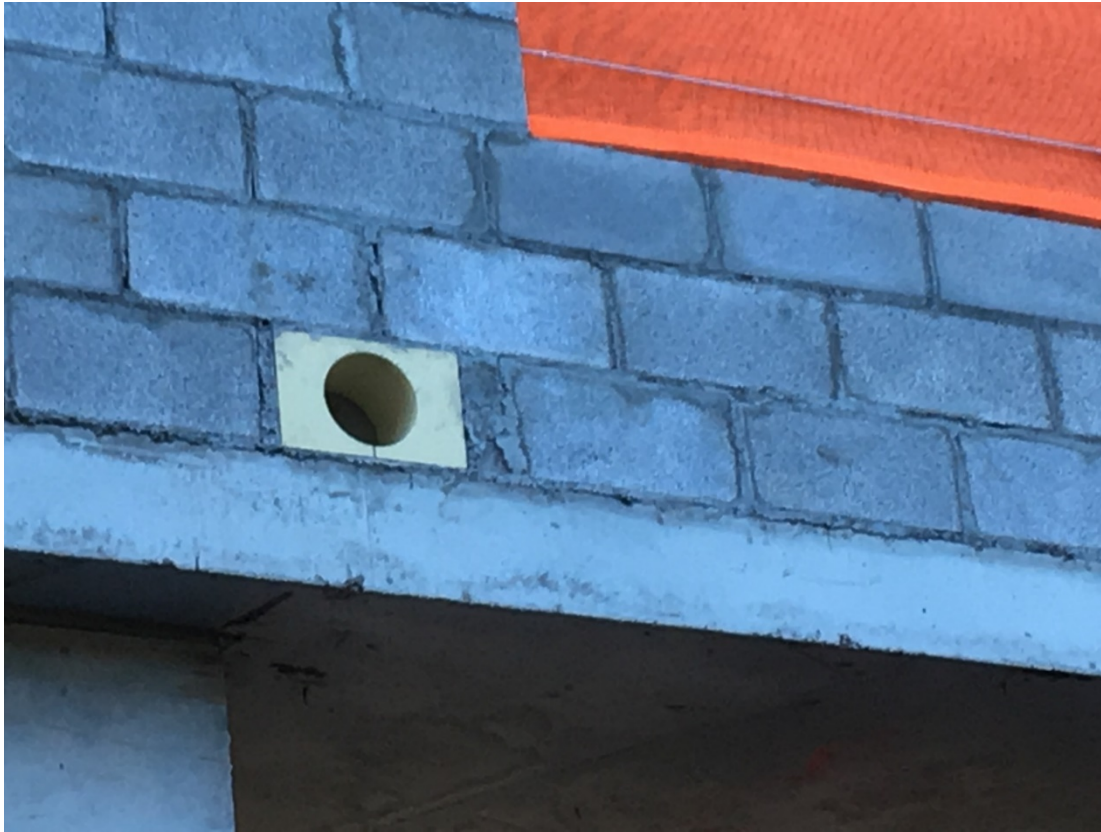
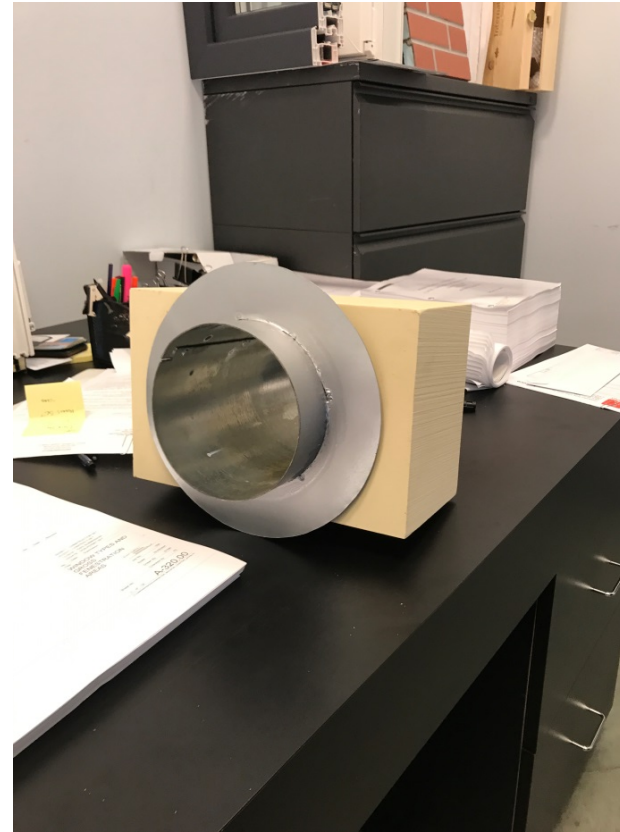
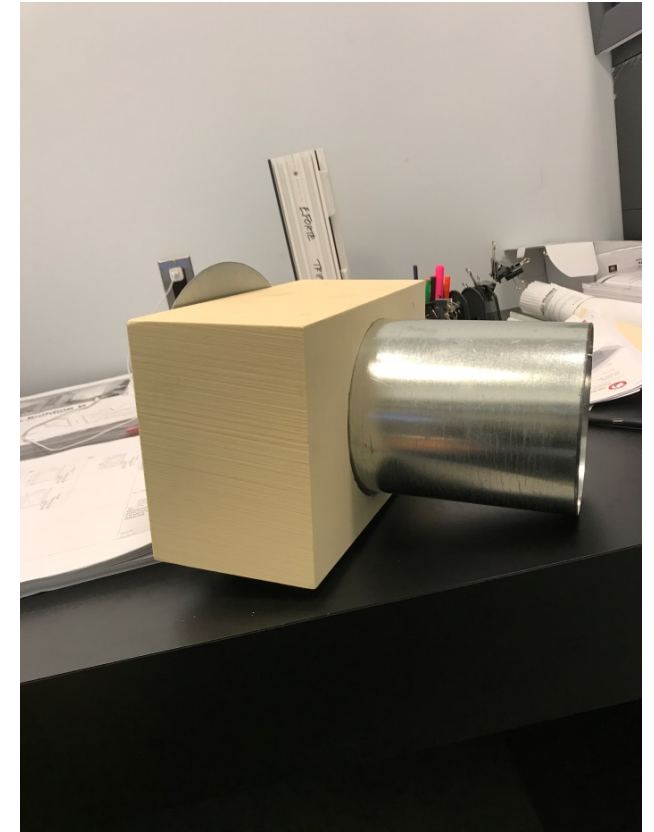
Contractor Solution

Use structural grade thermal blocks around ducts which the mason can then place perfectly in the 8" CMU rough opening

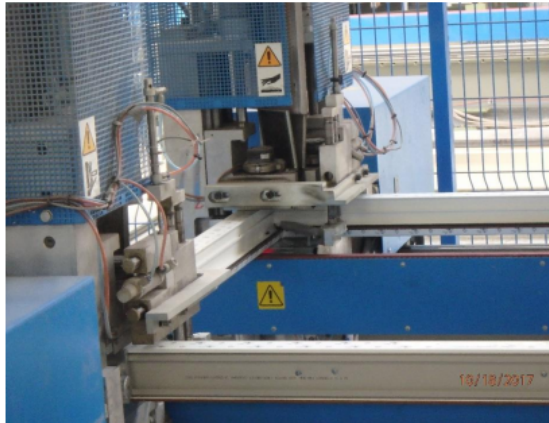
Photograph #27

View of the window main frame corners being welded with automated welding machine.

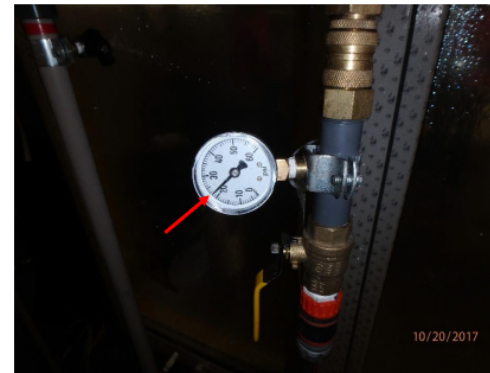
Photograph #19

View of a water pressure gauge at the hose connected to spray rack. Water pressure was set to 24PSI (red arrow).

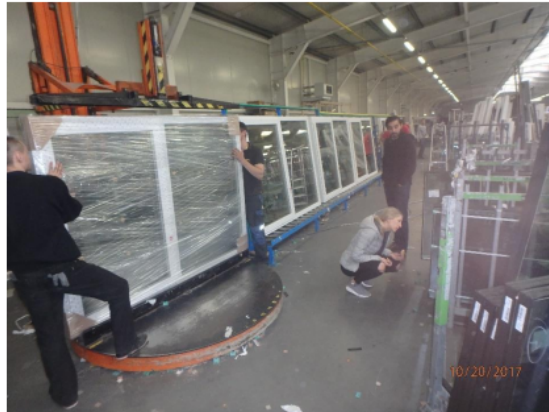
Photograph #64

Overview of typical window frames fully glazed with insulated glass and being wrapped with cellophane wrap.

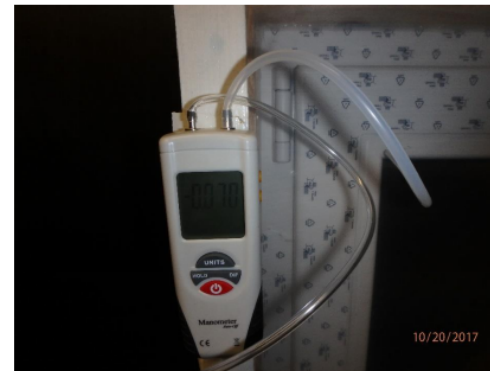
Photograph #20

View of the electrical Dual Dig-Monometer used to measure the differential air pressure in the chamber.

differential air pressure in chamber is 0.07PSI (red w).

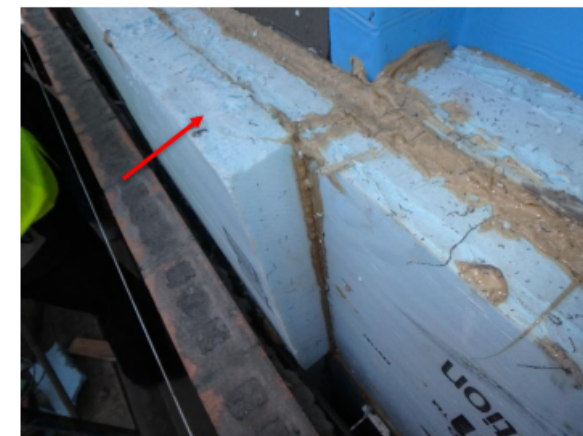
1.4

Locations: Ground Floor – West Elevation, various locations

Observation: The Contractor added DOW Scoreboard rigid insulation at the columns (*red arrow*) where it was previously missing, in accordance with CANY's previous recommendation (*refer to Report #26 – Section 1, Item 1.10 for previous observation*).

Conforming / Nonconforming: Conforming.

Referenced Document: Contract Drawings Detail 1/A341.

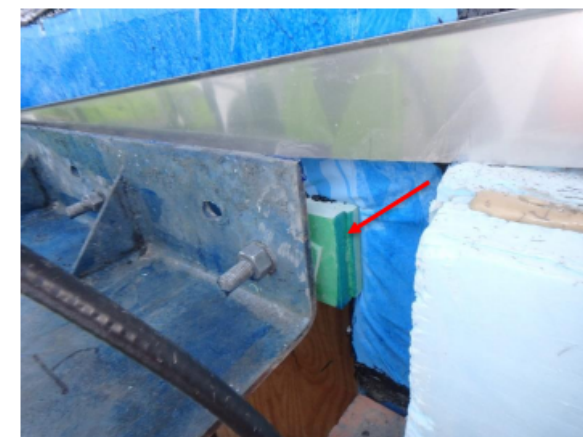
1.5

Locations: Ground Floor – West Elevation, various locations

Observation: Relieving angle installation was in progress. The fiber glass reinforced plastic structure plates were installed at each anchor location (*red arrow*).

Conforming / Nonconforming: In Progress.

Referenced Document: Contract Drawings Detail 4/A321.
