Multifamily
Deep Retrofit Profiles

High Rise / Low Carbon Multifamily

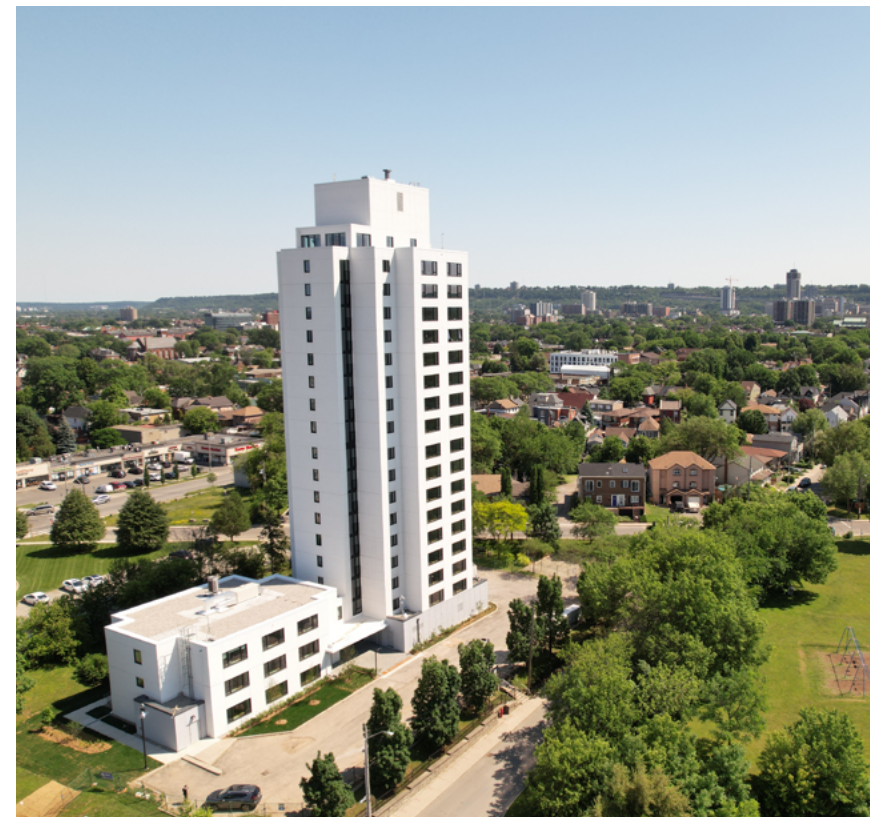
Major passive house rejuvenation drives dramatic energy reduction.

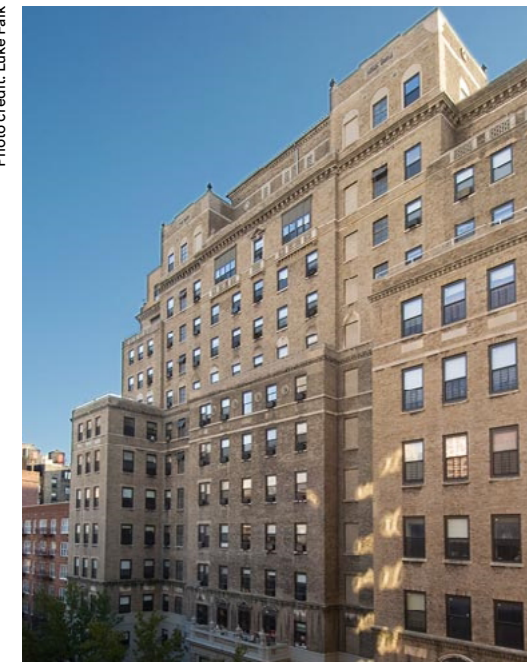
Energy use from inefficient heating systems can drop nearly 50% by replacing old boilers, installing controls, sealing windows, and balancing the steam distribution network.

TRVs were installed on all radiators throughout the building to more accurately control steam flow and temperature in apartments. A radiant barrier behind the radiator accompanied the TRVs. Air sealing and spray foam insulation reduced drafts in windows above the radiators, and storm windows were installed as well to further reduce infiltration. Like many old steam heating systems, the steam risers required balancing to more evenly distribute steam to each floor.

These low-cost energy conservation measures (ECM) reduced the peak heating demand enough to right-size new boilers to a significantly lower capacity, which, in turn, operated more efficiently. Wireless controls and additional indoor and outdoor temperature sensors increased the accuracy and efficiency of the building's heating system. The boilers were converted to have burners with micro-actuators, which allowed variable heat output rather than boilers that were either completely on or off.

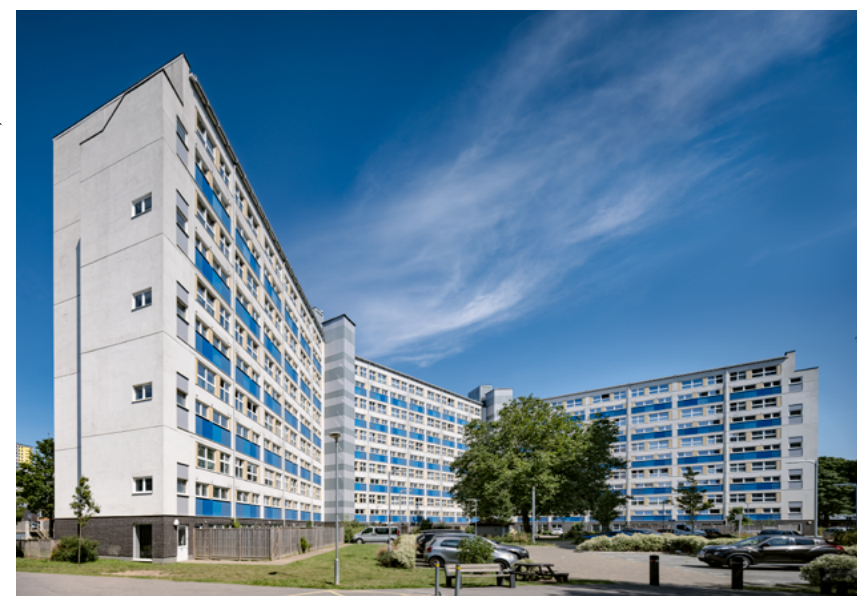
Passive House renovation drives down heating loads from leaky, uncomfortable, starting points.

Built in 1968, its original structure consisted of large, poorly insulated pre-cast concrete panels with inefficient windows and extensive thermal bridges, leading to high heat losses, internal condensation, mold growth, and low internal comfort levels. Due to its large panel system structure, natural gas was removed shortly after its original construction, and instead electric storage heaters were included in each maisonette, with electricity meters paid directly by each tenant. Unfortunately, after 50 years, the windows and facades were leaky, and the walls were poorly insulated, causing high electricity bills in the winter. Some low-income tenants experienced energy poverty and were unable to afford maintaining World Health Organization safe temperatures in their homes. Thus, a major envelope retrofit designed to EnerPhit/Passivhaus standards was developed and completed in 2018.

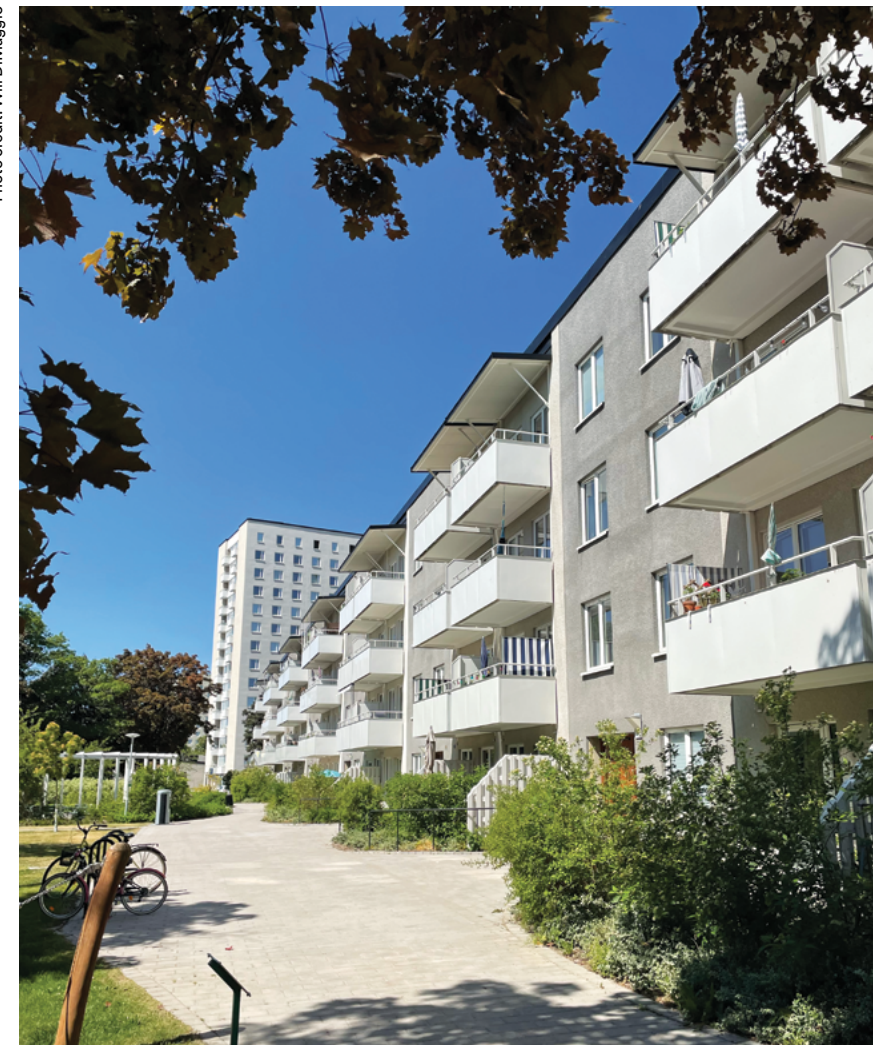
Nordic solutions for a deep energy retrofit of a housing complex.

Major envelope improvements led this retrofit. Old windows with a U-value of R3 were replaced with new R8 windows, and were installed with careful attention to air tightness and air sealing around the frames. Exterior walls received an additional 3” of exterior insulation, while roof areas received an additional 12” of insulation. Ventilation systems went from mechanical ventilation without heat recovery to a trickle vent under each window that drew fresh air past radiators to immediately heat intake air. Toilet and kitchen exhaust risers flowed to an exhaust air heat pump, which extracted heat from exhaust air and provided a heat source for the domestic hot water heat pump. A total of 80kW of rooftop solar photovoltaic panels were installed on various rooftops around the complex. Many other small ECMs were installed as well, including wastewater drain heat recovery to preheat domestic hot water, hot water distribution piping insulation, modern thermostats controlling radiators in each unit, and LED lighting in hallways and elevators.

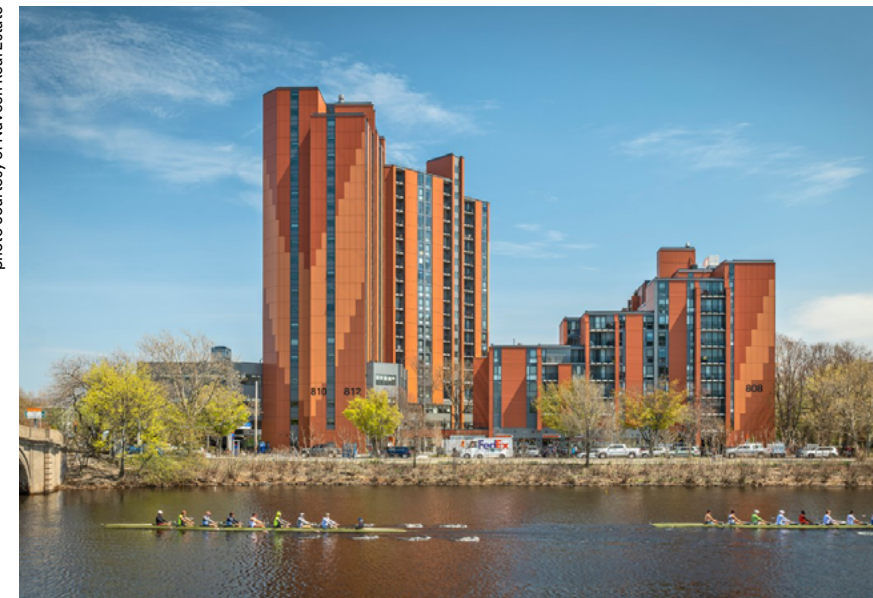
Years in the making, this major undertaking to put a new envelope on an iconic building in Cambridge was finally completed in 2023.

Securing funding for the more than \$15M project took many years, but finally came through in 2019. Most of the project cost went to the exterior insulated over-cladding panels and windows. About a third of the project cost was for air conditioning equipment and a new cooling tower. The incremental cost of LED lighting and ENERGY STAR appliances were minor, yet they were wrapped into the financing package.

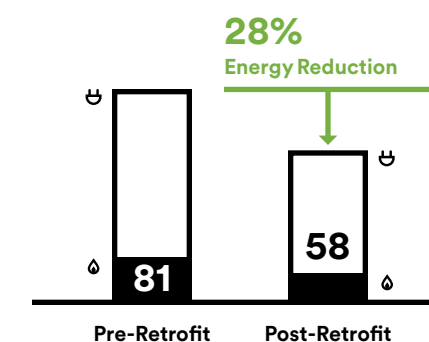
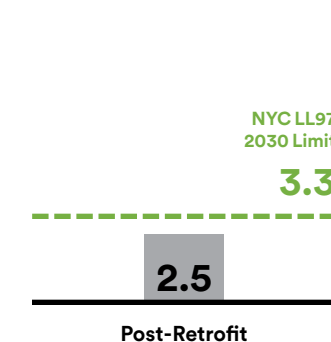
Site EUI

kBtu/sf

energy source
 ☺ electric
 ⬇ natural gas

GHGI (using NYC LL97 factors)

kg CO₂/sf

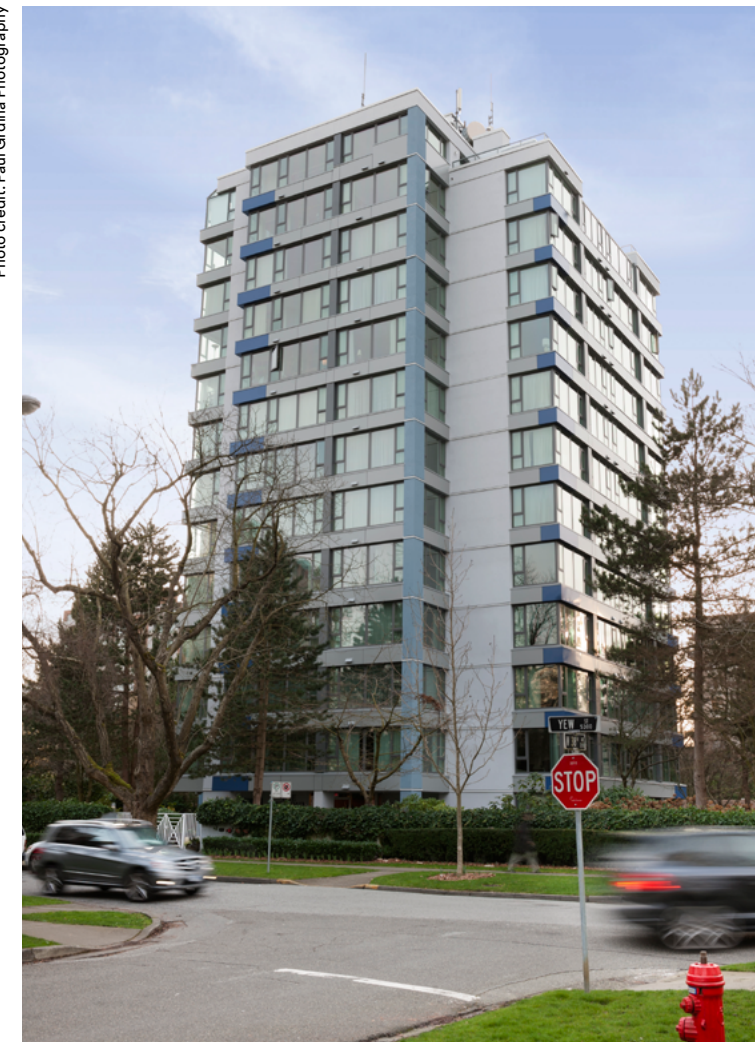
Envelope improvements alone reduced energy use by 17% and are keeping the feet warm in this senior living facility.

Because of the improvements to thermal bridging, air tightness, and overall insulation values of the new envelope, residents began seeing condensation on the exterior surfaces of windows some mornings and expressed concerns. The RDH team explained that some mornings after clear nights with a lot of black sky radiation would make the exterior surface of the windows quite cold and condenses moist air when relative humidity is high. Previously the glass would be warmer because of heat loss from the warm apartments inside and the exterior surface would not drop below the dew point.
